General Info

Category Skid Steer Travel System Wheels & Tires Comments Pear Year 2017 Make Bobcat Model S650 Fleet ID 46280BLA Serial Number ALJ820042 Serial Number Plate Plate Bobcat	General IIIIO			
Year 2017 Make Bobcat Model S650 Fleet ID 46280BLA Serial Number Plate Serial Number Plate Hour Meter Reading 1,117 Hour Meter Photo	Category	Skid Steer		
Year 2017 Make Bobcat Model S650 Fleet ID 46280BLA Serial Number Plate Serial Number Plate Hour Meter Reading 1,117 Hour Meter Photo	Travel System	Wheels & Tires		
Make Model Sefo Fleet ID 46280BLA Serial Number ALJ820042 Serial Number Plate Hour Meter Reading Hour Meter Photo	Comments			
Model S650 Fleet ID 46280BLA Serial Number ALJ820042 Serial Number Plate Hour Meter Reading 1,117 Hour Meter Photo	Year	2017		
Fleet ID Serial Number ALJ820042 Serial Number Plate Hour Meter Photo Hour Meter Photo	Make	Bobcat		
Serial Number Plate Hour Meter Photo Hour Meter Photo	Model	S650

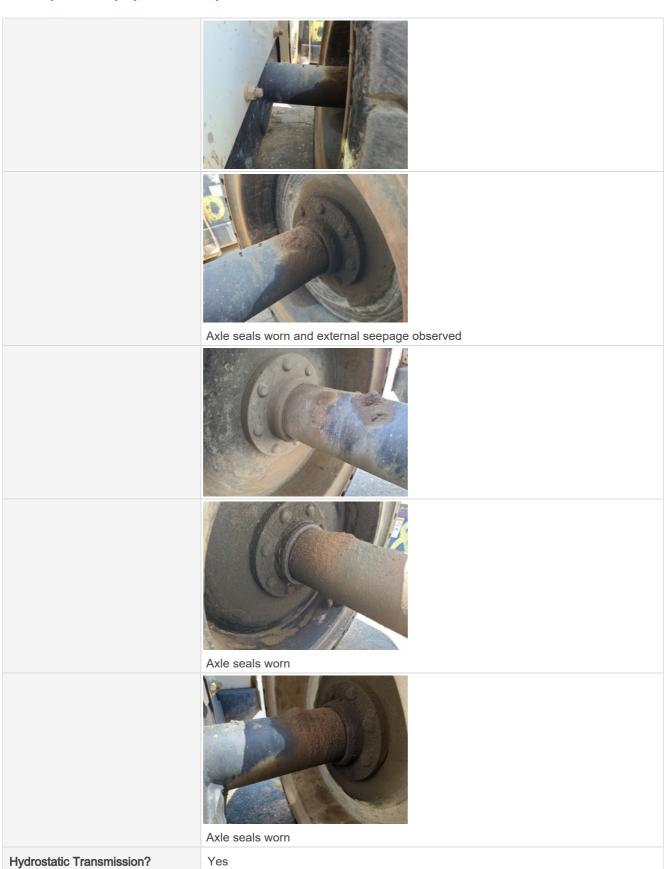
2 Speed?	No
Hydrostatic Drive Configuration	Split Transmission
Comments	
Transmission Info (Make/Model/Speeds)	
Drivetrain Rating	3 - Normal Wear & Tear
Drivetrain Comments	Some axles showing signs of grease leaking past seals.

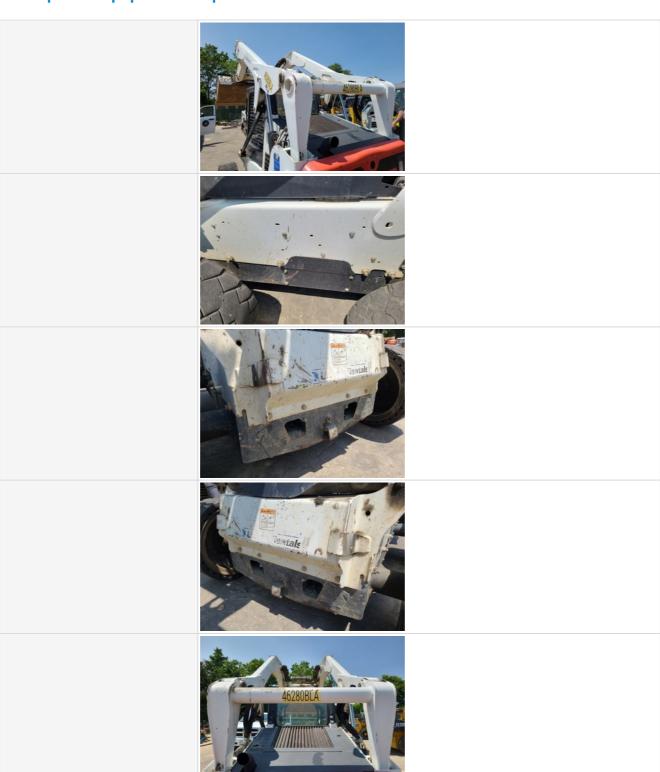
Chassis Rating

3 - Normal Wear & Tear

Frame in good shape and implements have no excess play in pin connections.
