Enterprise Equipment Inspection

Category	Other
Travel System	Other (see comments)
Comments	machine is a walk behind concrete saw
Year	2010
Make	Husqvarna
Model	FS6600D
Fleet ID	1282213001
Serial Number	PE4024R041529
Serial Number Plate

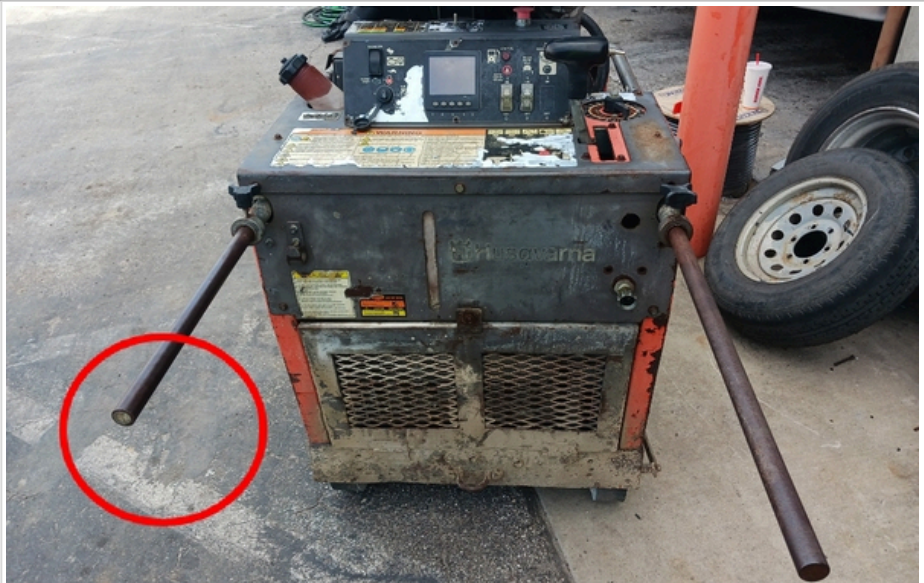
the handles are not the same length

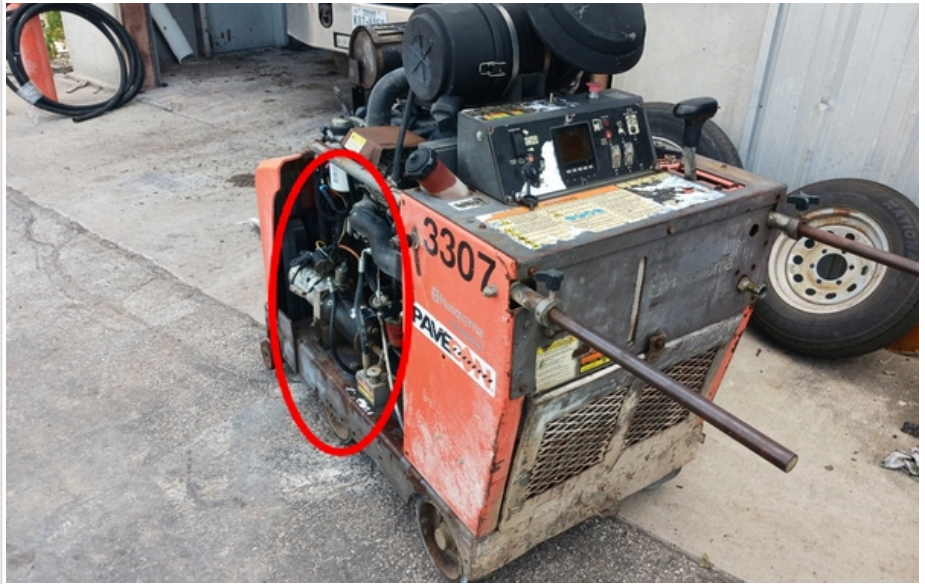
panel is not attached but fits loosely

Panels on the left and right hand side are not attached, but when attached fit loosely

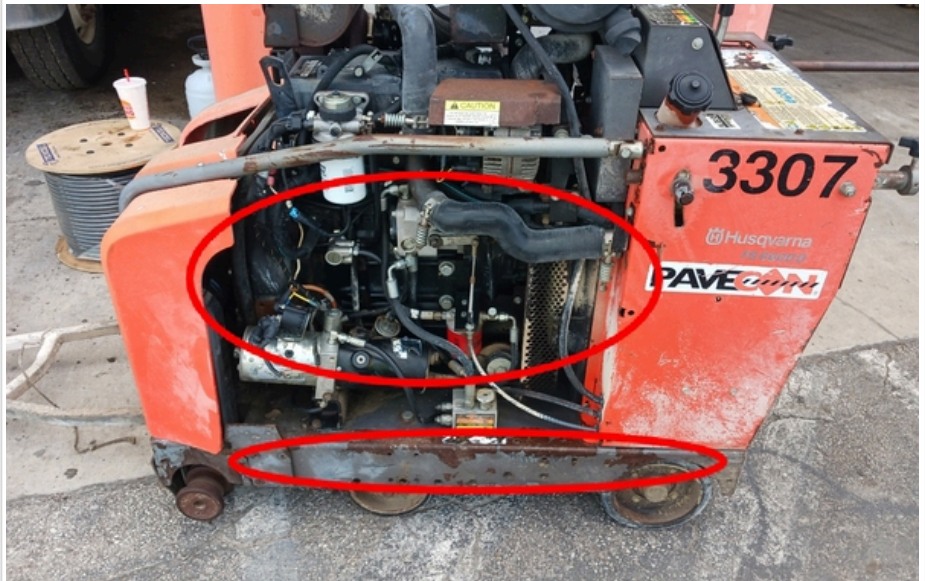
panel not attached but fits loosely when it is. areas of rust

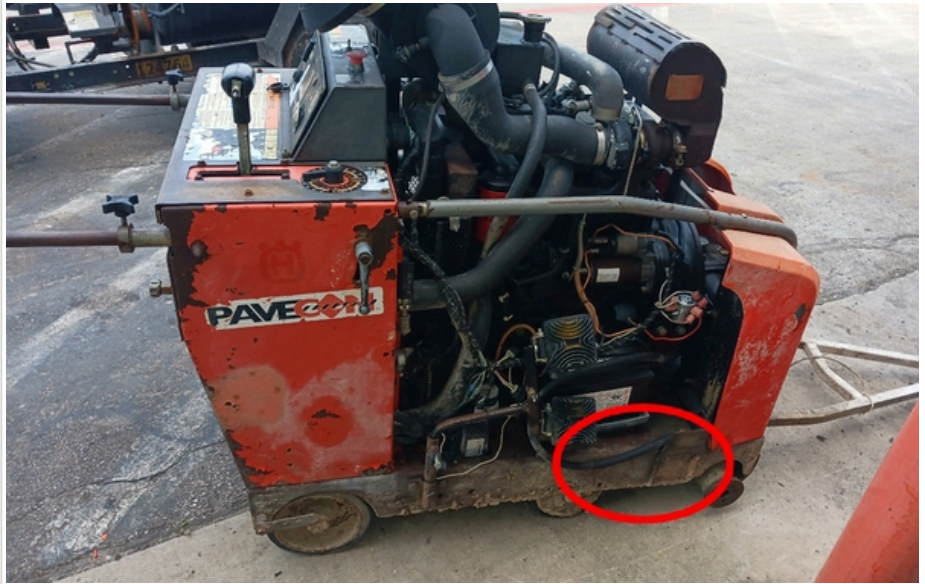
unattached hose

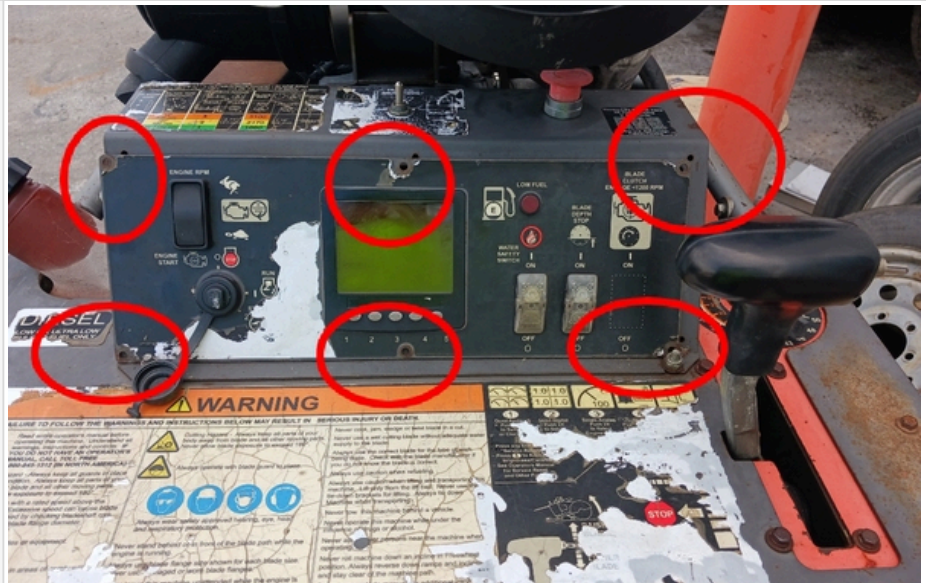
display screen is not screwed in

<p>the control to lift machine up and down comes out of place when used.</p>
	  <p>missing screws</p>
Control Station Rating	2 - Above Average Wear & Tear
Control Station Overall Comments	Display screen is not held in place properly. The switch that controls up and down movement comes out of place when used.

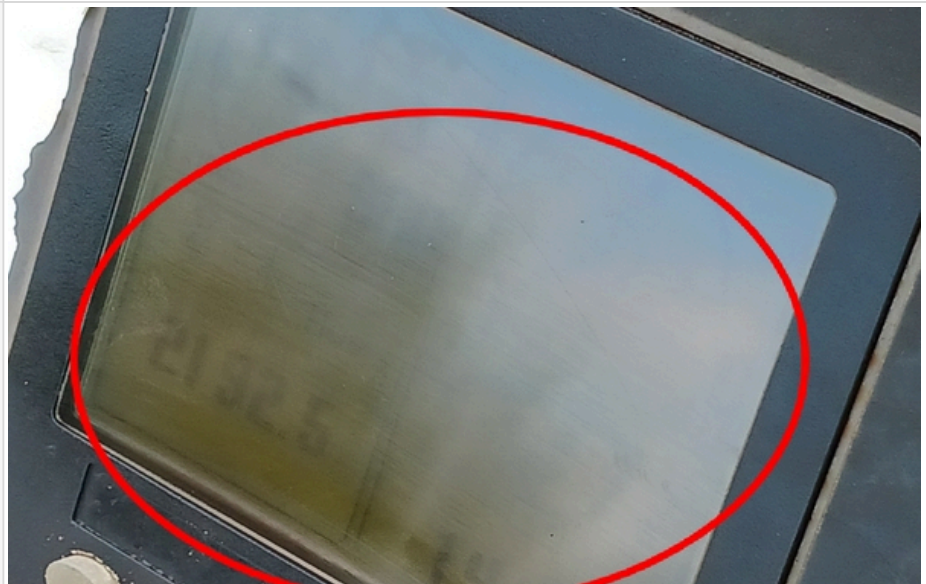
display worked but was a little difficult to see

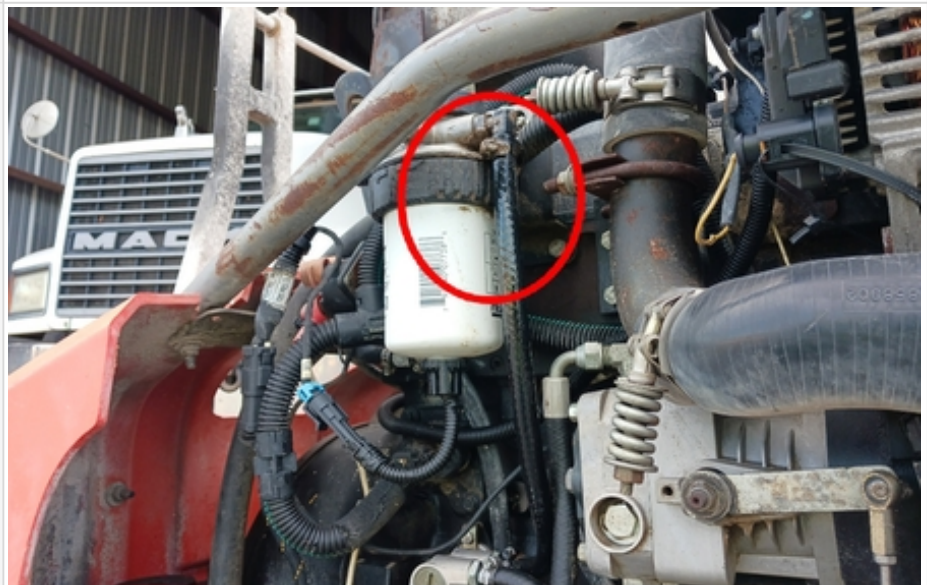
small leak

Engine Type (Make, Model, Cylinders, Hp)	john deere, 4024HF295, 2.4L, 60hp
Emissions Tier	Tier 3
Engine Rating	2 - Above Average Wear & Tear
Engine Overall Comments	The engine had some small leaks and blew out white smoke when idle was accelerated

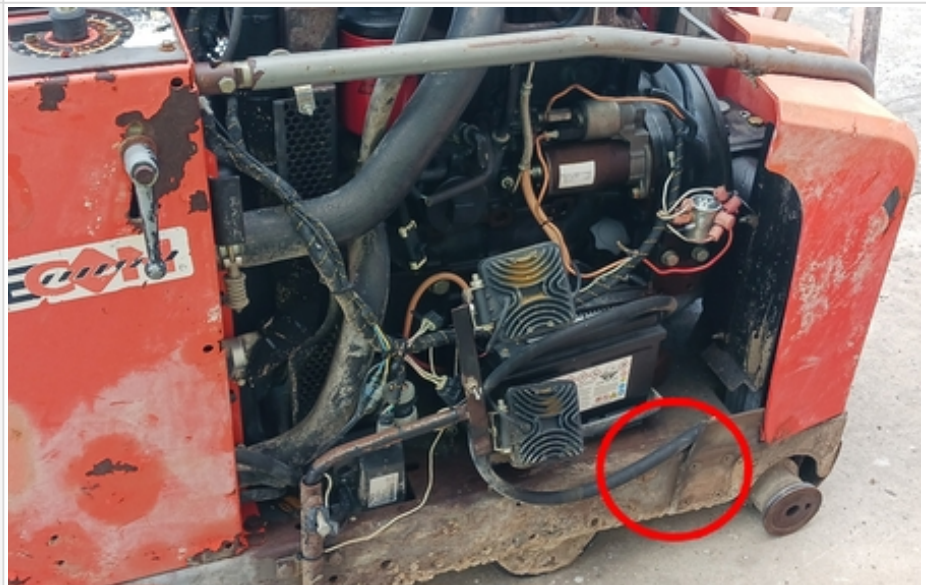
unconnected hose

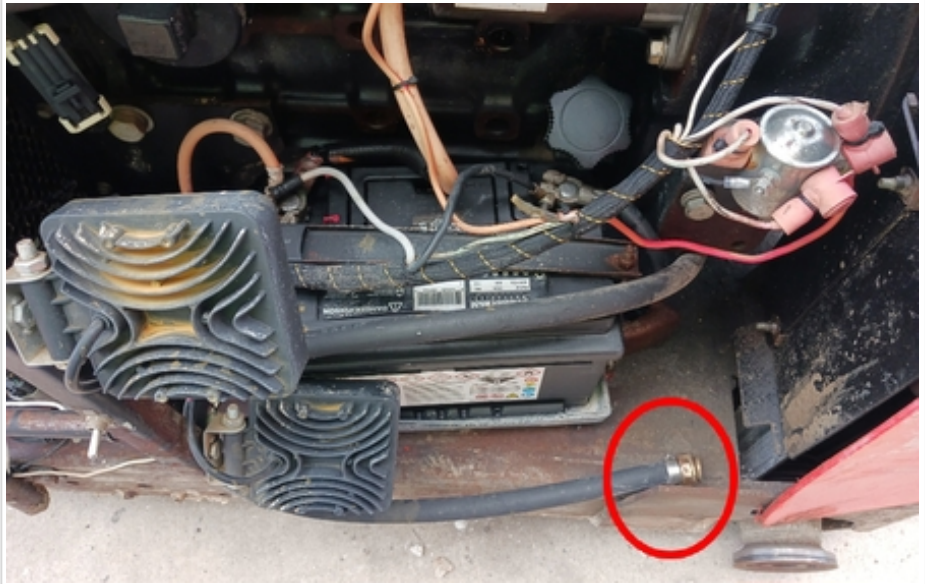
unconnected hose

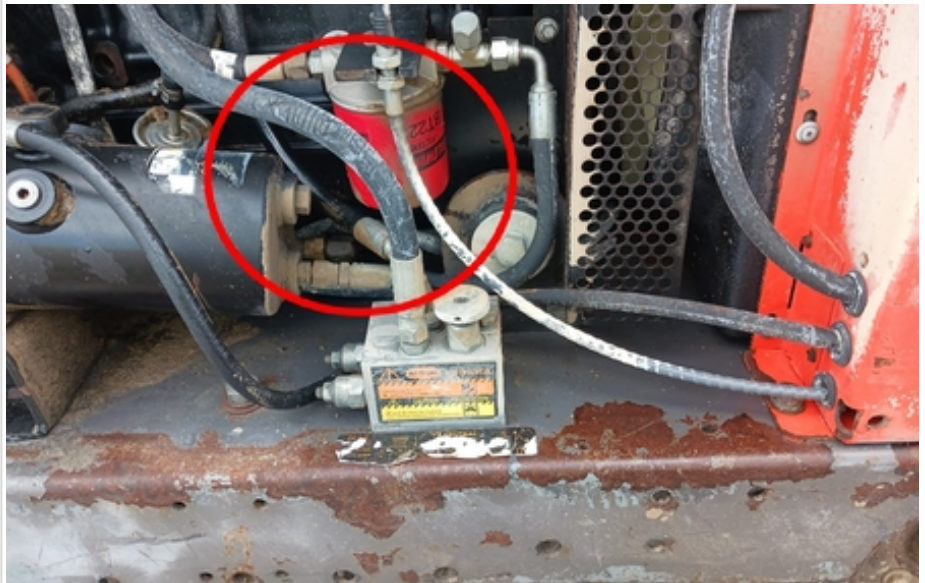
cracked/dried areas on hoses

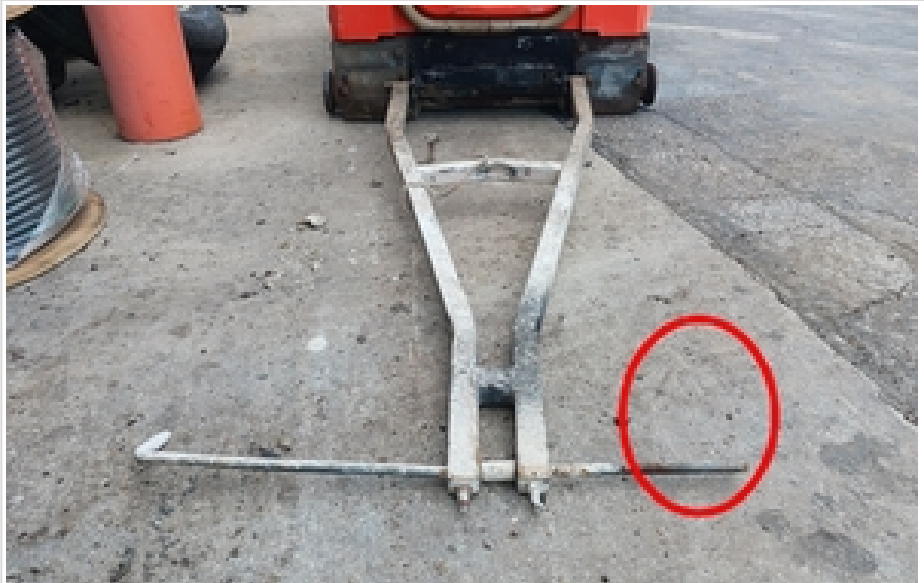
the attachment is missing a piece on the left hand side
