Inspection Report (Vibratory Compactor)

Year	2012
Make	Hamm
Model	HD12
Serial Number	H20Q1545
Hour Meter Reading	859.6
Previous Application (e.g., earth moving, mining, demolition, etc)	asphalt roller

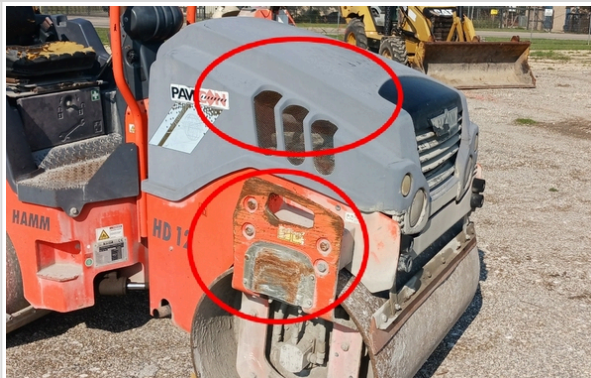
area of rust/missing paint, and faded hood

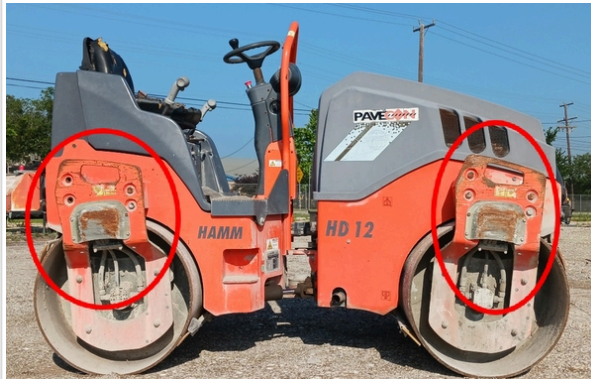
area of rust/missing paint

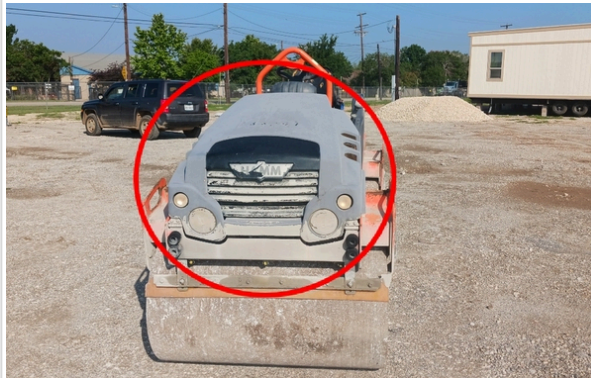
faded hood, the emblem is missing paint/decals, and the lights are dirty

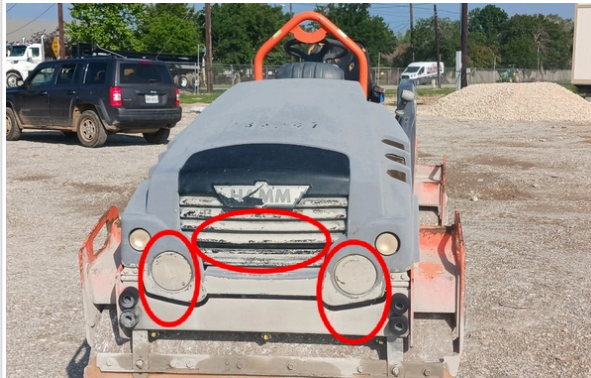
faded/missing paint on grill and the lights are dirty

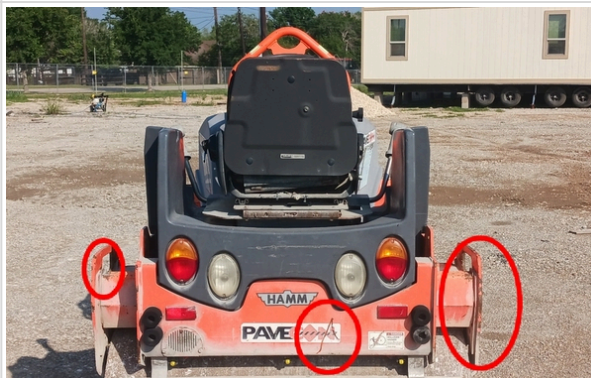
small areas of rust/missing paint

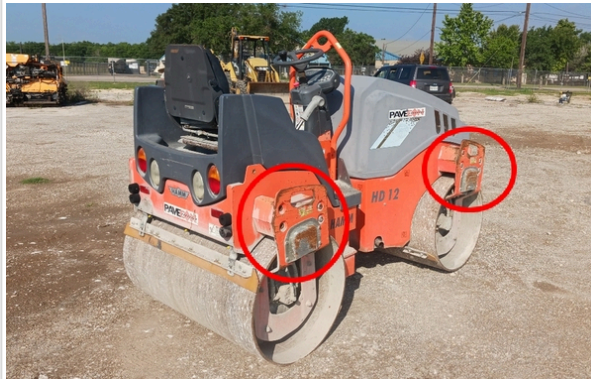
small areas of rust/missing paint

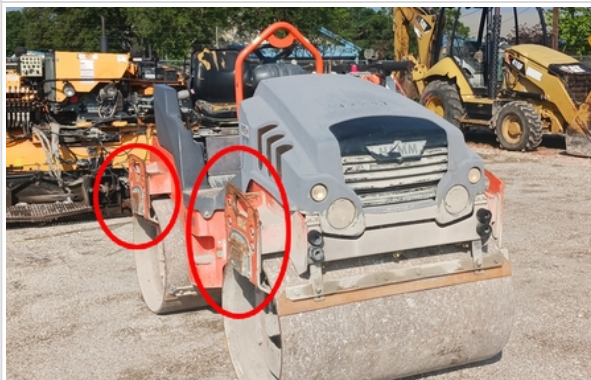
small areas of rust/missing paint

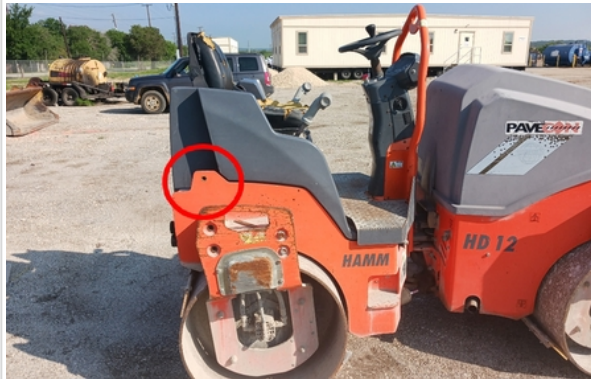
missing canopy

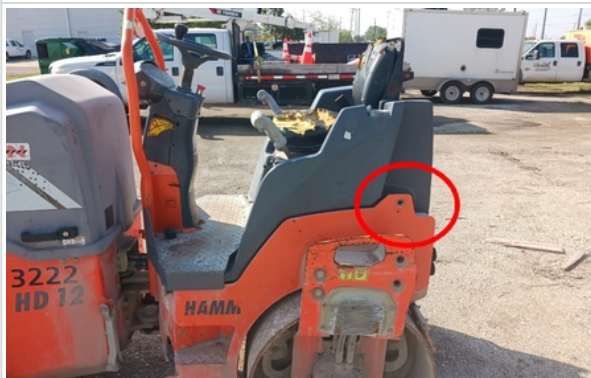
missing canopy

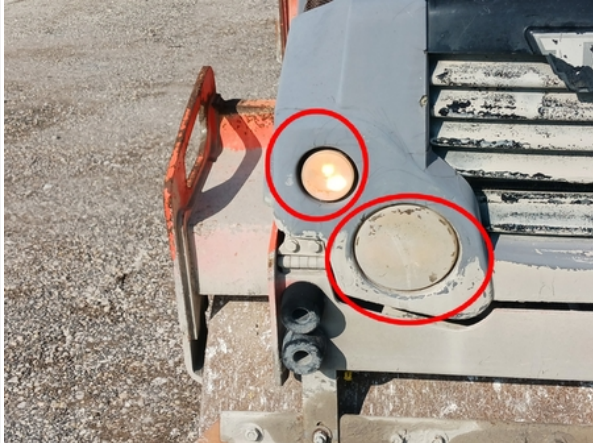
<p>light does work it is just dirty, blinkers work</p>

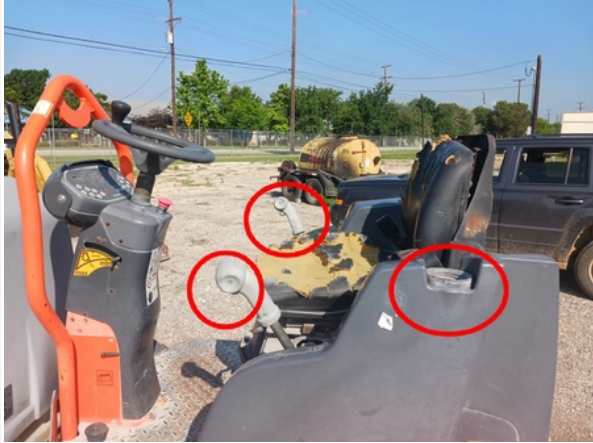
<p data-bbox="534 1933 1161 1960">missing cover for water system and the controls are faded</p>

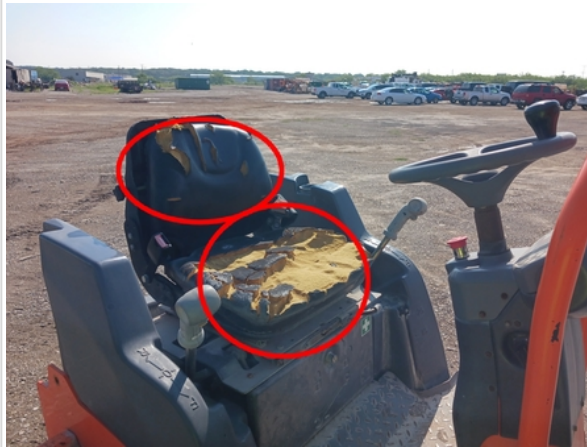
big tears on the seat

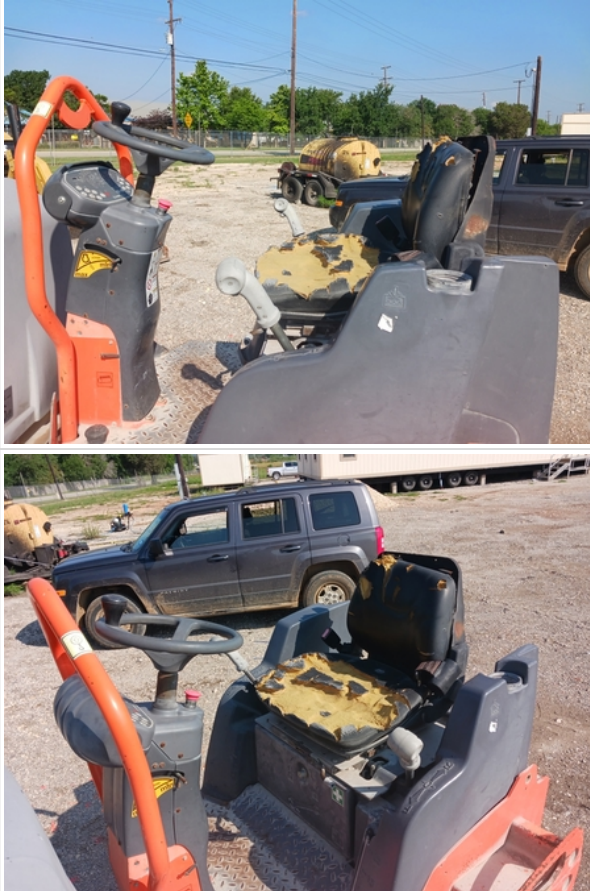
Operator Cabin Overall	3 - Normal Wear & Tear	
Operator Cabin Overall Condition	Minor cosmetic wear to cabin surfaces, floors, panels, and ceiling	
Operator Seat	2 - Above Average Wear	
Operator Seat Condition	Seat(s) is damaged due to sun exposure; fading, cracking observed, Seat(s) has major surface staining or tears, Seat belt secures properly, Seat belt is intact and in good condition	
Operator Seat Photos

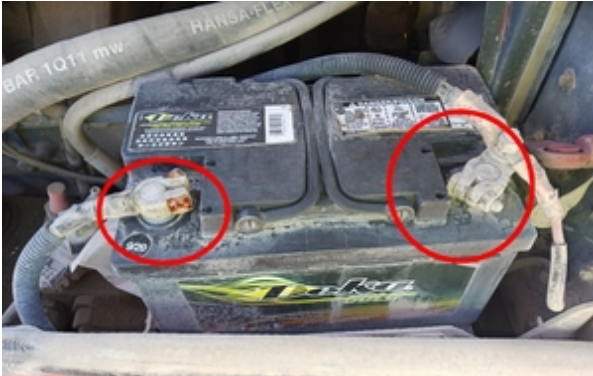
<p data-bbox="536 1361 770 1391">normal wear and tear</p>

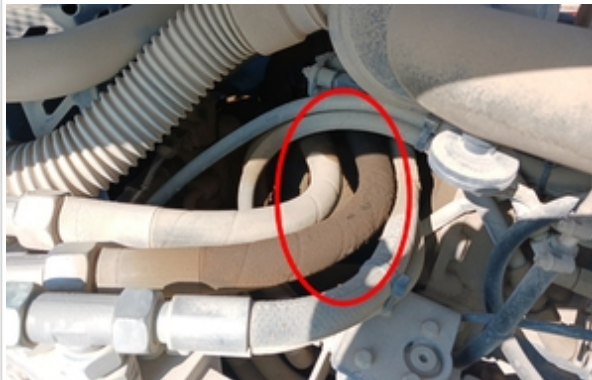
dirty/gunk area and area was moist

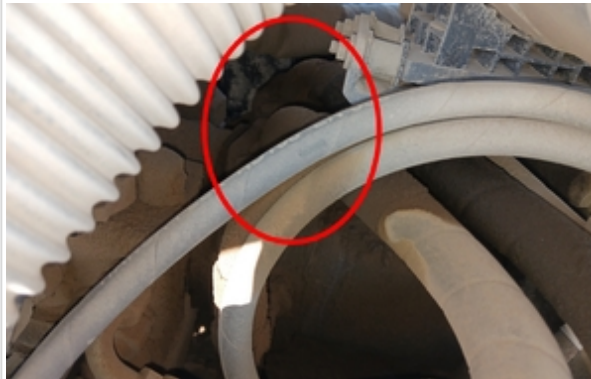
dirty/gunky area

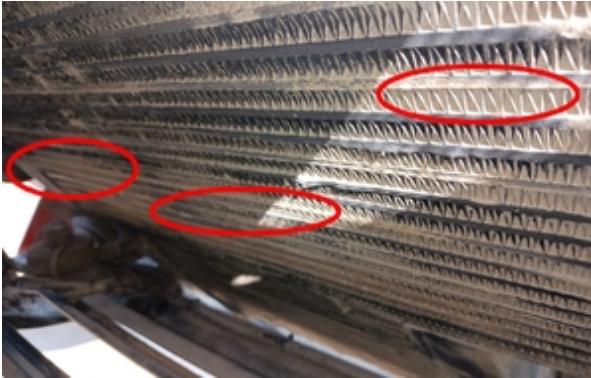
<p>clogged/dirty areas</p>

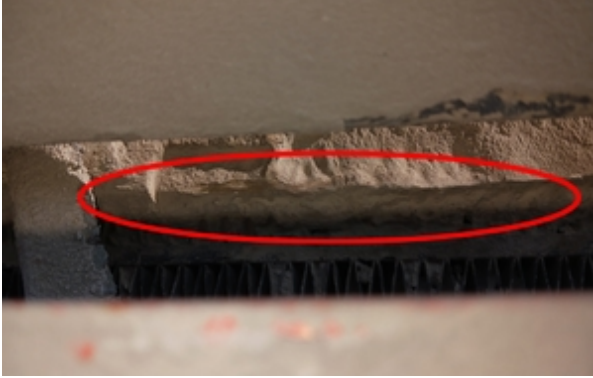
<p>clogged/dirty areas</p>	
Belts	<p>3 - Normal Wear & Tear</p>	
Belt Condition	<p>Belts appear in good condition & alignment with proper tension</p>	
Hoses	<p>3 - Normal Wear & Tear</p>	
Hose Condition	<p>Dried seepages observed, Other (see comments)</p>	
Comments	<p>some hoses have a moist appearance</p>	
Hose Photos

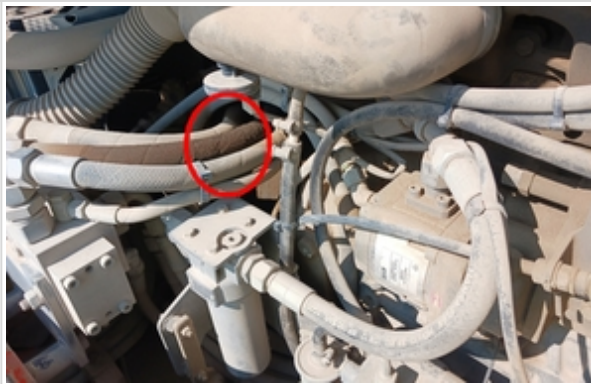
moist area with dirty/gunky residue on the hose

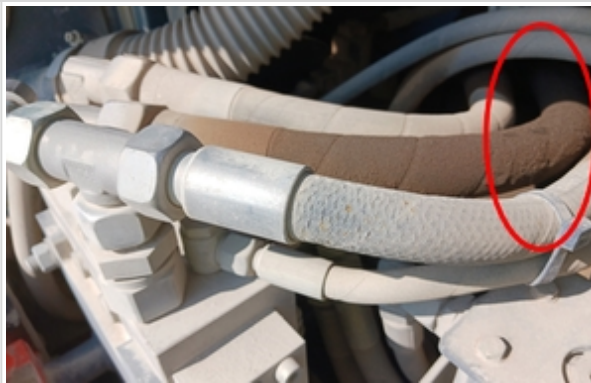
moist area with dirty/gunky residue on the hose

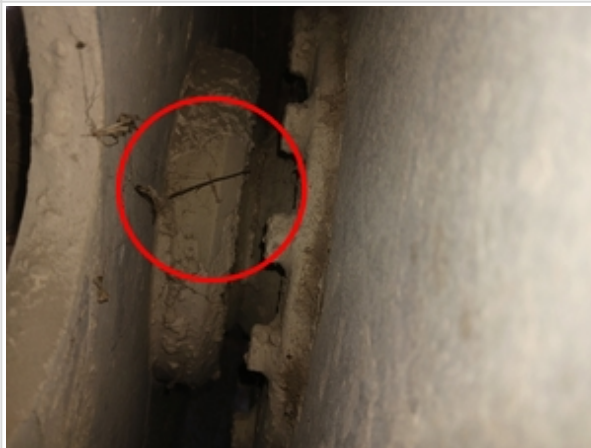
piece of grass/twig not a crack

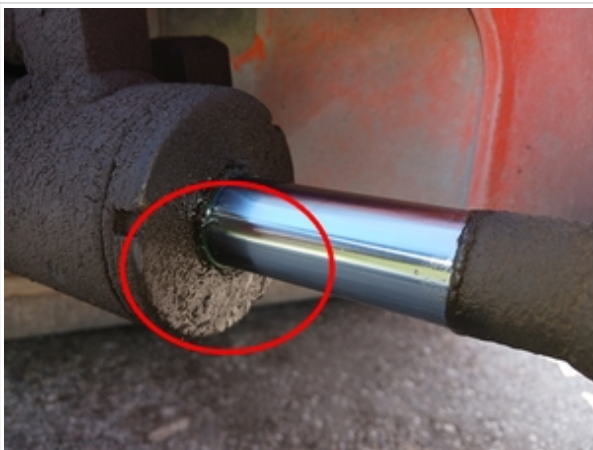
Steering Cylinders	Check the steering cylinder. Note any wear, pitting, discoloration, etc. Take photos.
Steering Cylinders: Mounting Pin	3
Steering Cylinders: Oil Leaks	Yes
Comments	the steering cylinder has a small leak coming from the seal
Steering Cylinders Photos

<p>damp area/ small leak coming from the seal</p>

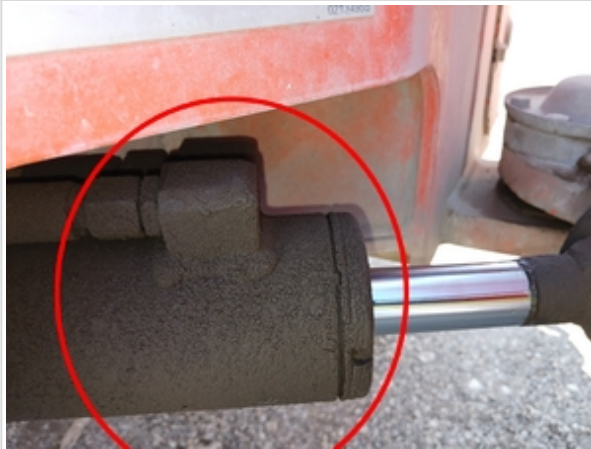
damp/moist area
