Inspection Report (On-Highway Flatbed Truck)

Year	2008
Make	Kenworth
Model	T300
Serial Number	2NKMHN6X78M222818
Truck Odometer Reading	240,289Miles. 7,764Hrs.
Current Inspection / State Cert / DOT	N/A
Previous Application (e.g., earth moving, mining, demolition, etc)	Service Truck

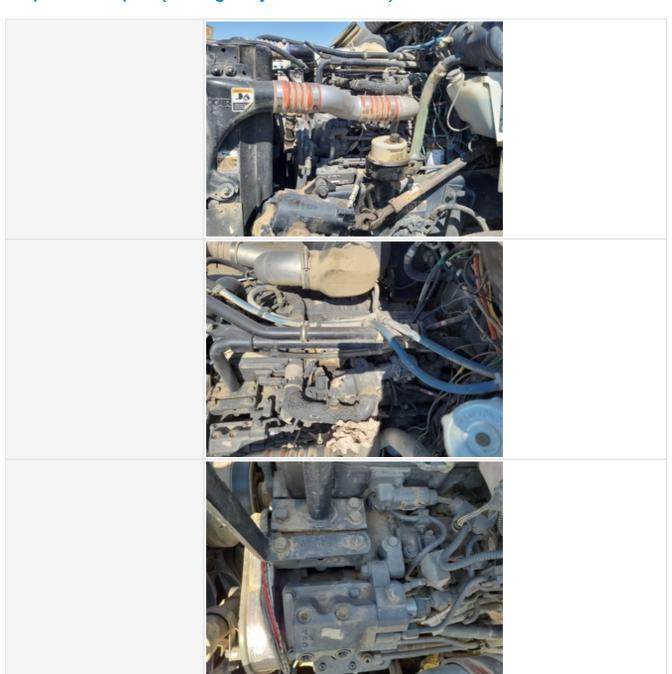
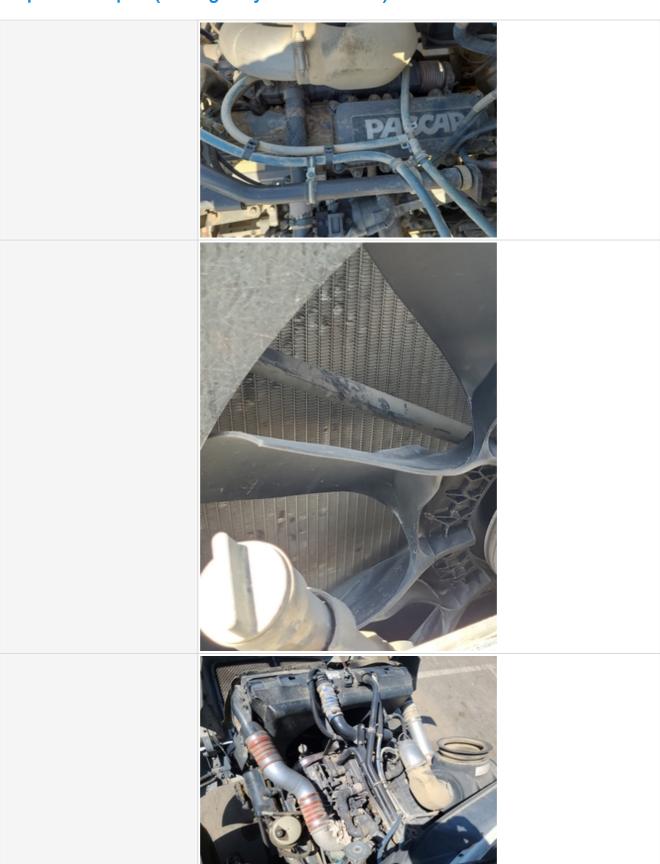
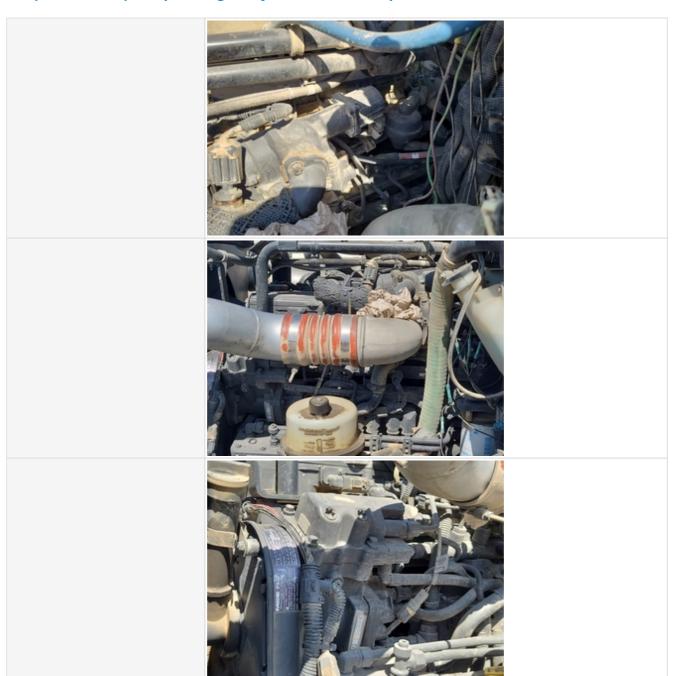
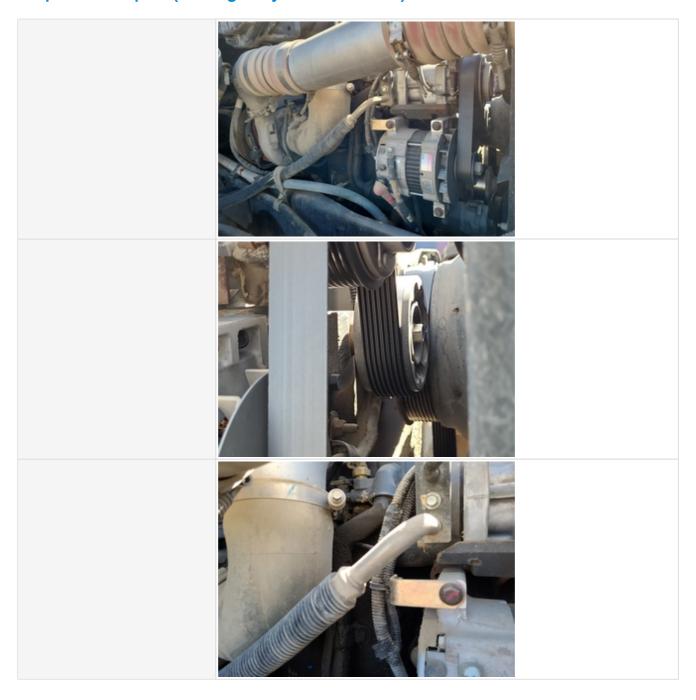
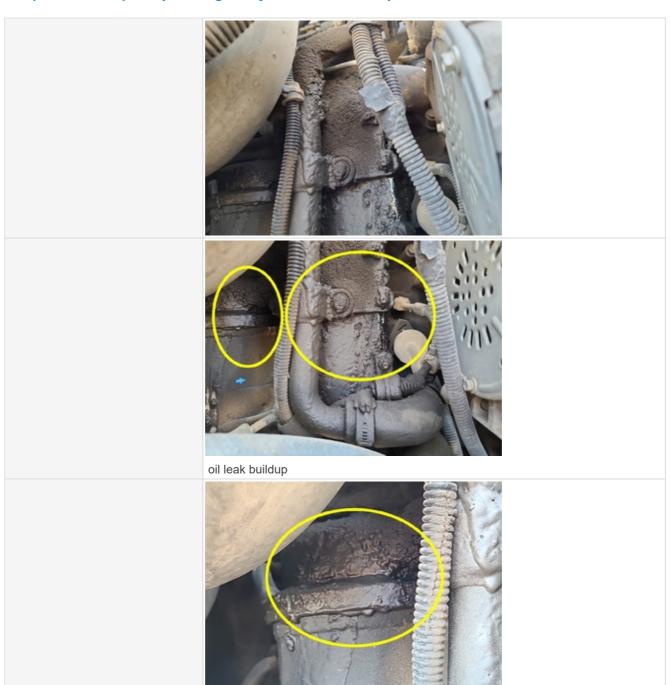
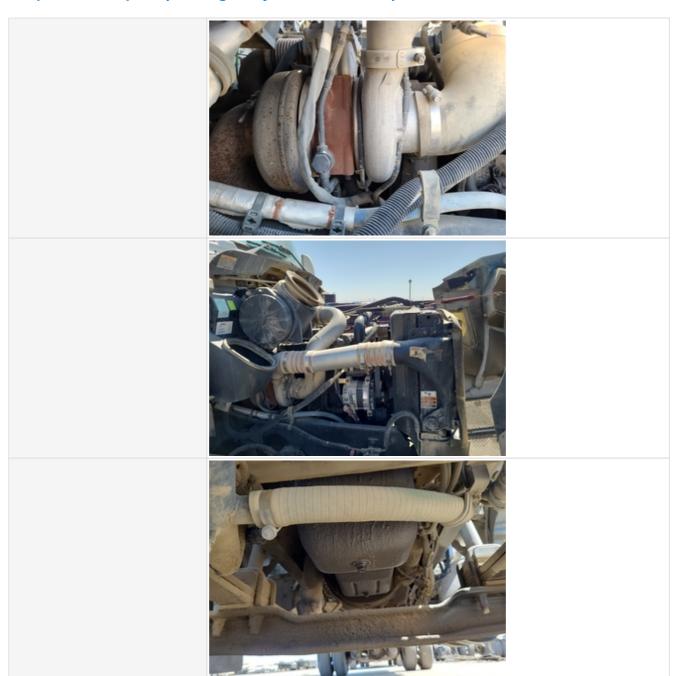
- 1111	oil leaks observed at right of engine.
Fuel Leaks No	nal Wear & Tear
Requires DEF (Diesel Exhaust No Fluid)	
Overall Engine Appearance Areas of	
Overall Engine Comments Overall filter ba a Tier 3	f dried seepage seen on engine hoses & components

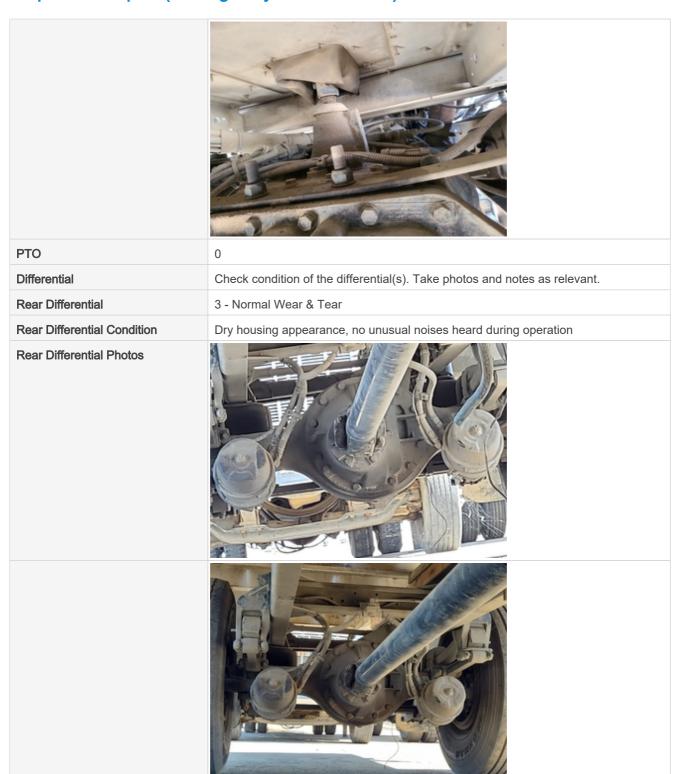
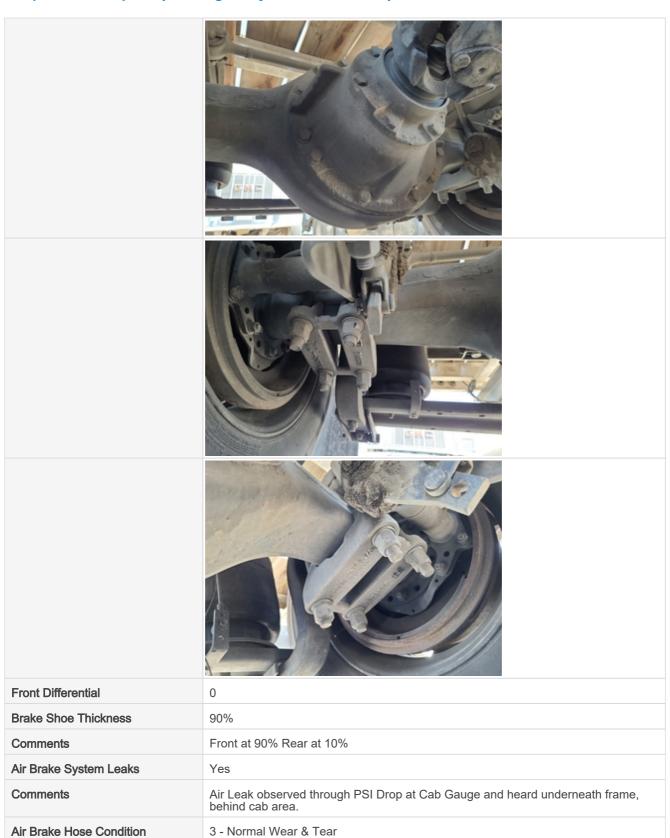
PTO mounting area exposed

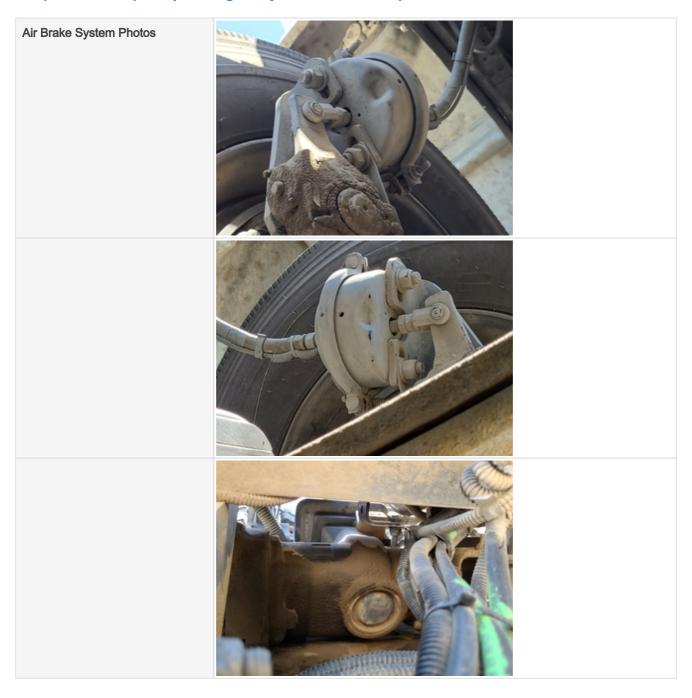
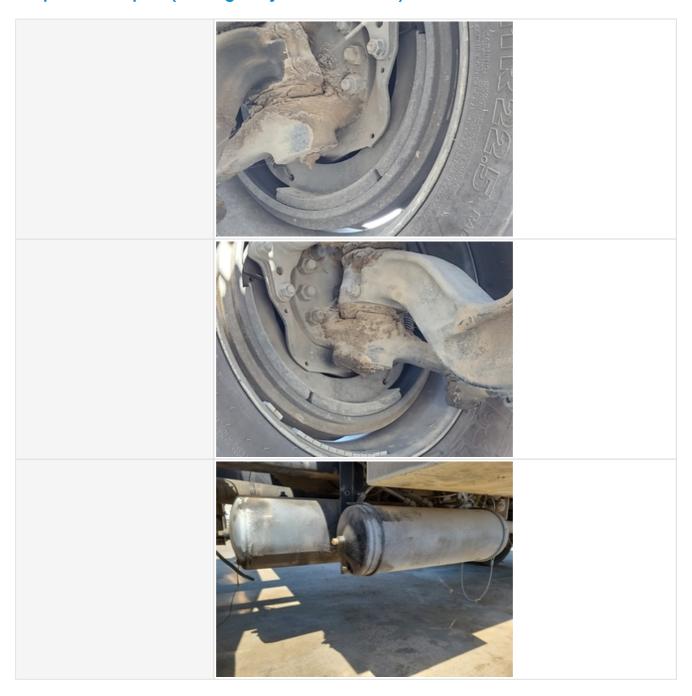
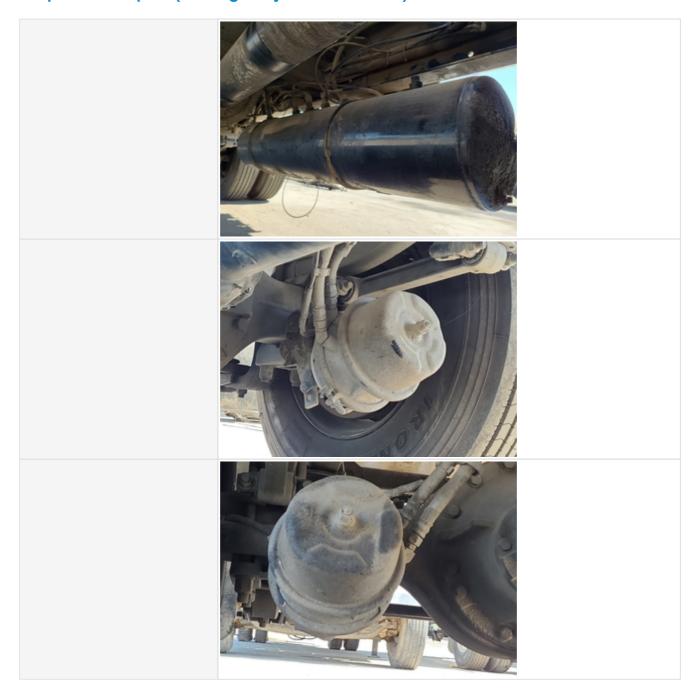
Brake shoes low

Shocks and rear brake shoe's should be replaced.

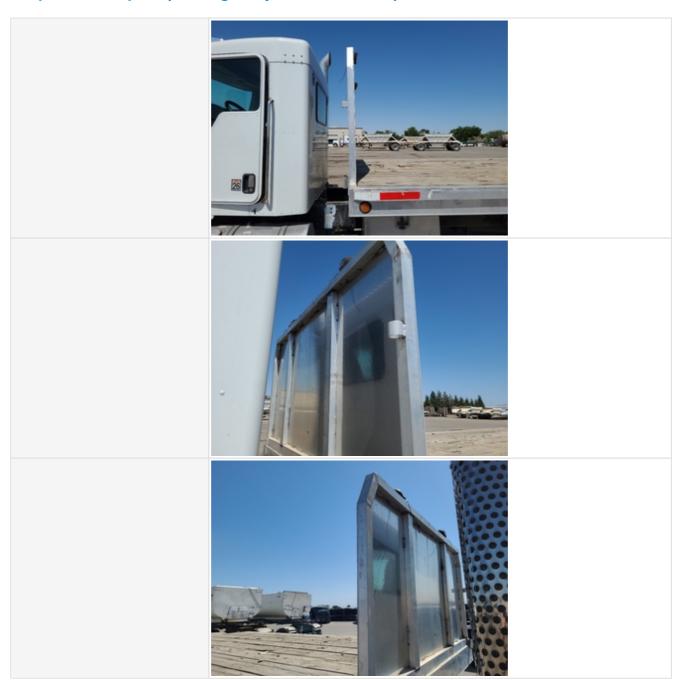
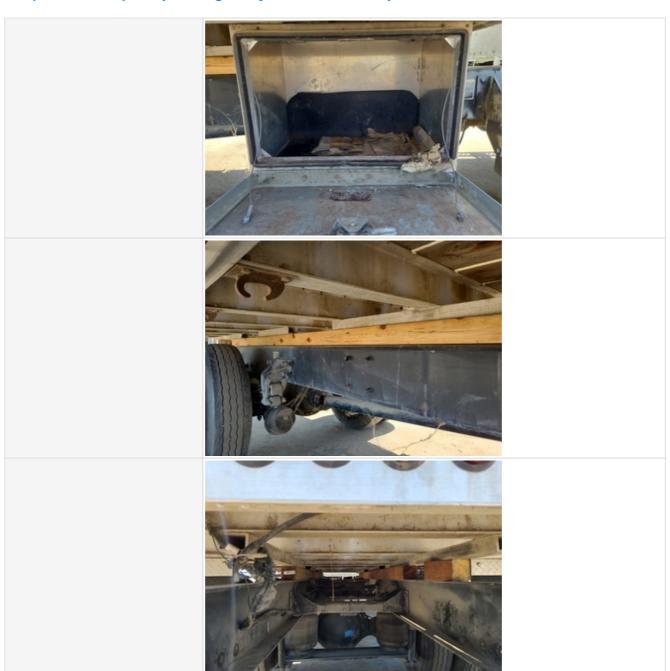
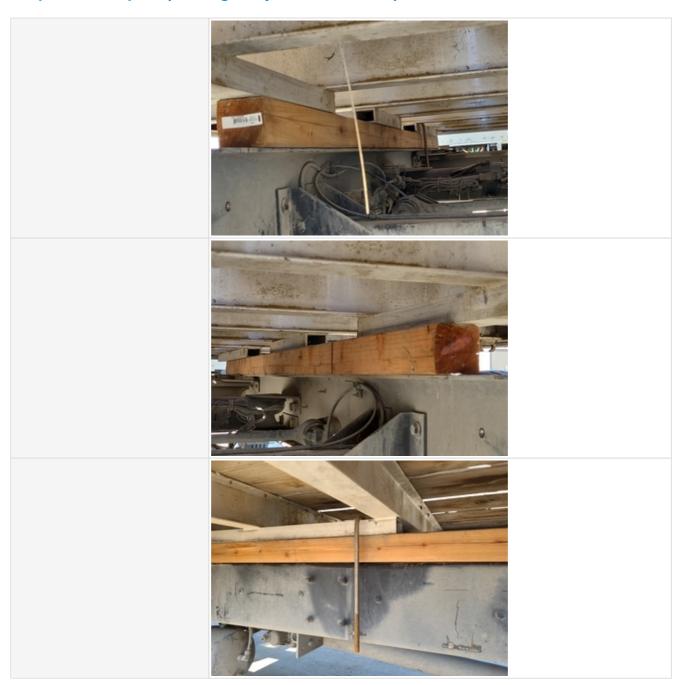
Flatbed Body Photos

Flatbed Body	Check the condition of the flat bed body. Note any damage or wear. Take photos.
Bed Details (Deck Type, Additional Features)	16' Aluminum Flatbed
Flatbed Length (ft and inches)	16'
Flatbed Width (ft and inches)	8'4"
Flatbed Body	3
Comments	Flatbed not 100% mounted to truck frame
