Inspection Report (Bulldozer)

B&B Stock Number	1
Year	2021
Make	CAT
Model	D3
Serial Number	XKW00589
Hour Meter Reading	626 Hrs.
Previous Application (e.g., earth moving, mining, demolition, etc)	Landscaping

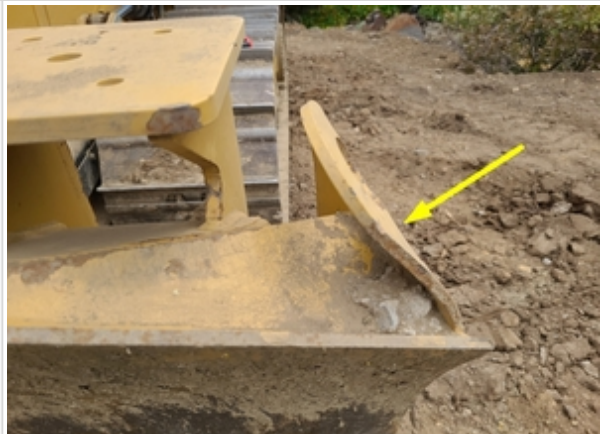
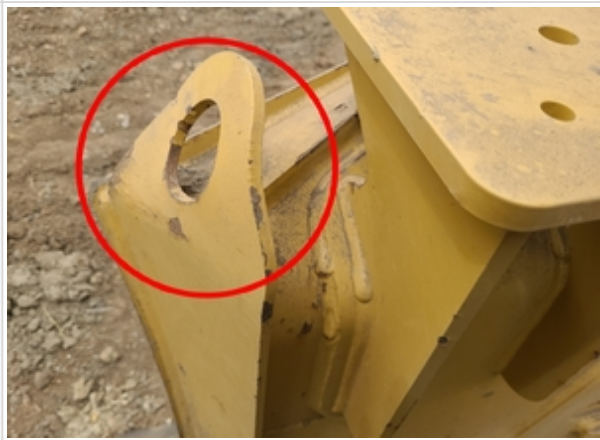
Attachment Type	6 Way Blade
Attachment Make	CAT
Attachment Size / Specs	9' Wide
Attachment Condition	4 - Very Light or Minimal Wear
Comments	Top Left Corner Hook/Ring Bent

<p data-bbox="531 1234 766 1274">Slightly Bent Inwards</p>
