Inspection Report (Excavator)

Year	2021
Make	CAT
Model	308 CR
Serial Number	JGG801957
Hour Meter Reading	450 Hrs.
Previous Application (e.g., earth moving, mining, demolition, etc)	Landscape/Rock Removal

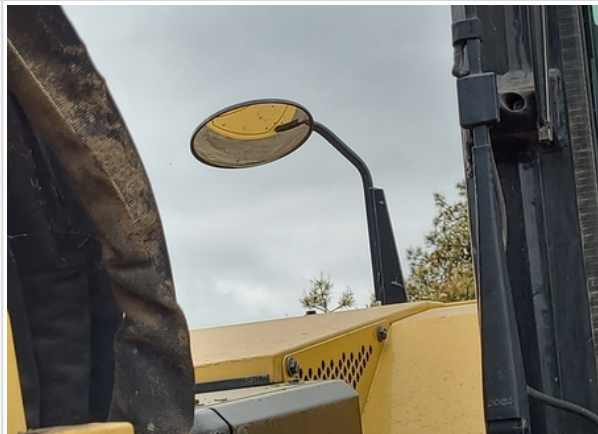
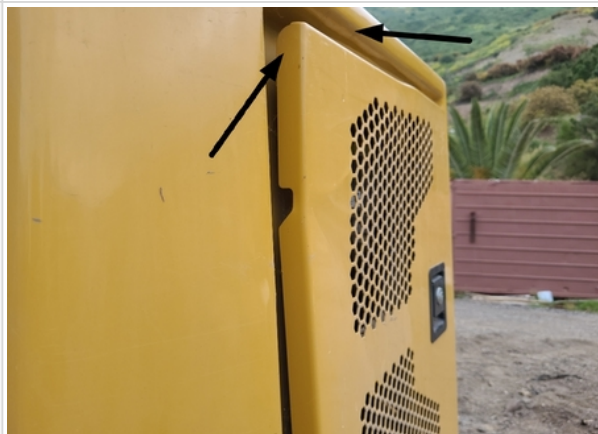
<p>Minor Panel Misalignment</p>
Body Panels	3 - Normal Wear & Tear
Body Panel Condition	No visible damage, good paint condition and panel fitment, Some panel misalignment observed
Comments	R/S Radiator/Air Filter Door Panel slightly bent
Doors / Canopy Latches	3 - Normal Wear & Tear
Doors / Canopy Latches Condition	No visible damage
Steps / Ladders	3 - Normal Wear & Tear
Steps / Ladders Condition	Steps/ladders are fully intact and appear structurally sound
Handrails	3 - Normal Wear & Tear
Handrails Condition	Handrails are fully intact and appear structurally sound
Glass	3 - Normal Wear & Tear
Glass Condition	Glass intact, no visible damage
Mirrors	3 - Normal Wear & Tear
Mirror Condition	Mirrors present and intact, no visible damage
Exterior Lights	4 - Like New, Recently Replaced
Exterior Lights Condition	No visible damage, lighting system is operational

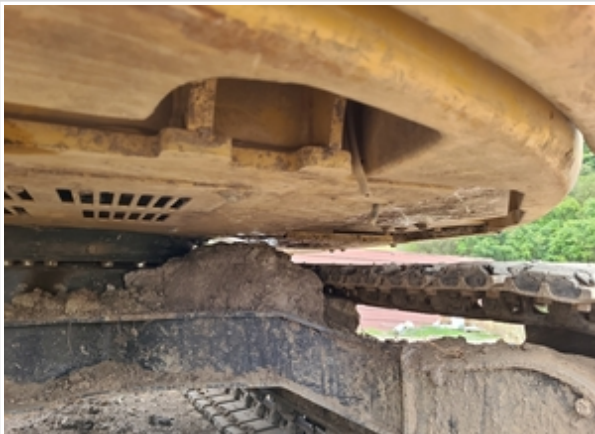
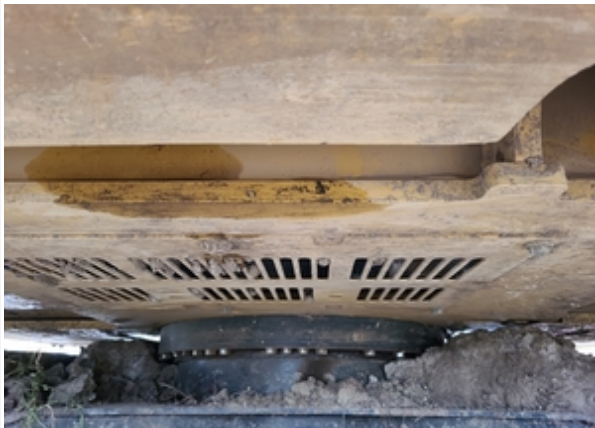
Bottom Covers	3 - Normal Wear & Tear	
Comments	Some scuff marks and minor dents observed.	
Bottom Covers Photos

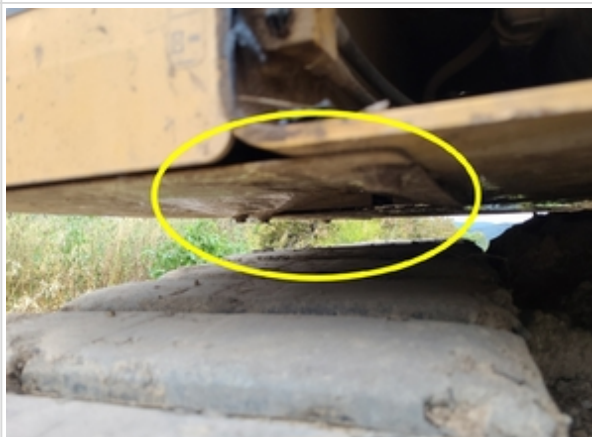
Bottom cover dented

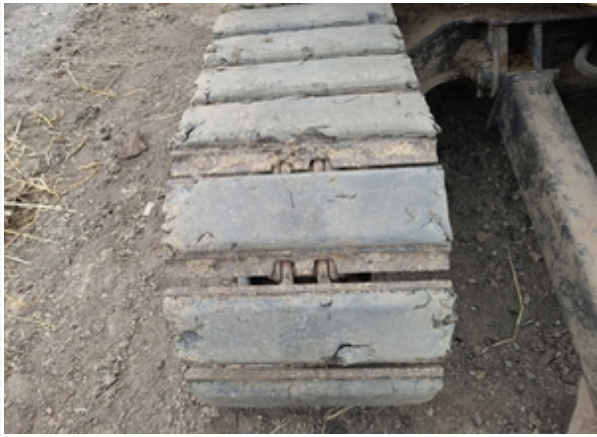
Tracks	3 - Normal Wear & Tear
Comments	Bolt-on Rubber Track Pads have normal wear and tear but still have plenty of life left

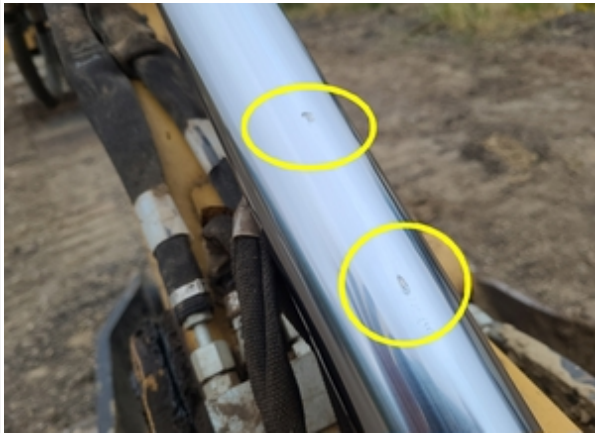
Bucket Cylinder	Check the bucket cylinder. Note any wear, pitting, discoloration, etc. Take photos.
Bucket Cylinder: Mounting Pin	3
Bucket Cylinder: Oil Leaks	No
Comments	Minor Score marks observed on chrome rod
Bucket Cylinder Photos

<p>Score Marks</p>
