Inspection Report (Motor Grader)

Year	2014
Make	CAT
Model	140 M3
Serial Number	N9J00126
Hour Meter Reading	11,131 Hrs.
Previous Application (e.g., earth moving, mining, demolition, etc)	Grading

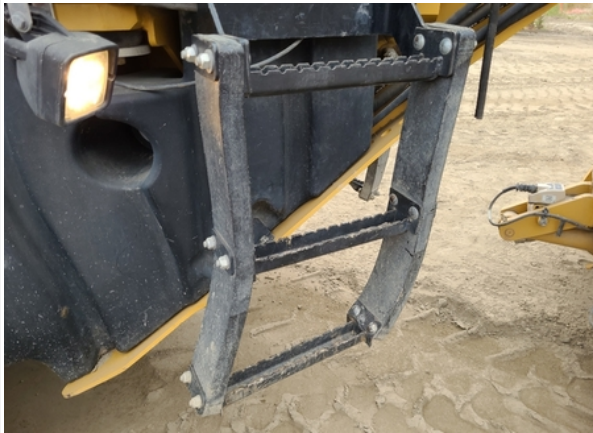
Steps / Ladders Photos

Body Panels	3 - Normal Wear & Tear
Body Panel Condition	No visible damage, good paint condition and panel fitment
Doors / Canopy Latches	3 - Normal Wear & Tear
Doors / Canopy Latches Condition	No visible damage
Steps / Ladders	3 - Normal Wear & Tear
Steps / Ladders Condition	Bent or broken steps or rungs, Other (see comments)
Comments	L/S Operator Cab Step Assembly bottom bent. R/S bottom slightly bent

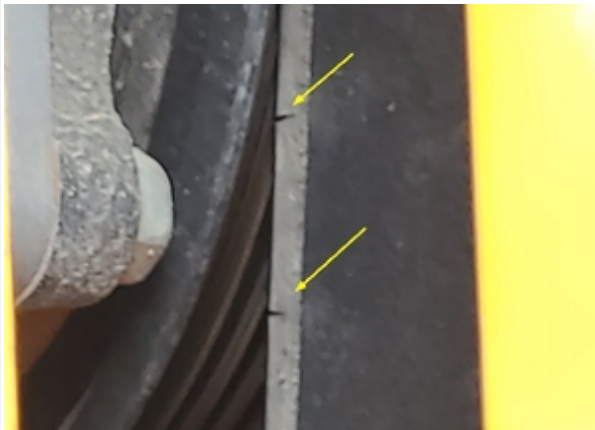
Blow-by (Visual Observation Check)	Yes
Comments	Minor and Consistent BlowBy Seen at breather hose L/S Bottom Pump Drive area.
Unusual Noises (Upon Start-up, Idle, Shutdown)	No
Unusual Noise Notes	No unusual noises heard
Engine Smoke (Upon Start-up, Idle, Shutdown)	No
Engine Smoke Notes	No engine smoke issues observed
Engine Exhaust Color	Clear
Battery	3 - Normal Wear & Tear
Battery Condition	Clean & dry appearance, tight connections
Radiator	3 - Normal Wear & Tear
Radiator Condition	Radiator fins & components appear to be in good working order, no signs of damage or leaks
Belts	2 - Above Average Wear
Belt Condition	Frayed belt edges observed, Cracks, missing grooves, or separating layers on one or more belts, Other (see comments)
Comments	Serpentine Belt needs to be replaced soon
Belt Photos

<p>Serpentine Cracked</p>

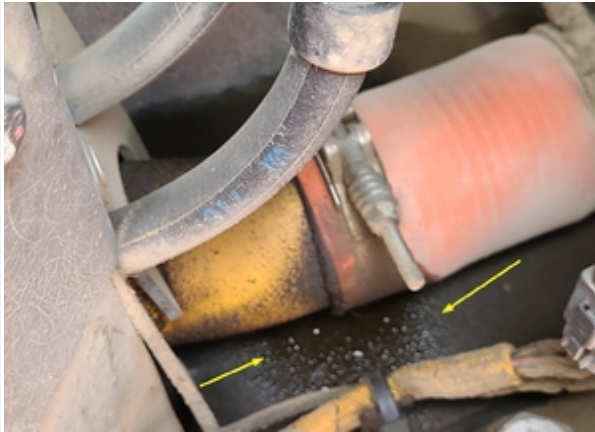
Hoses	3 - Normal Wear & Tear
Hose Condition	Leaks in one or more hoses or fittings observed, Other (see comments), Firm, pliant hoses with no signs of wear or leaks
Water Pump	3 - Normal Wear & Tear
Water Pump Condition	No unusual pump noises heard
Cooling System Leaks	Yes
Cooling System Condition	Wetness observed on cooling system hoses
Comments	Minor Leak observed at rear L/S Radiator Hose
Cooling System Leaks Photos

<p>Minor Coolant Seen</p>
Coolant Color / Appearance	3 - Normal Wear & Tear
Coolant Color/Appearance Notes	Normal Translucent appearance, no visual signs of contamination
Oil Leaks	Yes
Oil Leak Notes	Dried oil seepages seen, Wetness & discoloration observed, Other (see comments)
Comments	Possible engine oil leak at cooler hose routing beneath R/S Pump Housing. Minor residual oil around valve cover (May not be active)
Oil Leak Photos

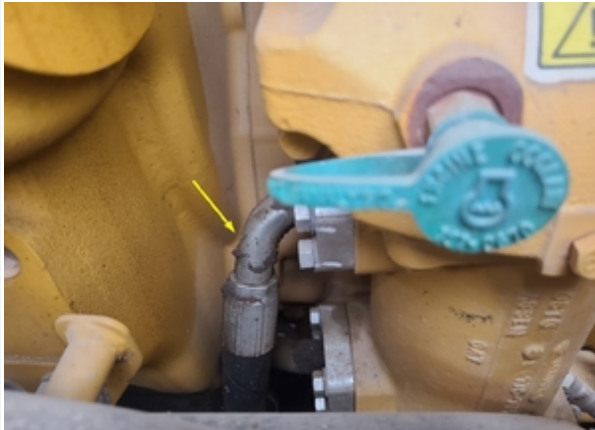
<p>This hose has residual oil buildup</p>

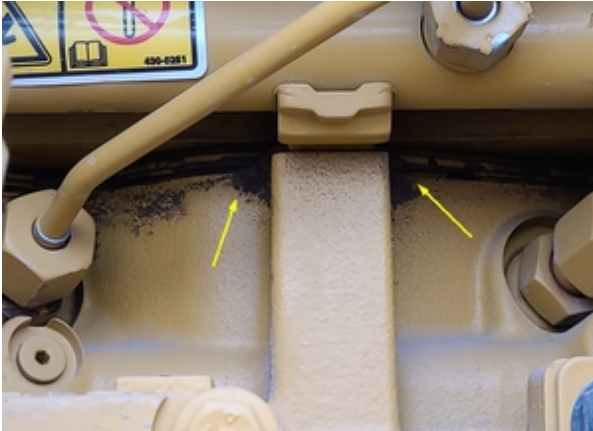
<p>Hose and bottom of pump drive housing has residual oil buildup</p>

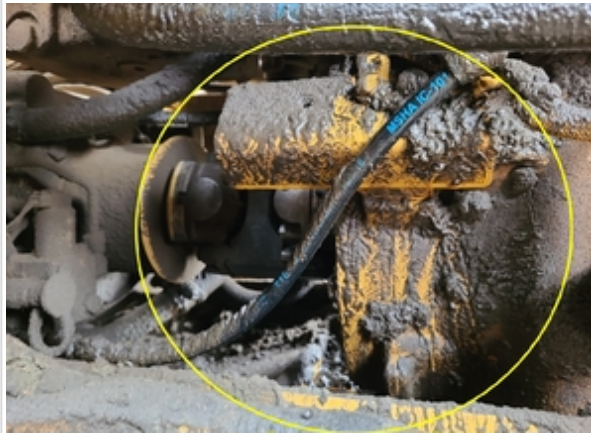
L/S of Transmission Housing has residual buildup. Actual Origins of leak unknown.

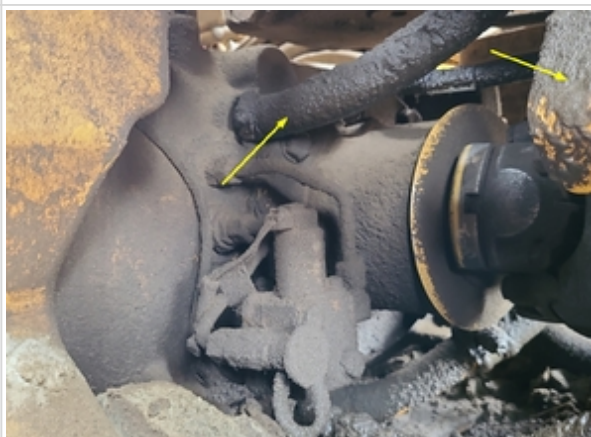
Residual oil buildup on rear axle area

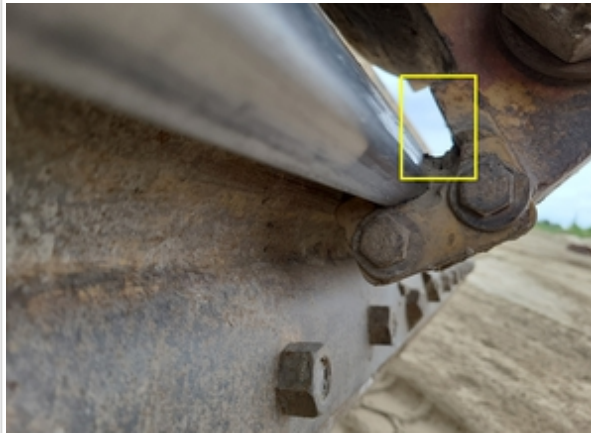
Large Gap, worn wearpads all around

Blade slide rail Bushings/wear plates worn and some missing

Large gap = worn bushings

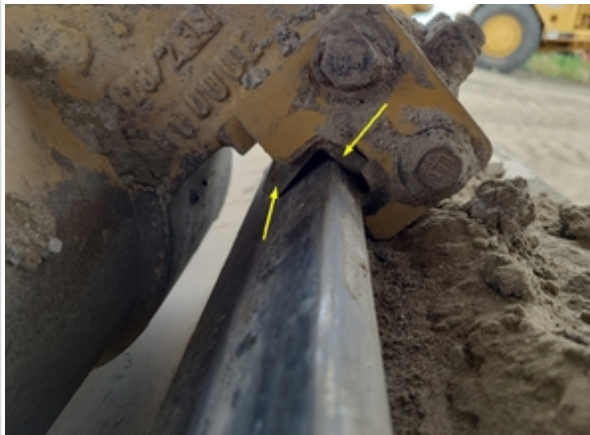
worn

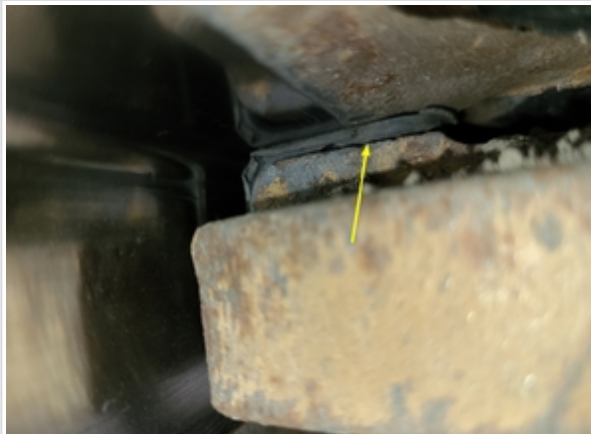
Inside of circle wear pad to top

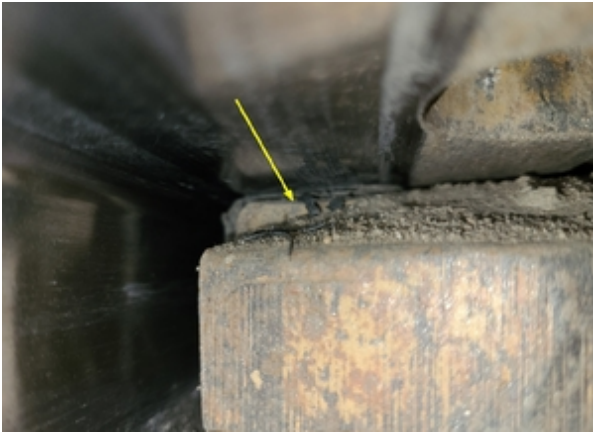
<p>Circle rotational wear pads worn</p>

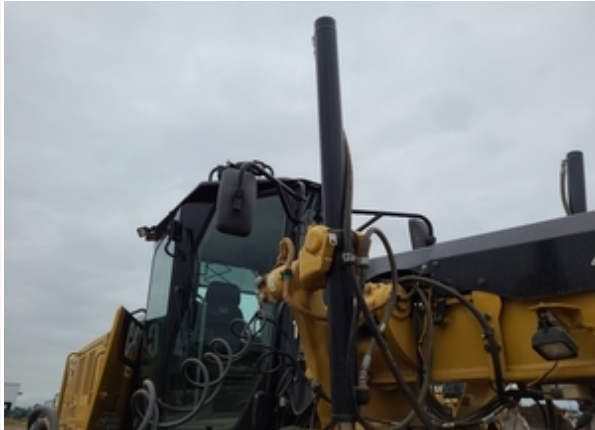
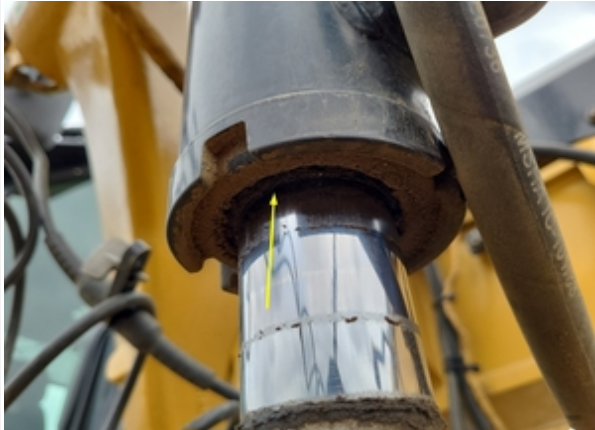
<p>very minor residual oil buildup at rod seal</p>

<p>very minor residual oil buildup at rod seal</p>
Blade Angle Cylinder	Check the cylinders and mounting pins. Note any wear, pitting, discoloration, etc. Take photos.
Blade Angle Cylinder: Mounting Pin	3
Blade Angle Cylinder: Oil Leaks	No

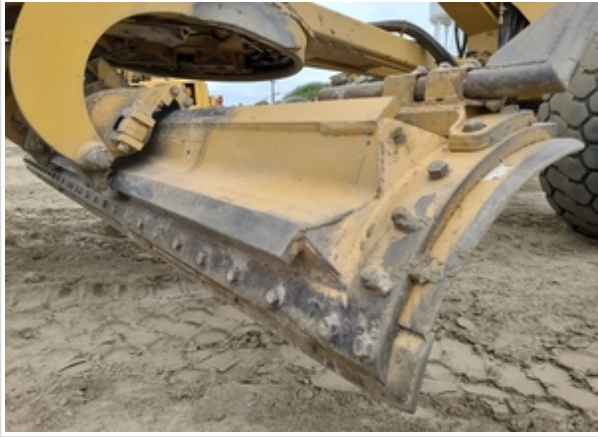
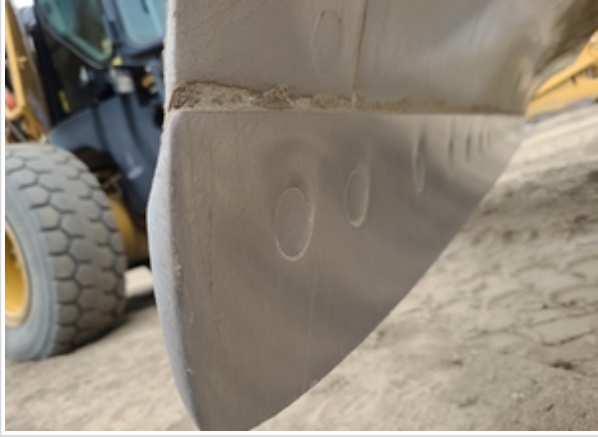
Blade Cutting Edge Condition	2 - Above Average Wear	
Comments	Bottom edge blade can be flipped to extend life.	
Blade Edge Photos
