B&B Stock Number	1
Year	2023
Make	John Deere
Model	700L XLT
Serial Number	1T0700LXHPF445537
Hour Meter Reading	25 Hrs.
Previous Application (e.g., earth moving, mining, demolition, etc)	Landscape/Rock Removal

Inspection Report (Bulldozer)

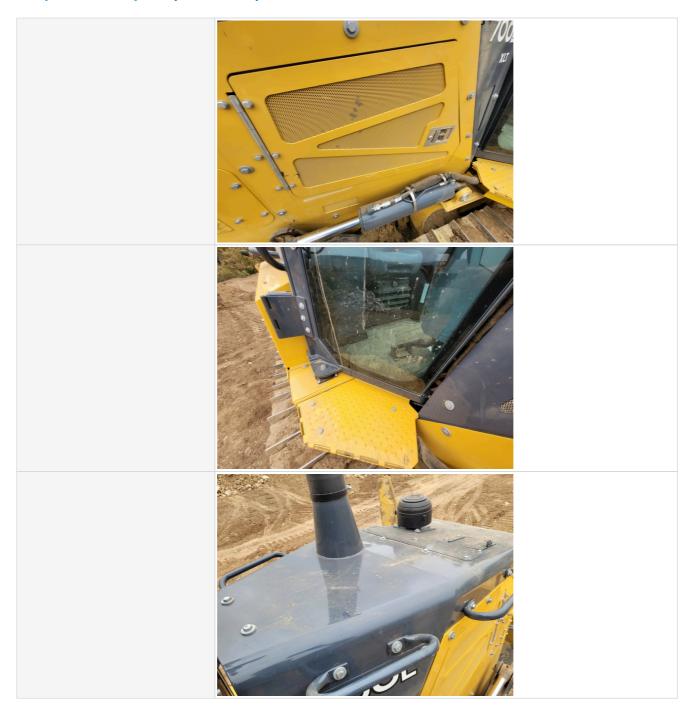
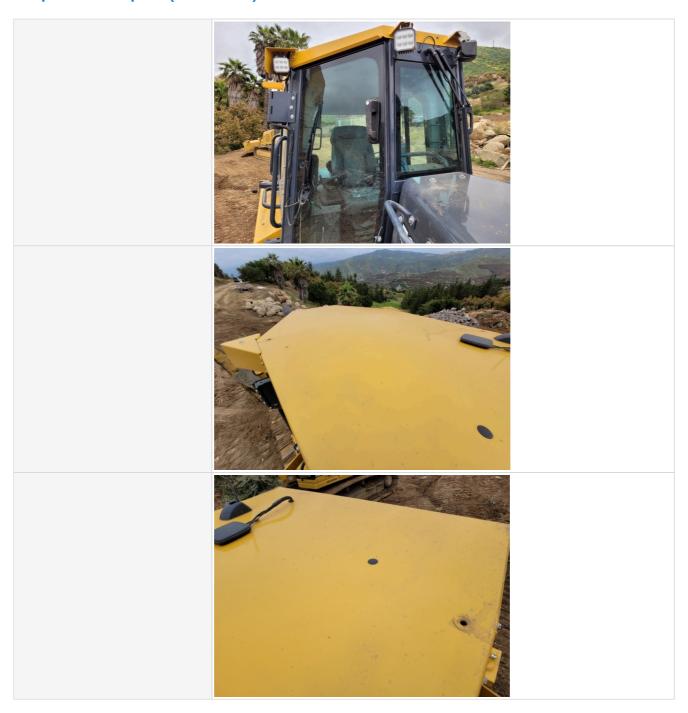
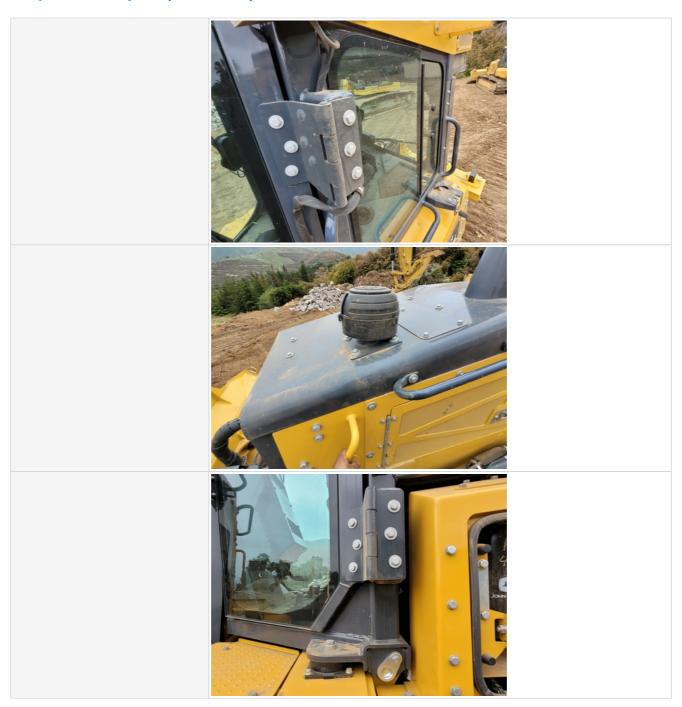
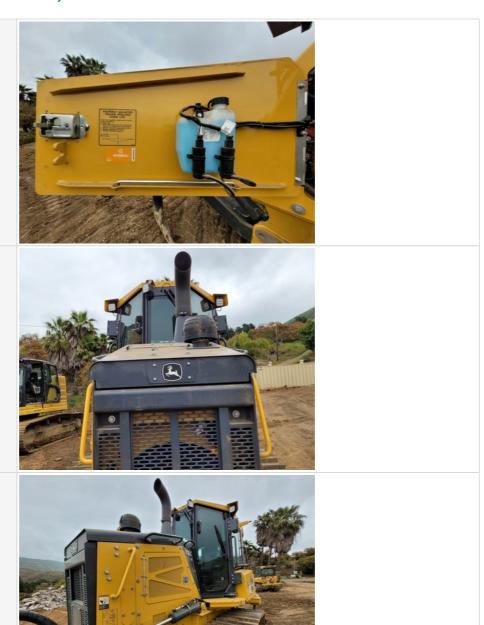
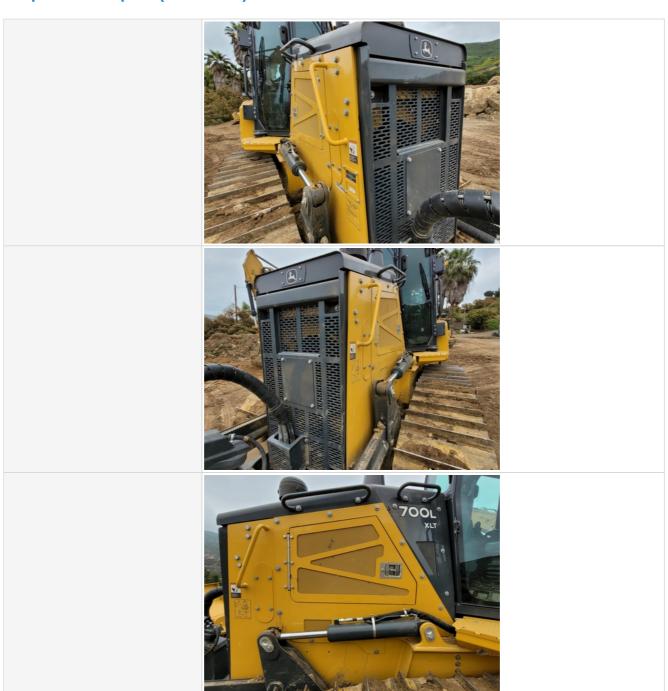
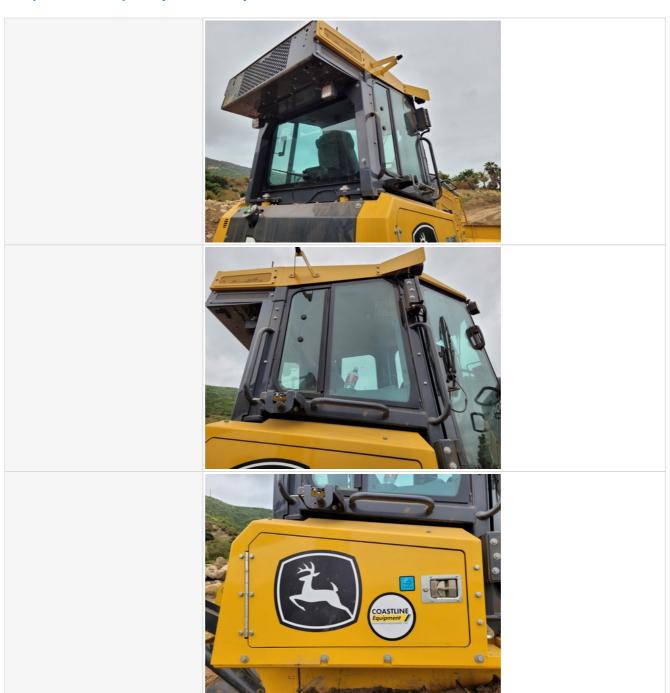
General Appearance Photos

Body Panels	5 - Like New, Recently Replaced
Doors / Canopy Latches	5 - Like New, Recently Replaced
Steps / Ladders	5 - Like New, Recently Replaced
Handrails	5 - Like New, Recently Replaced
Glass	5 - Like New, Recently Replaced
Mirrors	5 - Like New, Recently Replaced
Exterior Lights	5 - Like New, Recently Replaced

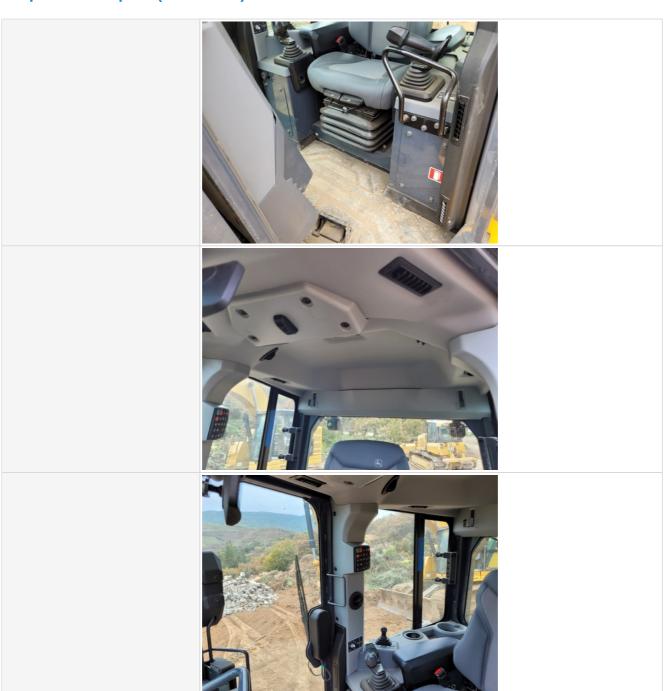
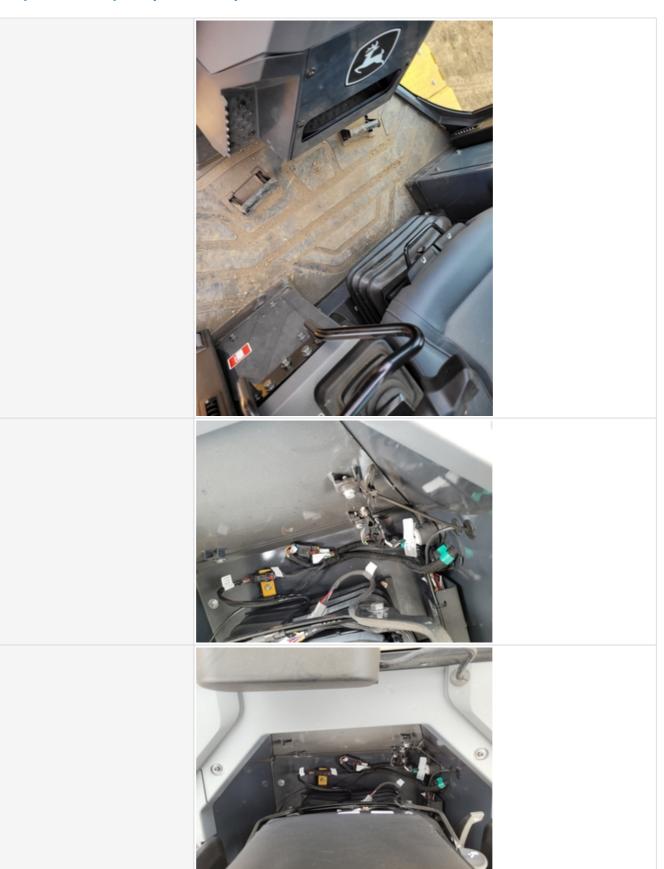
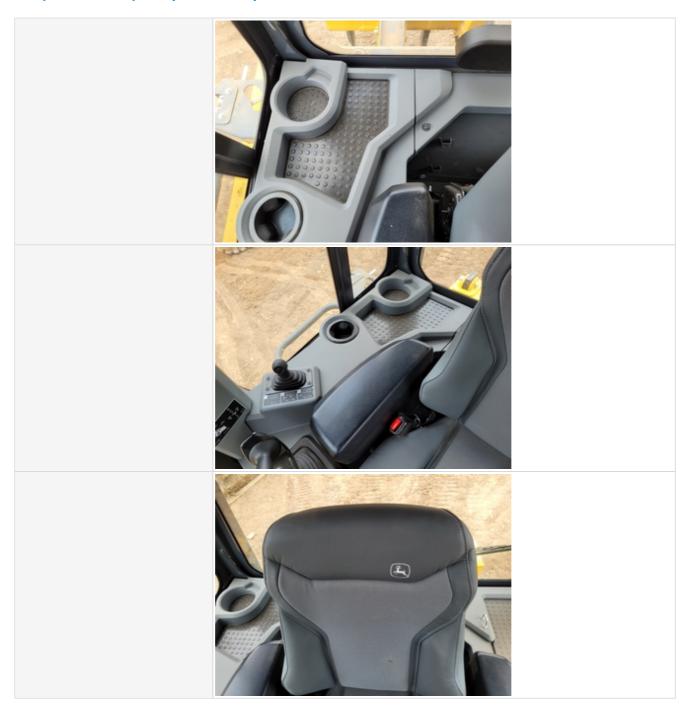
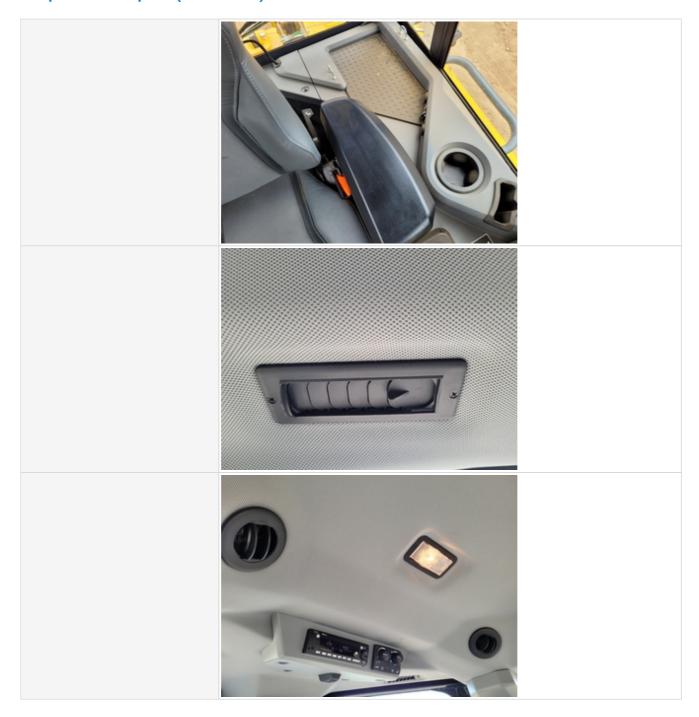
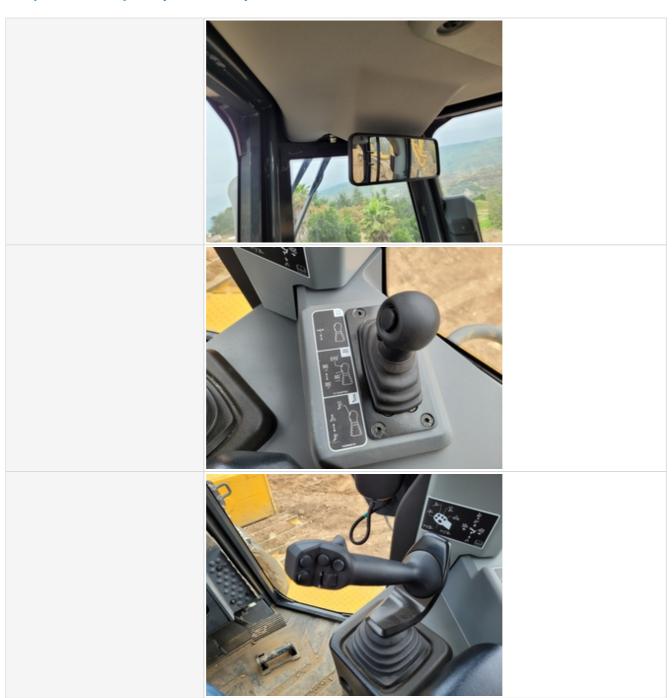
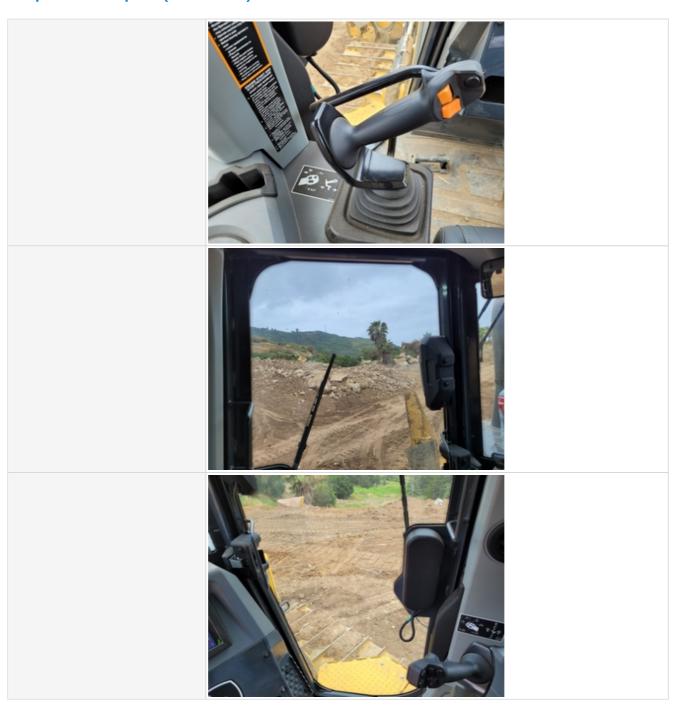
Control Station Photos

Control Station Overall Rating	5 - Like New, Recently Replaced
Operator Seat	5 - Like New, Recently Replaced
Cabin Lights	5 - Like New, Recently Replaced
Safety Lock Out / Stop	5 - Like New, Recently Replaced
Controls & Switches	5 - Like New, Recently Replaced
Hour Meter Activity	5 - Like New, Recently Replaced
Other Gauge Activity	5 - Like New, Recently Replaced
Heater & A/C	5 - Like New, Recently Replaced

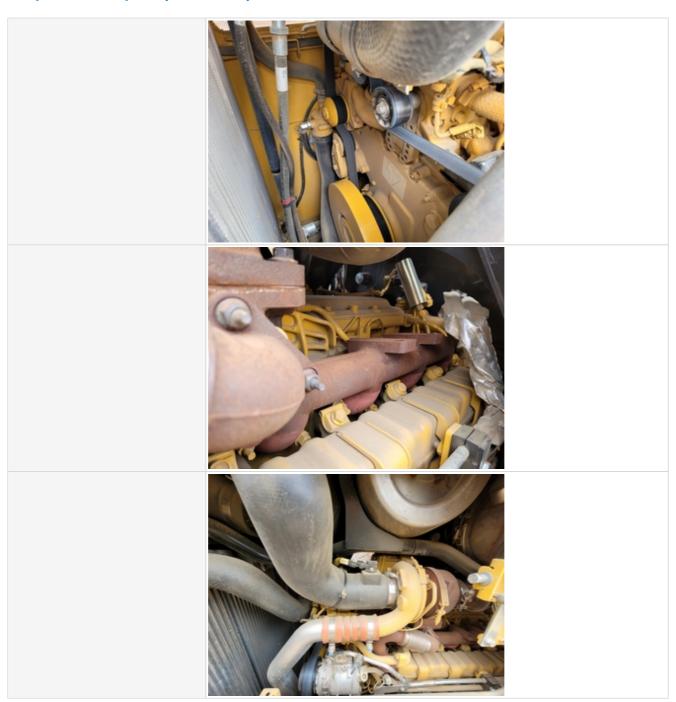
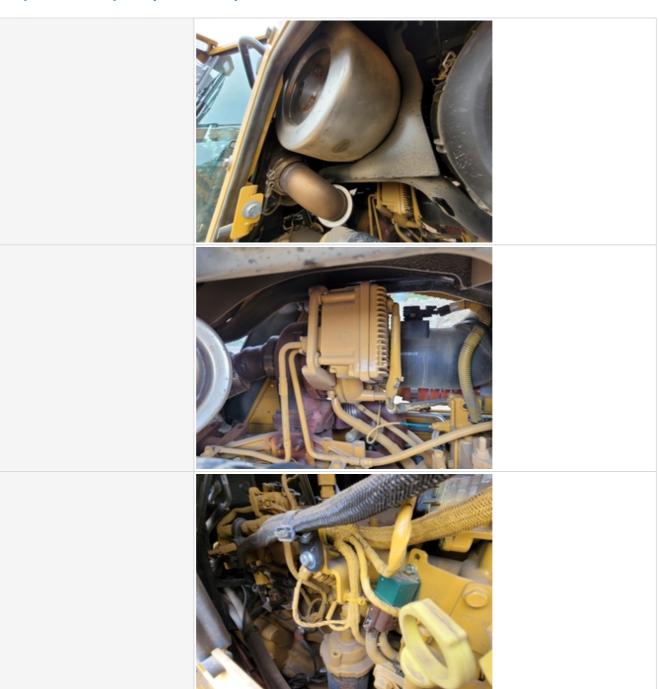
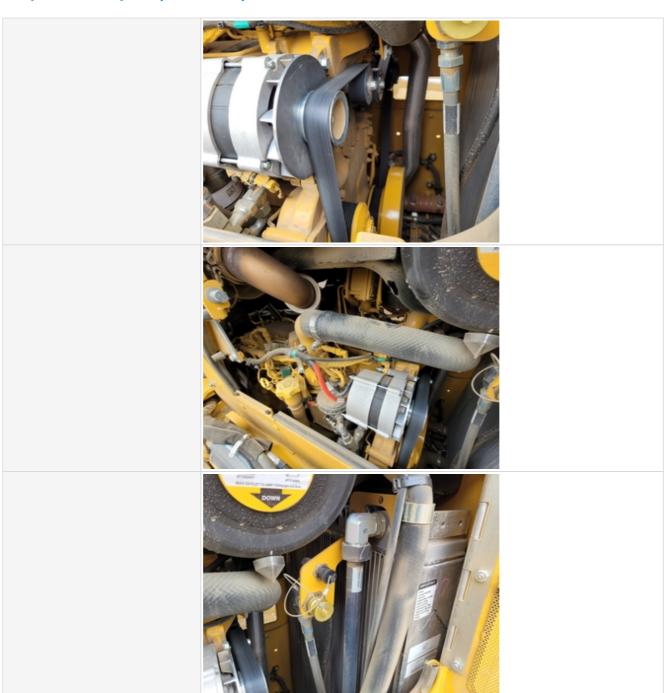
Engine Compartment Photos

Engine Smoke (Upon Start-up,	No
Idle, Shutdown)	
Engine Exhaust Color	Clear
Battery	5 - Like New, Recently Replaced
Battery Condition	Like new, recently replaced
Radiator	5 - Like New, Recently Replaced
Radiator Condition	Radiator fins & components appear to be in good working order, no signs of damage or leaks
Belts	5 - Like New, Recently Replaced
Belt Condition	Belts appear in good condition & alignment with proper tension
Hoses	5 - Like New, Recently Replaced
Hose Condition	Firm, pliant hoses with no signs of wear or leaks
Water Pump	5 - Like New, Recently Replaced
Water Pump Condition	No unusual pump noises heard
Cooling System Leaks	No
Coolant Color / Appearance	5 - Like New, Recently Replaced
Coolant Color/Appearance Notes	Normal Translucent appearance, no visual signs of contamination
Oil Leaks	No
Oil Color / Appearance	5 - Like New, Recently Replaced
Oil Color / Appearance Notes	Clean oil appearance, no signs of cross contamination, Appropriate oil level

Fuel Leaks	No
Equipped with DPF (Diesel Particulate Filter)	Yes
DPF Condition	5 - Like New, Recently Replaced
DPF Condition Notes	Filter housing is intact with no signs of damage or malfunction, DPF indicator is not illuminated
Requires DEF (Diesel Exhaust Fluid)	Yes
DEF Tank	5 - Like New, Recently Replaced
DEF Tank Condition	Area around DEF tank cap is clean, fluid is clear & appears free of contaminants
Overall Engine Rating	5 - Like New, Recently Replaced
Overall Engine Appearance	Clean & dry, Dusty & dry
Overall Engine Comments	Engine has "like new" appearance and runs great, as expected.

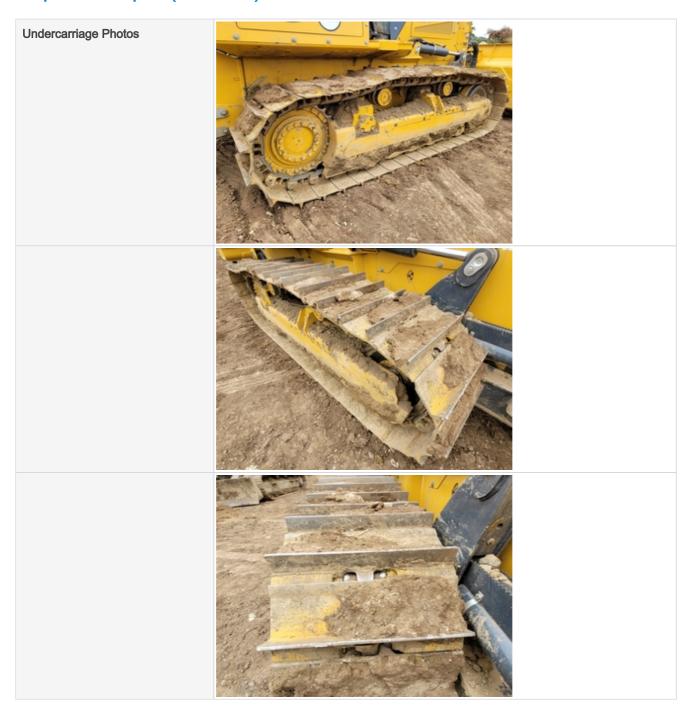
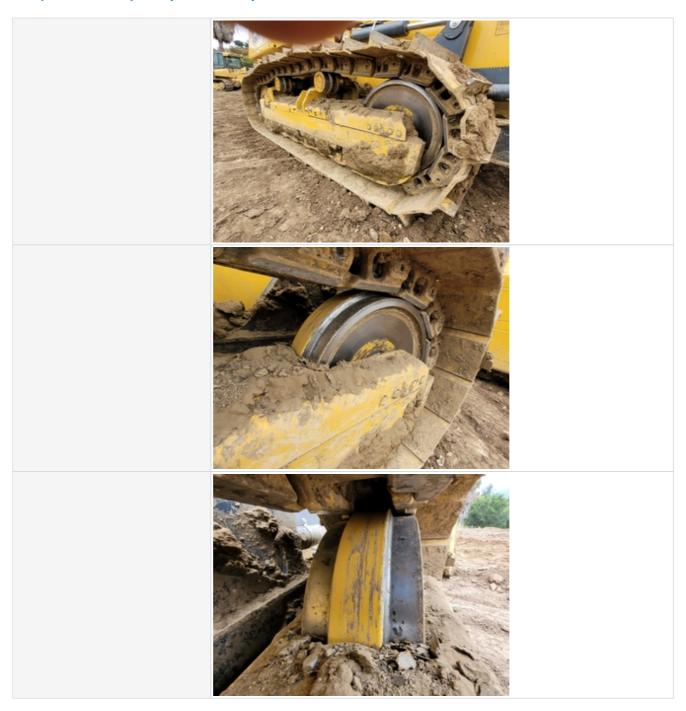
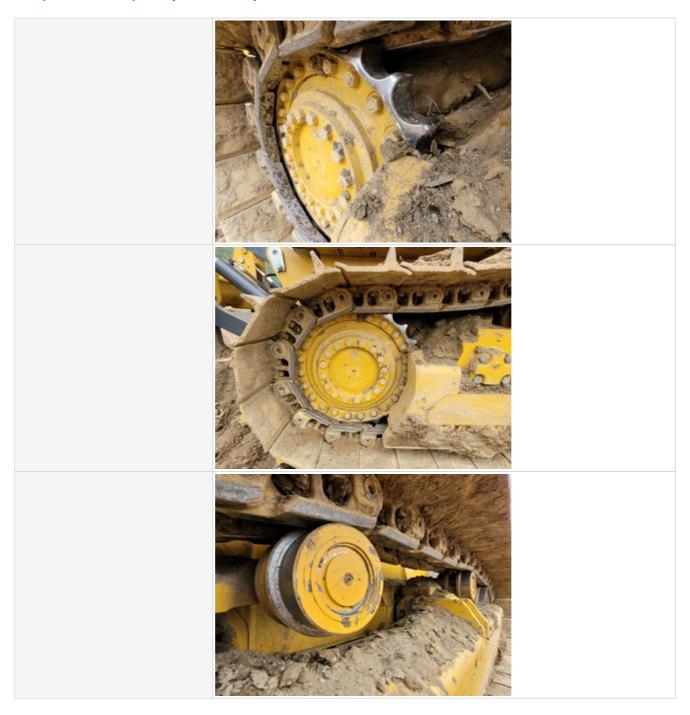
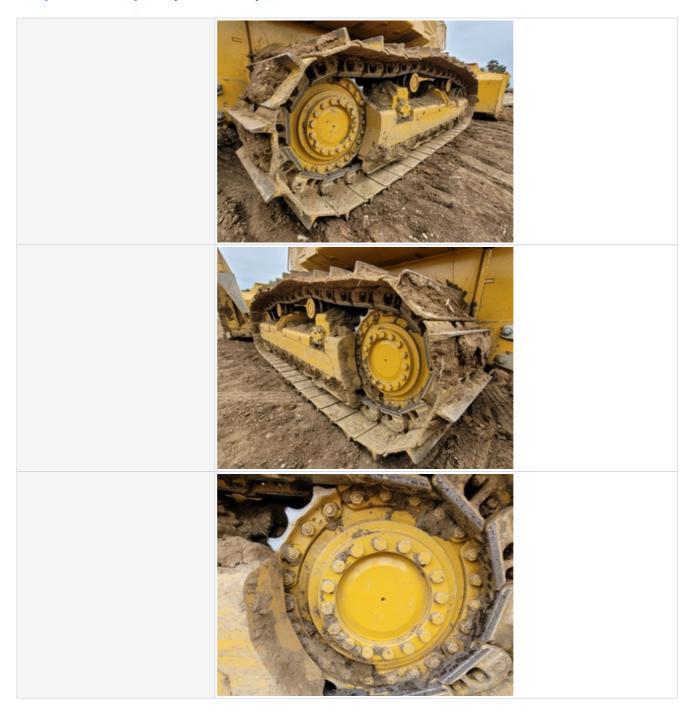
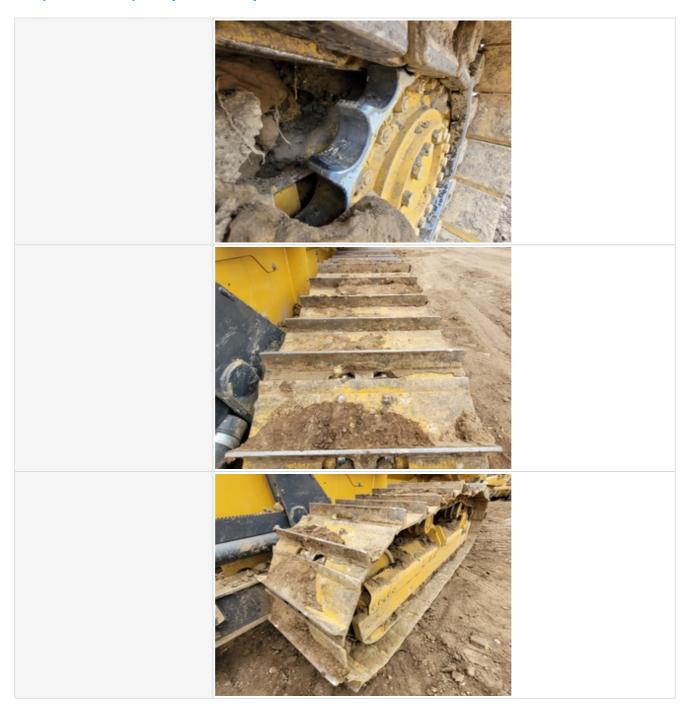
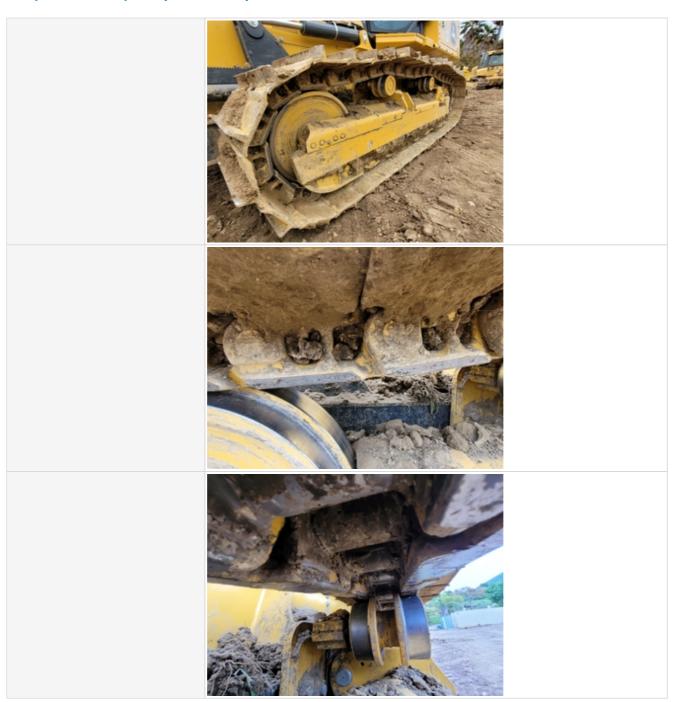
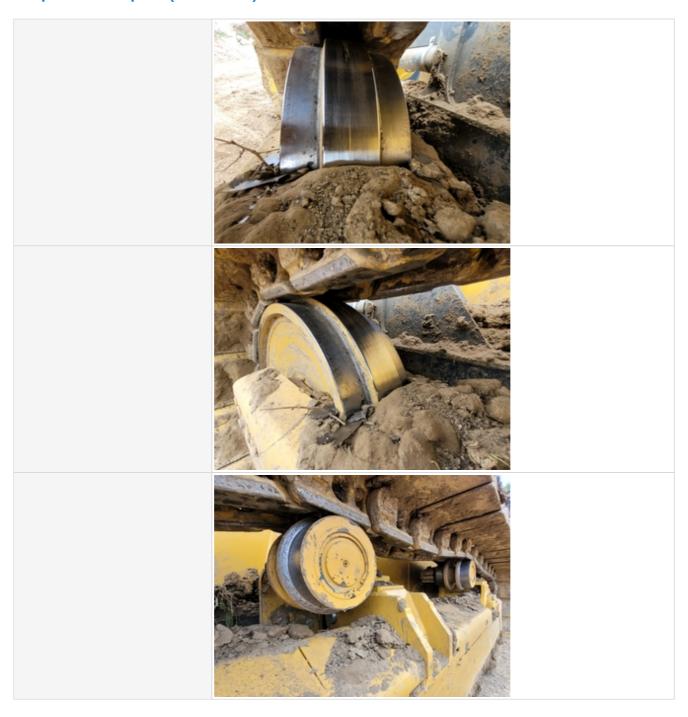
Undercarriage Photos

ondereamage compensate		
Sprocket Teeth	4 - Very Light or Minimal Wear	
Track Bushings	4 - Very Light or Minimal Wear	
Track Frames	5 - Like New, Recently Replaced	
Pivot Shafts	5 - Like New, Recently Replaced	
Equalizer Bar & Joints	5 - Like New, Recently Replaced	
Front Idler	4 - Very Light or Minimal Wear	
Track Tensioner	5 - Like New, Recently Replaced	
Track links	5 - Like New, Recently Replaced	
Bottom Rollers	4 - Very Light or Minimal Wear	
Carrier Rollers	4 - Very Light or Minimal Wear	
Overall Undercarriage	5 - Like New, Recently Replaced	
Overall Undercarriage Comments	Great shape, Normal break-in wear.

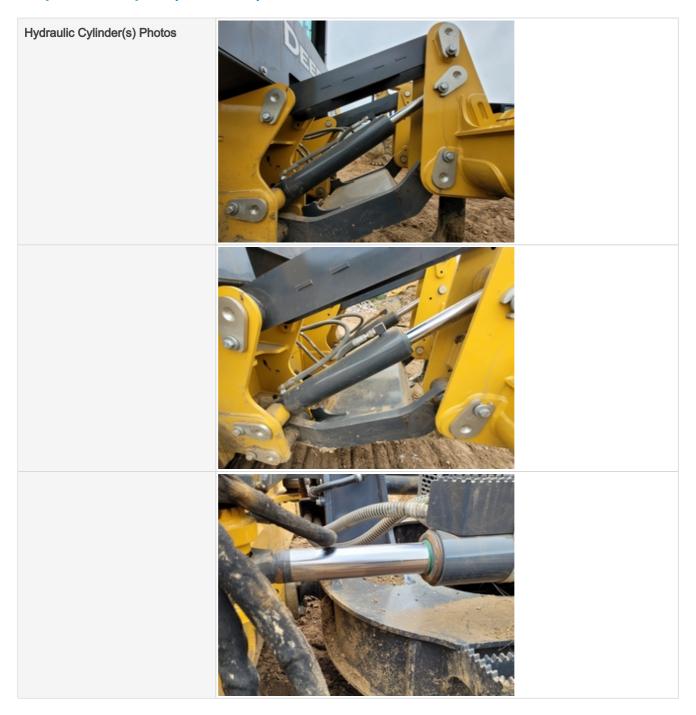
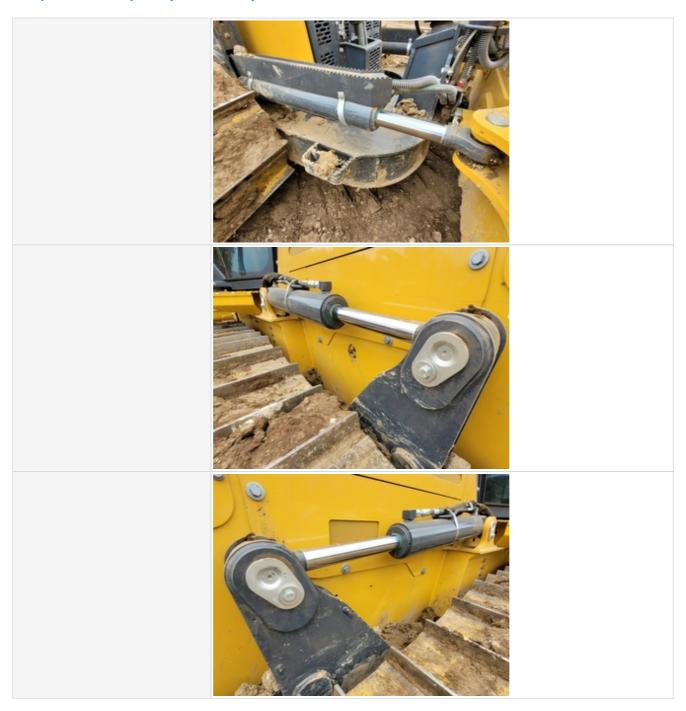
Hydraulics Cylinders Inspection Points

Hydraulic Cylinder(s) Condition	5 - Like New, Recently Replaced
Mounting Pins	5 - Like New, Recently Replaced
Cylinder: Oil Leaks	No

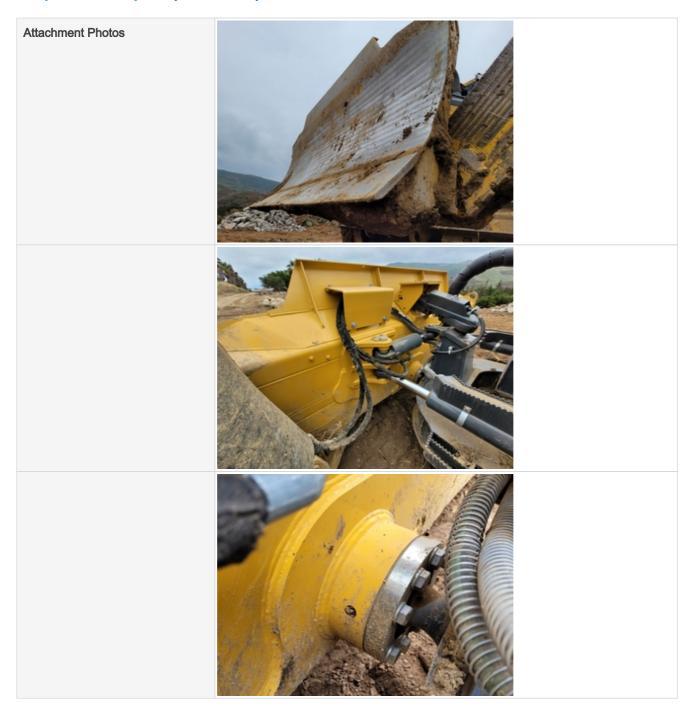
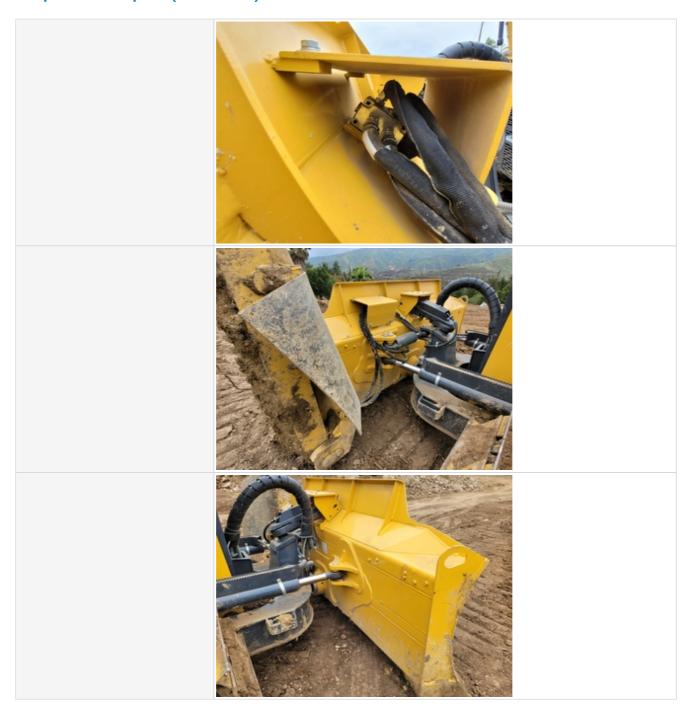
Attachments

Attachment Type	6 Way Blade
Attachment Make	JD
Attachment Size / Specs	10'W - 4'4"H
Attachment Condition	4 - Very Light or Minimal Wear
Comments	Normal Break-In Wear
