## Inspection Report (Asphalt Paver)

Year	2006
Make	Gomaco
Model	Gt 3600
Serial Number	902900-732
Hour Meter Reading	1242.3
Previous Application (e.g., earth moving, mining, demolition, etc)	Paving

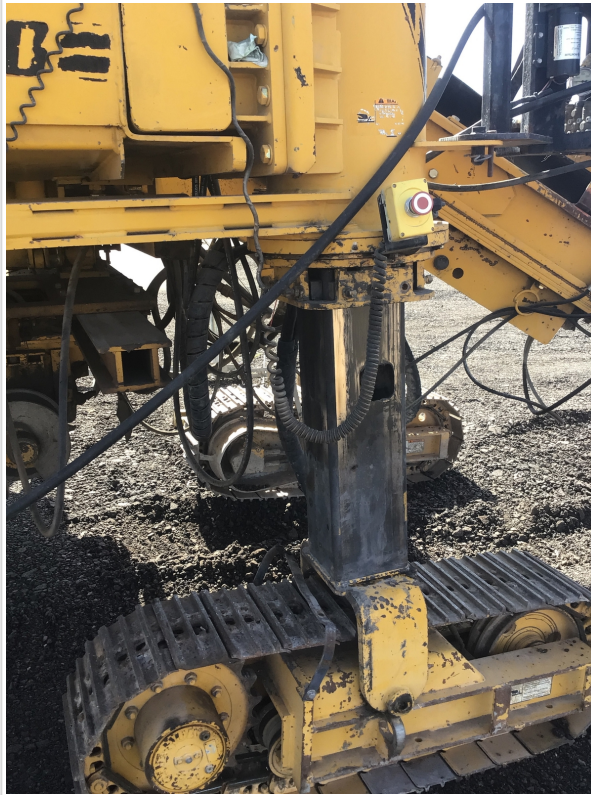
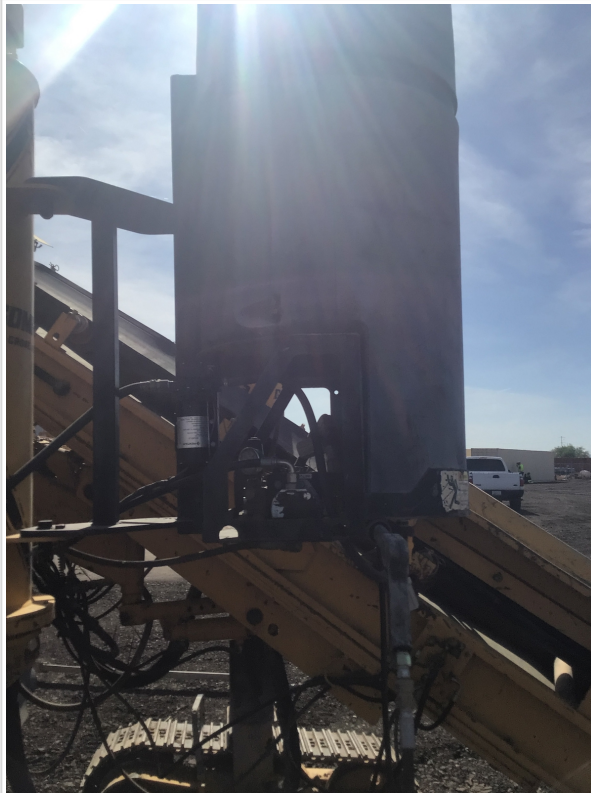
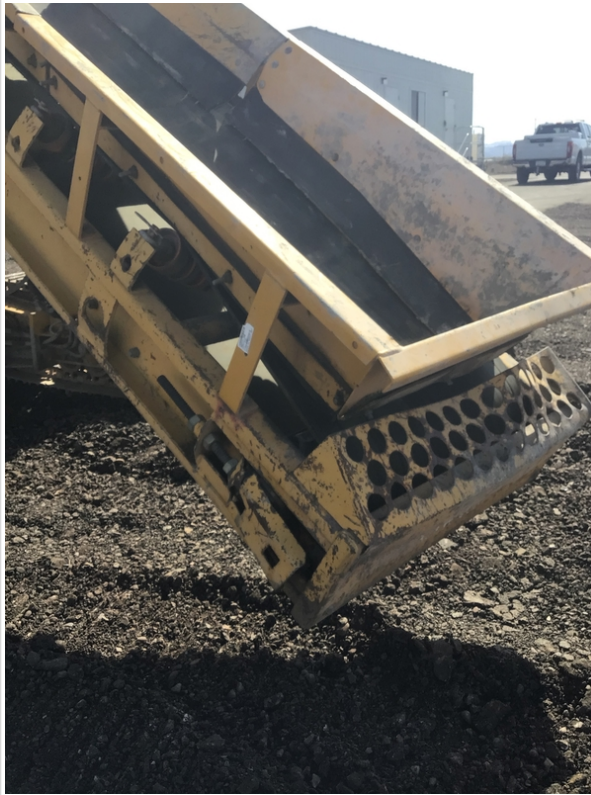
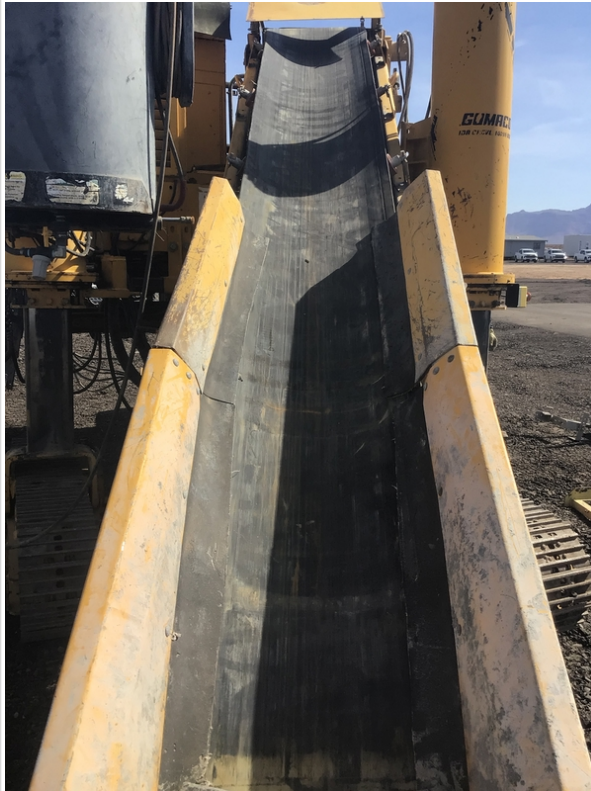
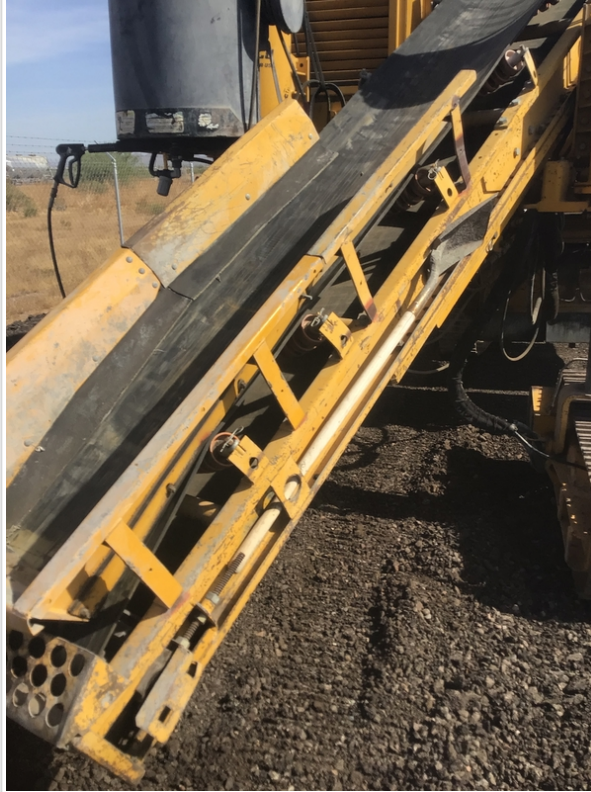
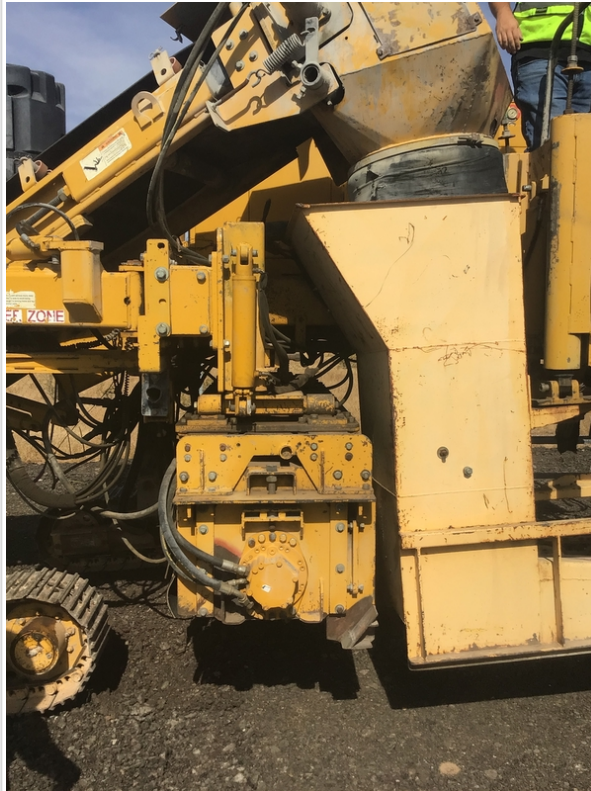
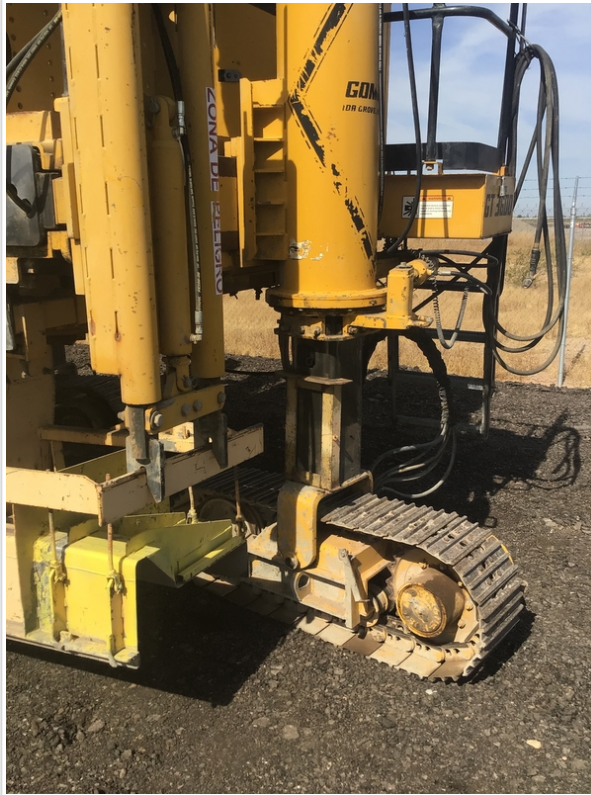
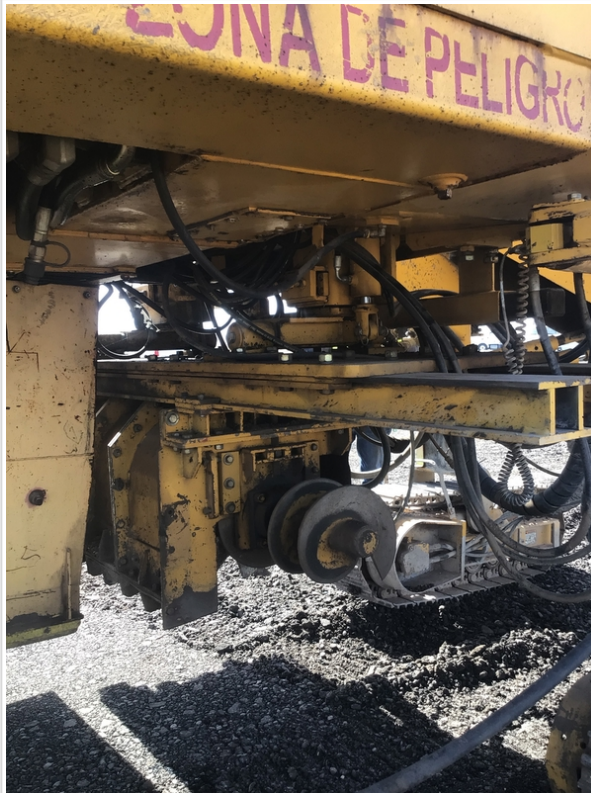
Close-up Exterior Photos

3 - Normal Wear &amp; Tear

Body Panel Condition	Visible chipped paint or dents
Doors / Canopy Latches	5 - Like New, Recently Replaced
Steps / Ladders	5 - Like New, Recently Replaced
Handrails	5 - Like New, Recently Replaced
Glass	0
Mirrors	0
Exterior Lights	0

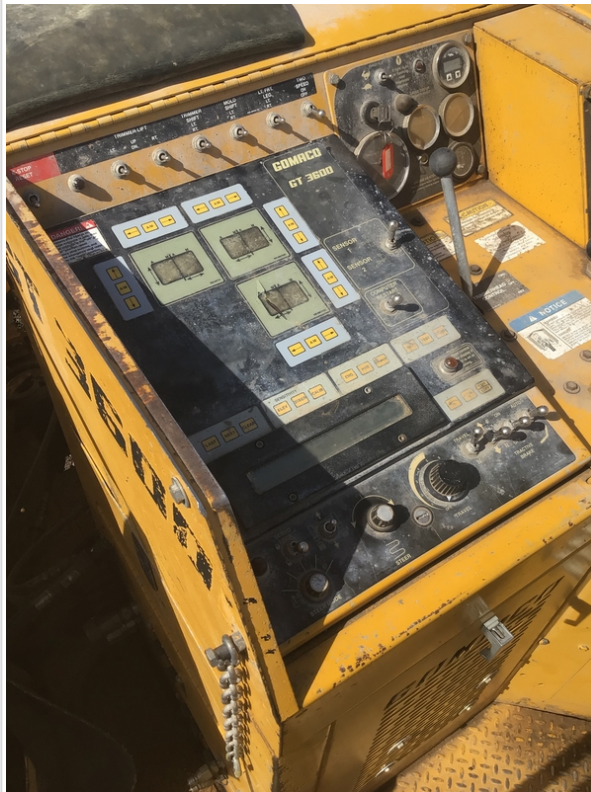
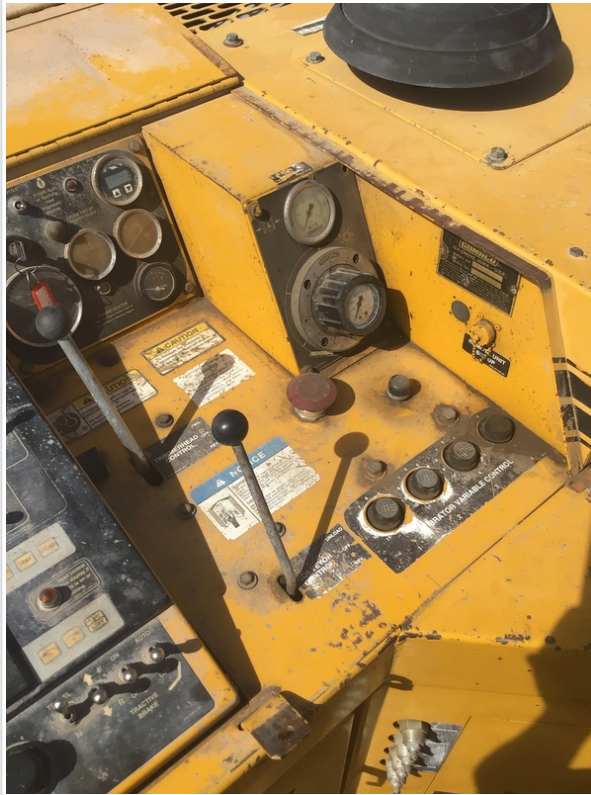
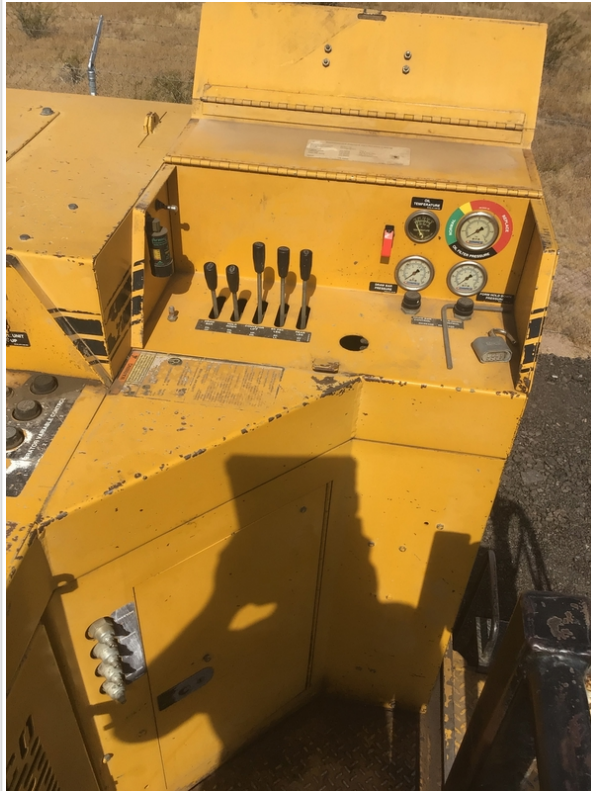
Control Station Photos

<p>Serial Number Plate</p>	 
<p>Hour Meter/Odometer</p>	 
<p>Control Station Overall Rating</p>	<p>2 - Above Average Wear &amp; Tear</p>
<p>Control Station Overall Condition</p>	<p>Significant wear and tear to cabin floor, panels, and ceiling</p>
<p>Operator Seat</p>	<p>0</p>

Cabin Lights	0
Safety Lock Out / Stop	3 - Normal Wear & Tear
Safety Lock Out / Stop Condition	Safety lock out device is present, in good condition, and functional
Controls & Switches	3 - Normal Wear & Tear
Controls & Switches Condition	Switches have good functionality, minor cosmetic damage observed
Comments	Worn out
Hour Meter Activity	5 - Like New, Recently Replaced
Other Gauge Activity	1 - Service Required
Other Gauge Condition	One or more gauges are unreadable or not functioning (specify in comments)
Comments	Display is cracked
Heater & A/C	0
Travel Alarm	0
Horn	0
Backup Camera	0

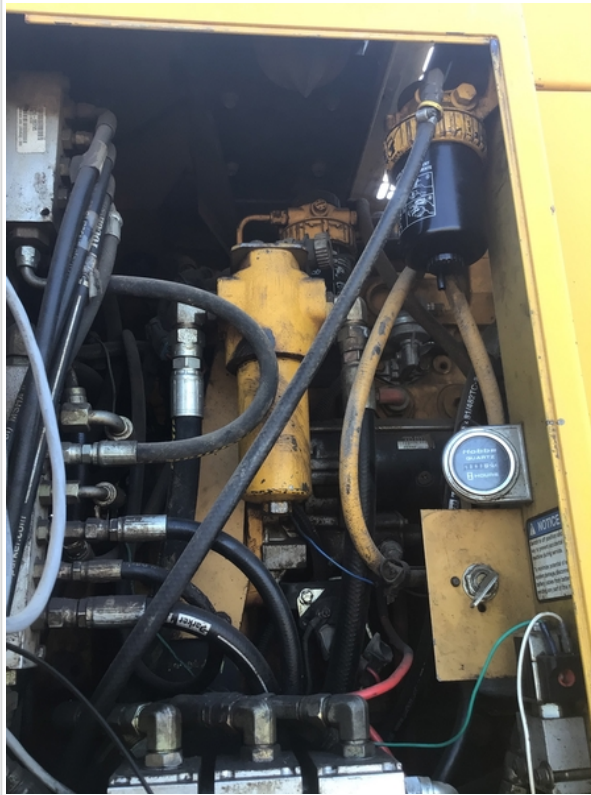
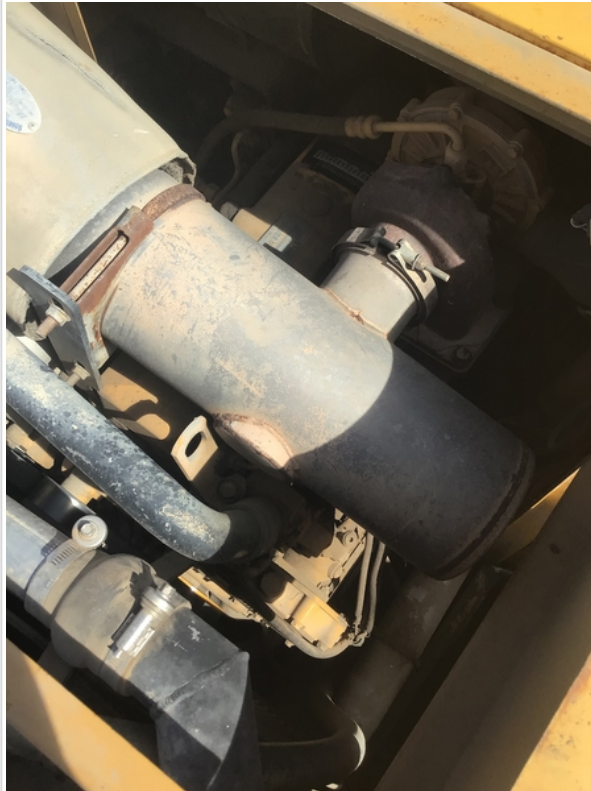
Engine Compartment Photos

Engine Fuel Type	Diesel
Blow-by (Visual Observation Check)	No
Unusual Noises (Upon Start-up, Idle, Shutdown)	No
Engine Smoke (Upon Start-up, Idle, Shutdown)	No
Engine Exhaust Color	Clear
Battery	3 - Normal Wear & Tear
Battery Condition	Dusty & dirty appearance
Radiator	5 - Like New, Recently Replaced
Radiator Condition	Radiator fins & components appear to be in good working order, no signs of damage or leaks
Belts	5 - Like New, Recently Replaced
Belt Condition	Belts appear in good condition & alignment with proper tension
Hoses	5 - Like New, Recently Replaced
Hose Condition	Firm, pliant hoses with no signs of wear or leaks
Water Pump	5 - Like New, Recently Replaced
Water Pump Condition	No unusual pump noises heard
Cooling System Leaks	No
Coolant Color / Appearance	1 - Service Required
Coolant Color/Appearance Notes	Other (see comments)
Comments	It's water
Oil Leaks	No
Oil Color / Appearance	5 - Like New, Recently Replaced

Oil Color / Appearance Notes	Clean oil appearance, no signs of cross contamination
Fuel Leaks	No
Equipped with DPF (Diesel Particulate Filter)	No
Requires DEF (Diesel Exhaust Fluid)	No
Overall Engine Rating	3 - Normal Wear & Tear
Overall Engine Appearance	Very dirty
Overall Engine Comments	Dirty and has rags stuffed in for rubbing

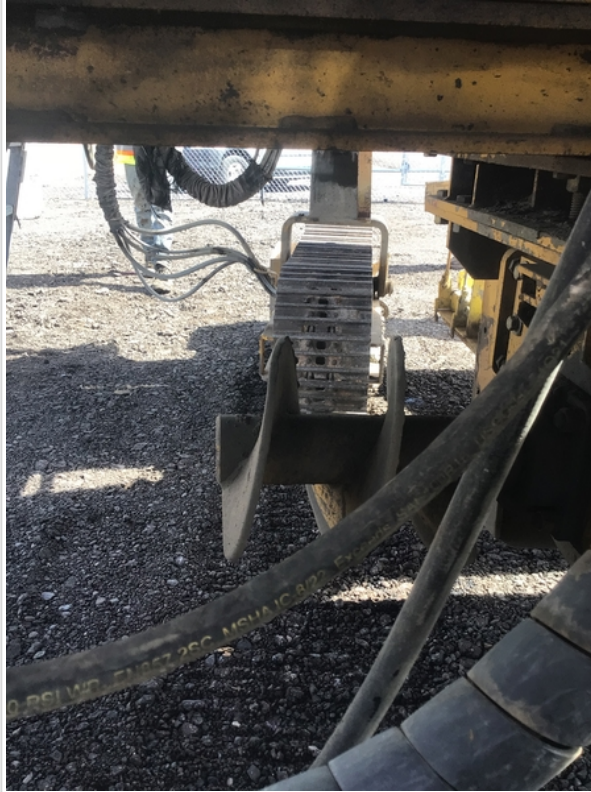
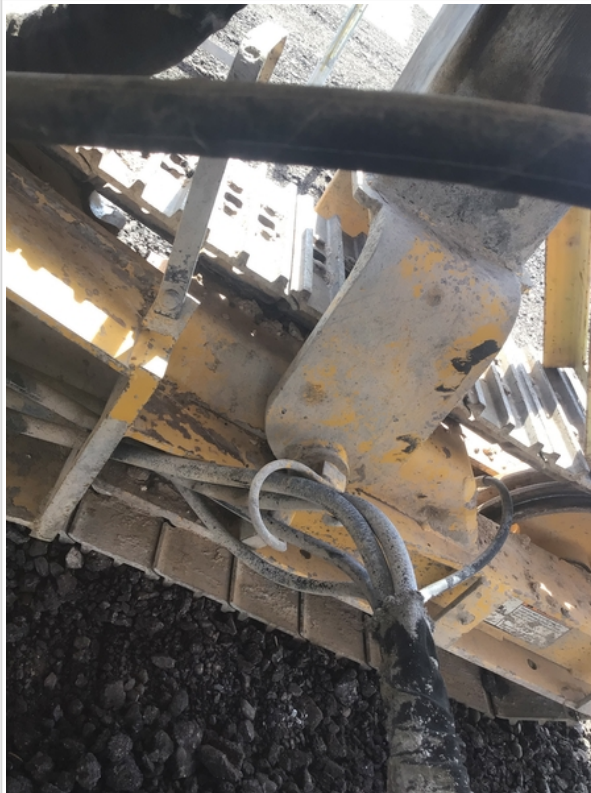
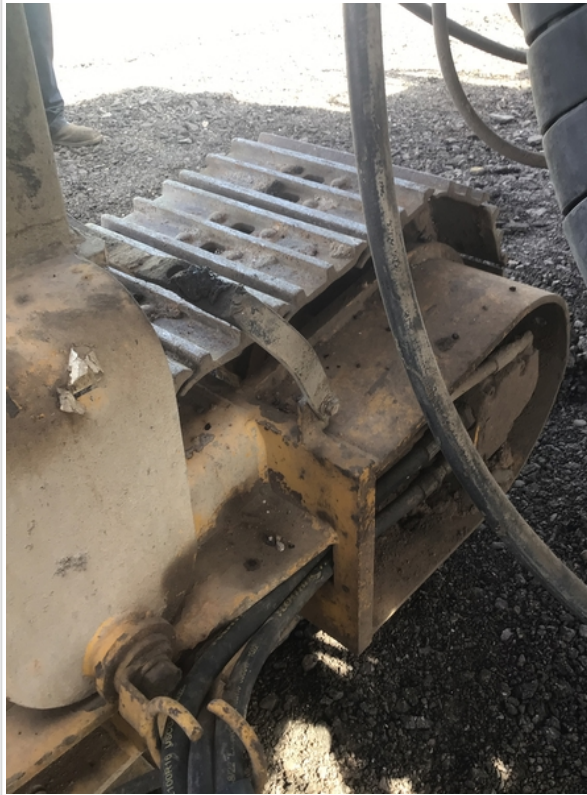
Drivetrain Photos

Hydrostatic Transmission?	Yes
2 Speed?	Yes
Hydrostatic Drive Configuration	Close Coupled Transmission
Transmission Components	5 - Like New, Recently Replaced
Transmission Condition	Good forward and reverse function
Drive Motors	5 - Like New, Recently Replaced
Parking Brake	5 - Like New, Recently Replaced
Parking Brake Function	Good brake function
Overall Drivetrain Comments	Dirty but work as should

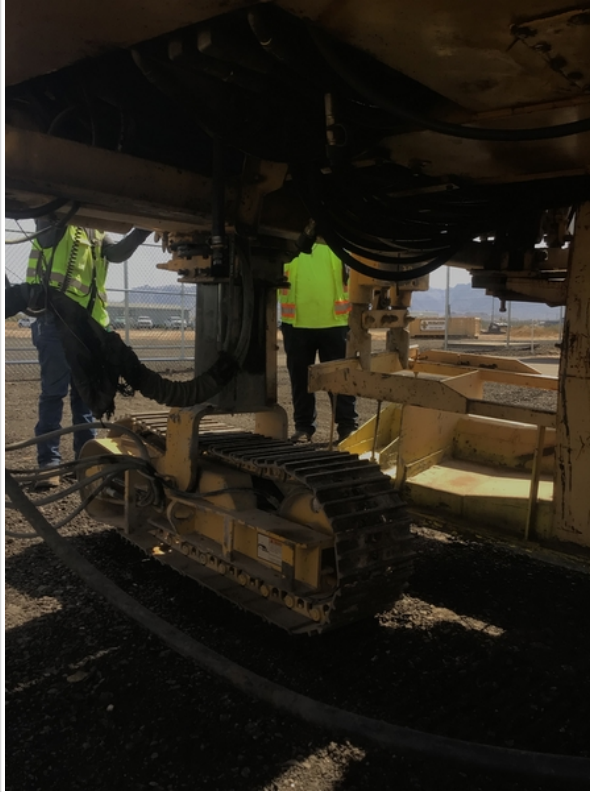
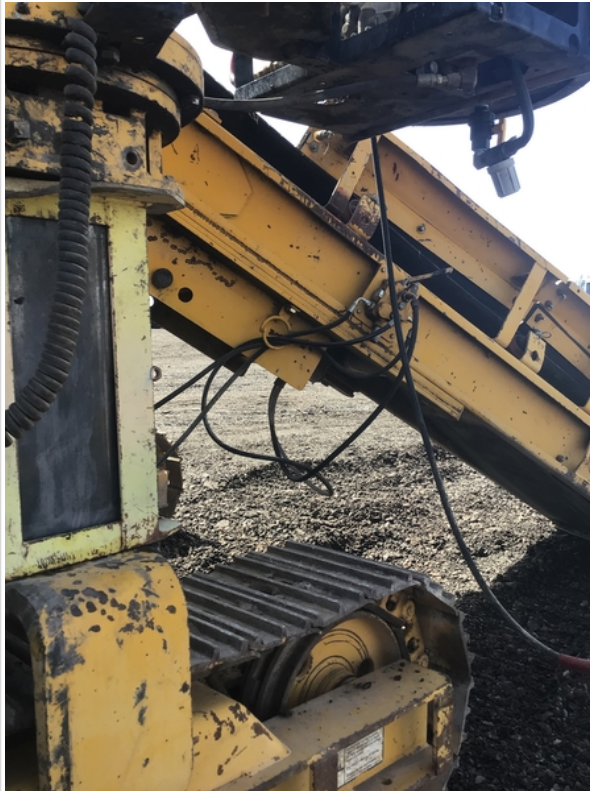
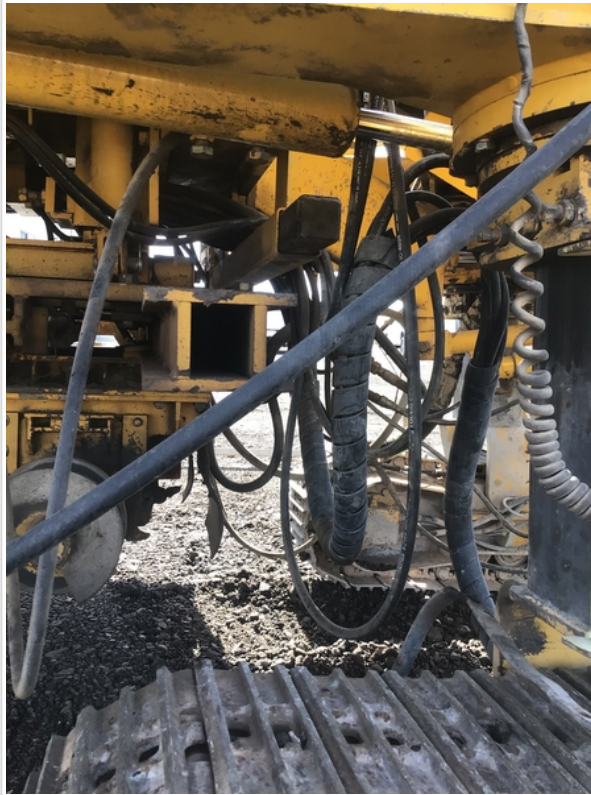
Undercarriage Photos

Track Width (inches)	6.7ft
Track Length (inches)	5.6ft
Roller Frames	3 - Normal Wear & Tear
Track Belt	4 - Very Light or Minimal Wear
Rubber Belt Drive Lugs	0
Track Tensioners	4 - Very Light or Minimal Wear
Front Idlers	5 - Like New, Recently Replaced
Rear Idlers	5 - Like New, Recently Replaced
Track Rollers	5 - Like New, Recently Replaced
Sprockets	5 - Like New, Recently Replaced

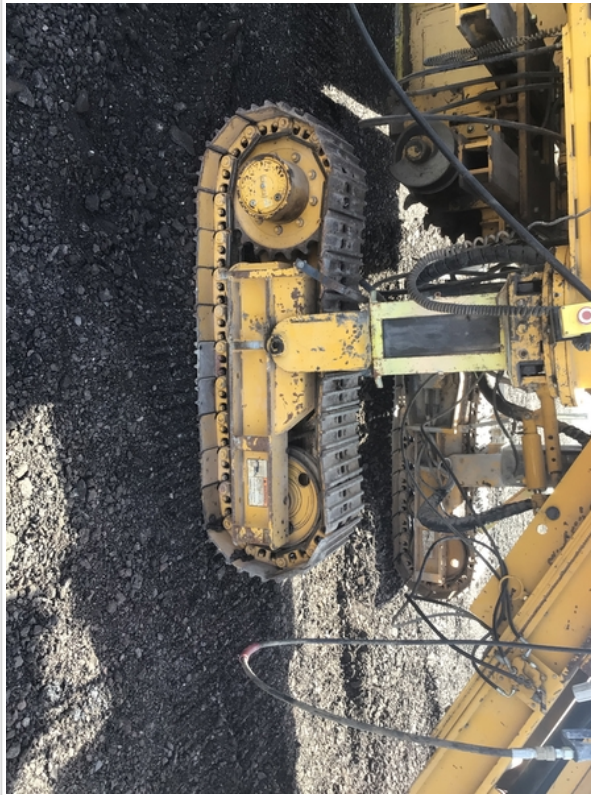
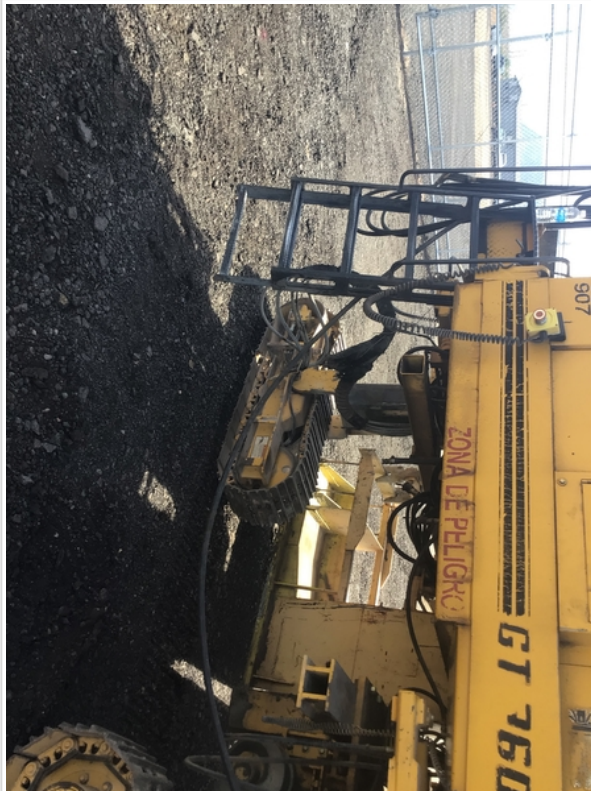
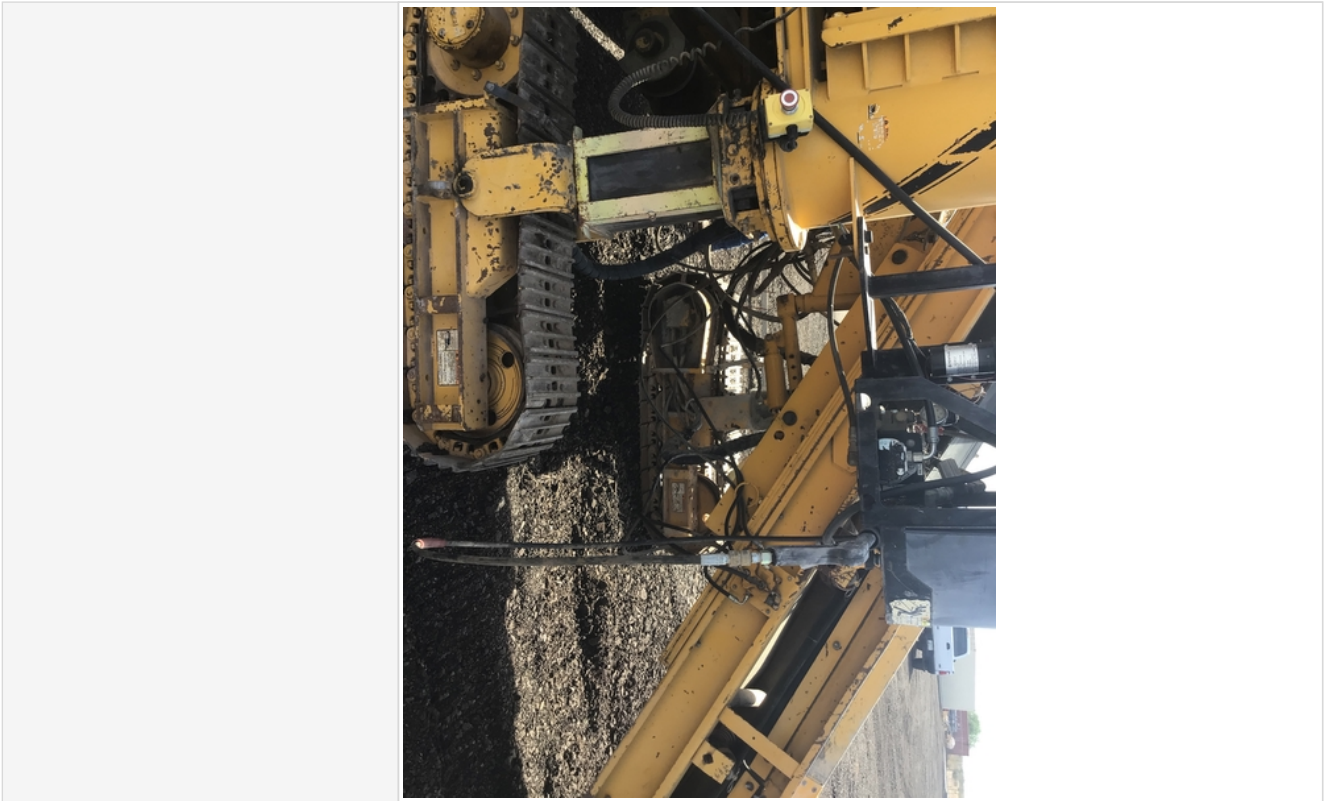
Chassis Photos

Conveyor & Auger Drives/Chains/Sprockets	5 - Like New, Recently Replaced
Conveyor & Auger Bearing Remote Lube Lines	5 - Like New, Recently Replaced
Overall Chassis	3 - Normal Wear & Tear
Overall Chassis Comments	Paint faded, scratched

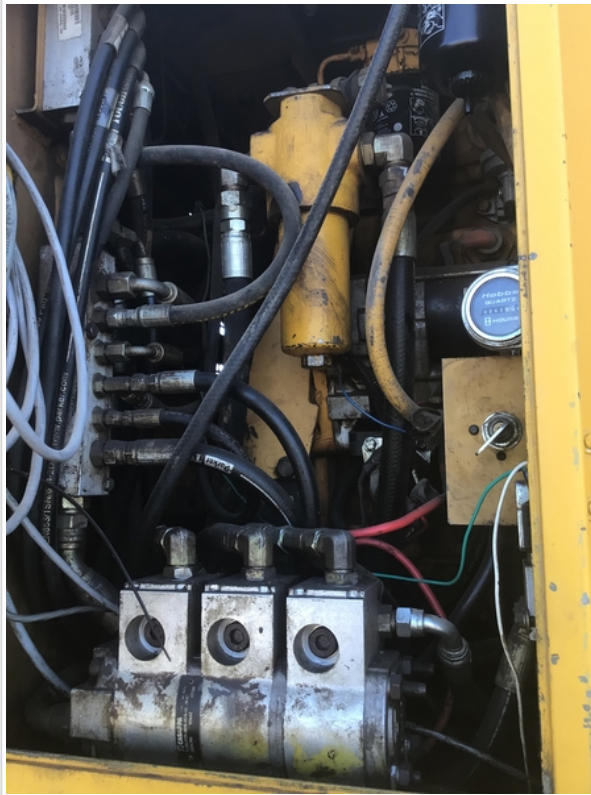
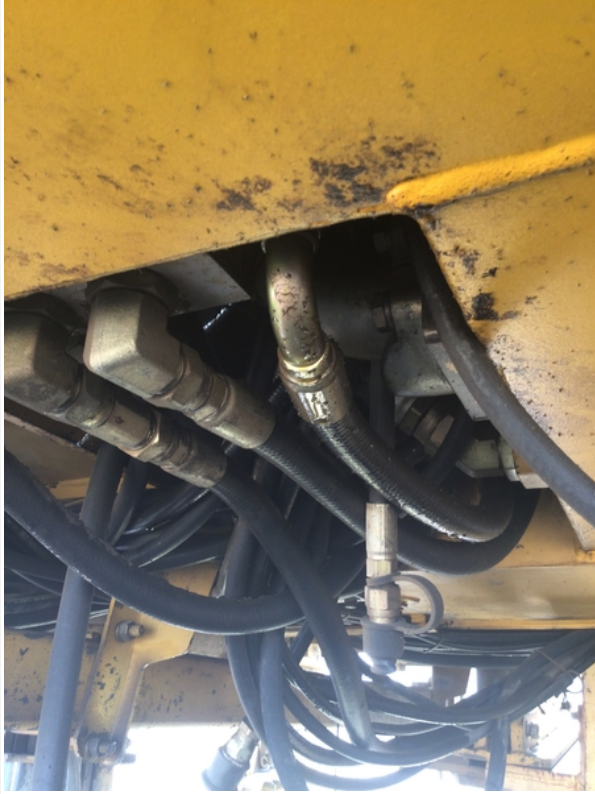
Hydraulic System Photos

Wet or Damp Hydraulic Lines / Fittings	Yes
Appearance of Hydraulic Lines / Fittings	5 - Like New, Recently Replaced
Hydraulic Lines / Fittings Condition	Hydraulic lines & fittings are clean and in good condition
Hydraulic Pump(s)	4 - Very Light or Minimal Wear
Unusual Noises (Hydraulic Pump)	No
Hydraulic Pump Notes	No unusual noises heard during operation
