Inspection Report (Excavator)

B&B Stock Number	1
Year	2020
Make	CAT
Model	325
Serial Number	TEL00737
Hour Meter Reading	720 Hrs.
Previous Application (e.g., earth moving, mining, demolition, etc)	Landscape/Rock Removal

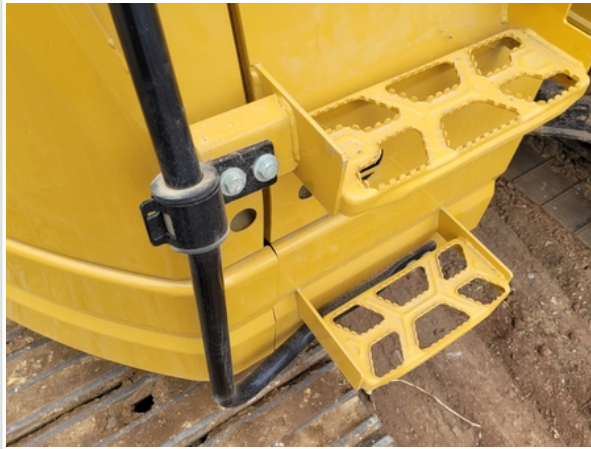
Bottom Panel Dented
