Inspection Report (Excavator)

B&B Stock Number	N/a
Year	2017
Make	Doosan
Model	Dx420lc
Serial Number	Dwgcecbfje1010006
Hour Meter Reading	1
Previous Application (e.g., earth moving, mining, demolition, etc)	Earth moving

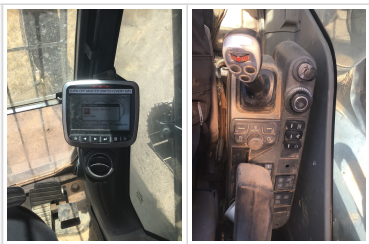
<p>Control Station Photos</p>

Control Station Overall Rating	3 - Normal Wear & Tear
Control Station Overall Condition	Significant wear and tear to cabin floor, panels, and ceiling
Operator Seat	3 - Normal Wear & Tear
Operator Seat Condition	Seat(s) have minor surface staining or small tears
Cabin Lights	0
Safety Lock Out / Stop	5 - Like New, Recently Replaced
Controls & Switches	3 - Normal Wear & Tear
Controls & Switches Condition	Switches have good functionality, minor cosmetic damage observed
Hour Meter Activity	5 - Like New, Recently Replaced
Other Gauge Activity	5 - Like New, Recently Replaced
Heater & A/C	5 - Like New, Recently Replaced
Travel Alarm	5 - Like New, Recently Replaced
Horn	5 - Like New, Recently Replaced
Backup Camera	5 - Like New, Recently Replaced

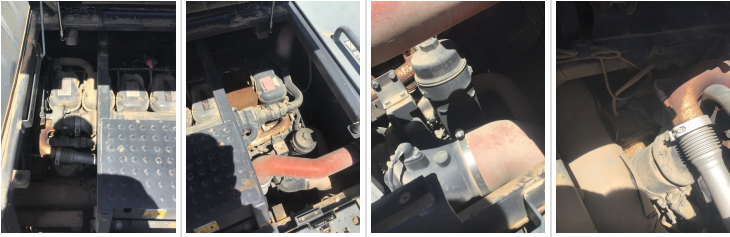
Engine Compartment Photos

Engine Type (Make, Model, Cylinders, Hp)	6cyl scani
Emissions Tier	Tier 3
Engine Serial Number	Scania cv ab
Engine Fuel Type	Diesel
Blow-by (Visual Observation Check)	Yes
Unusual Noises (Upon Start-up, Idle, Shutdown)	No
Engine Smoke (Upon Start-up, Idle, Shutdown)	No
Engine Exhaust Color	Clear
Battery	1 - Service Required
Battery Condition	Other (see comments)
Comments	Was dead
Radiator	5 - Like New, Recently Replaced

Radiator Condition	Radiator fins & components appear to be in good working order, no signs of damage or leaks
Belts	2 - Above Average Wear & Tear
Belt Condition	Cracks, missing grooves, or separating layers on one or more belts
Hoses	2 - Above Average Wear & Tear
Hose Condition	Firm, pliant hoses with no signs of wear or leaks
Water Pump	5 - Like New, Recently Replaced
Cooling System Leaks	No
Coolant Color / Appearance	5 - Like New, Recently Replaced
Coolant Color/Appearance Notes	Normal Translucent appearance, no visual signs of contamination
Oil Leaks	No
Oil Color / Appearance	3 - Normal Wear & Tear
Oil Color / Appearance Notes	Dirty oil appearance, signs of particulate matter & deposits seen, Appropriate oil level
Fuel Leaks	No
Equipped with DPF (Diesel Particulate Filter)	Yes
DPF Condition	5 - Like New, Recently Replaced
Requires DEF (Diesel Exhaust Fluid)	Yes
DEF Tank	3 - Normal Wear & Tear
Overall Engine Rating	3 - Normal Wear & Tear

Overall Engine Appearance	Dusty & dry, Areas of dried seepage seen on engine hoses & components
Overall Engine Comments	Minor wear, lots of blow by by oil cap

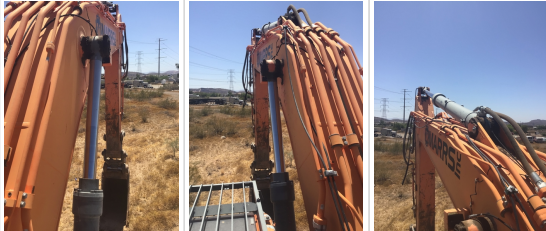
Hydraulic Cylinder Photos

Hydraulic Cylinder(s): Mounting Pins	5 - Like New, Recently Replaced
Cylinder: Oil Leaks	No

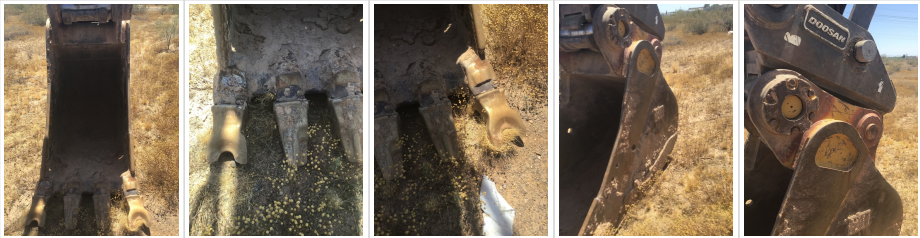
Attachment Photos

Bucket	5 - Like New, Recently Replaced
Bucket Teeth	5 - Like New, Recently Replaced
Blade	0
Blade Edge	0
