Inspection Report (Backhoe Loader)

B&B Stock Number	A5447729
Year	2018
Make	case
Model	580sn
Serial Number	JJGN58SNPJC753003
Hour Meter Reading	2052.6
Previous Application (e.g., earth moving, mining, demolition, etc)	used in asphalt

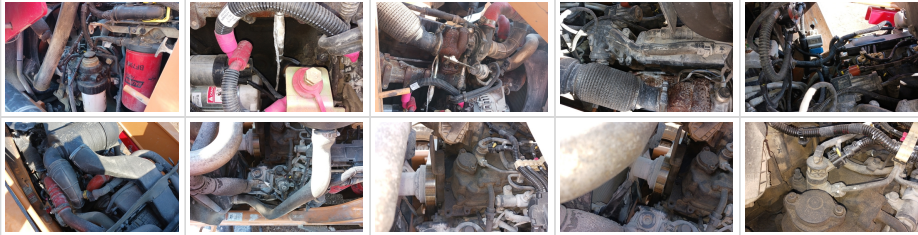
Engine Compartment Photos

Water Pump	3 - Normal Wear & Tear
Water Pump Condition	No unusual pump noises heard
Cooling System Leaks	No
Coolant Color / Appearance	0
Oil Leaks	No
Oil Color / Appearance	2 - Above Average Wear & Tear
Oil Color / Appearance Notes	Very dark, black & burnt oil appearance
Fuel Leaks	No
Equipped with DPF (Diesel Particulate Filter)	Yes
DPF Condition	3 - Normal Wear & Tear
DPF Condition Notes	Filter housing is intact with no signs of damage or malfunction, DPF indicator is not illuminated
Requires DEF (Diesel Exhaust Fluid)	Yes
DEF Tank	3 - Normal Wear & Tear
DEF Tank Condition	Area around DEF tank cap is clean, fluid is clear & appears free of contaminants
Overall Engine Rating	3 - Normal Wear & Tear
Overall Engine Appearance	Dusty & dry, Very dirty
Overall Engine Comments	The engine is making an unusual noise when on and seems to shut off when force is needed.

Engine	2 - Above Average Wear & Tear
Comments	Engine is making an odd sounds and it turned off when force was needed
Transmission/Drivetrain	3 - Normal Wear & Tear
Travel (Forward/Reverse/Steering)	3 - Normal Wear & Tear
Brakes	3 - Normal Wear & Tear
Hydraulic System	3 - Normal Wear & Tear
Electric Operating System	3 - Normal Wear & Tear
Controls	3 - Normal Wear & Tear
Safety Systems	3 - Normal Wear & Tear
Core Functions	3 - Normal Wear & Tear
Attachments	3 - Normal Wear & Tear
Overall Functional Test Comments	Machine is in operating condition, just needs the engine looked at.

What Needs Work	The engine needs to be looked at and the left hand side rigger arm needs a pad.	
Date/Time	06-09-2023

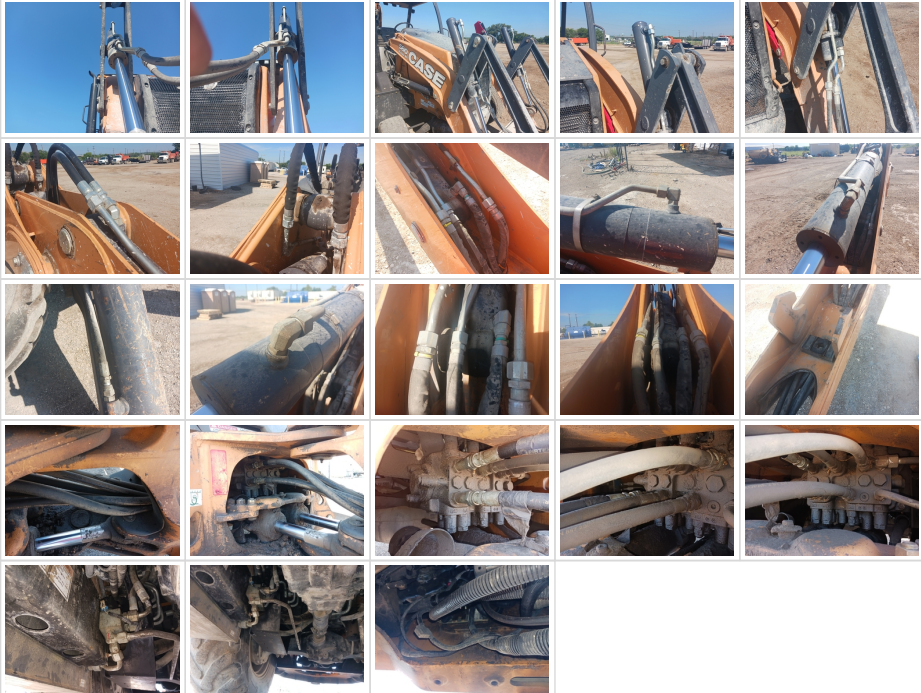
Emissions Tier	Tier 4F
Engine Serial Number	unable to verify
Engine Fuel Type	Diesel
Blow-by (Visual Observation Check)	Yes
Comments	Nothing unusual seen
Unusual Noises (Upon Start-up, Idle, Shutdown)	Yes
Unusual Noise Notes	Continuous muffled, hollow sound heard
Engine Smoke (Upon Start-up, Idle, Shutdown)	No
Engine Exhaust Color	Clear
Battery	3 - Normal Wear & Tear
Battery Condition	Dusty & dirty appearance
Radiator	3 - Normal Wear & Tear
Radiator Condition	Radiator fins & components appear to be in good working order, no signs of damage or leaks
Belts	3 - Normal Wear & Tear
Belt Condition	Belts appear in good condition & alignment with proper tension
Hoses	2 - Above Average Wear & Tear
Hose Condition	Leaks in one or more hoses or fittings observed
Comments	some hoses have leaks
Hose Photos

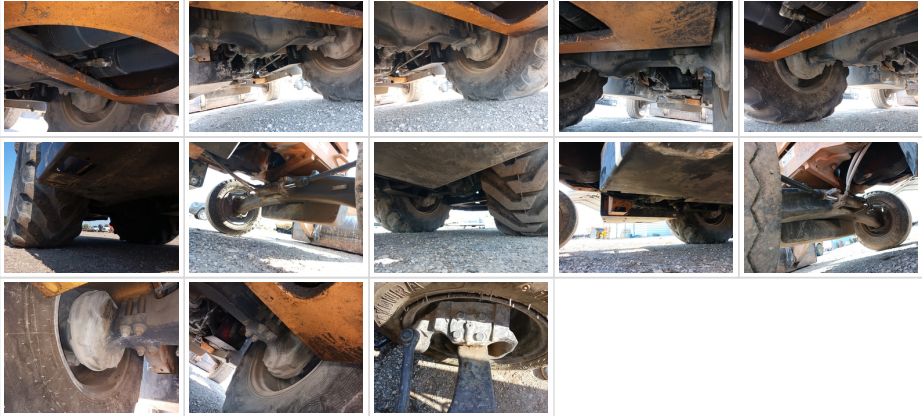
Chassis Photos

Frame	3 - Normal Wear & Tear
Stance	3 - Normal Wear & Tear
Front Axle Appearance	3 - Normal Wear & Tear
Rear Axle Appearance	3 - Normal Wear & Tear
Oscillating Pin Appearance	0
Lift Arm	3 - Normal Wear & Tear
Chassis to Arm Pins	3 - Normal Wear & Tear
Tilt Linkage	0
Tilt Linkage Pins & Bushings	0
Bucket to Arm Pins	3 - Normal Wear & Tear
Boom	3 - Normal Wear & Tear
Stick	3 - Normal Wear & Tear
Stick Extension Wear Guides	0
Boom Lock	3 - Normal Wear & Tear
Swing Tower Pivot	3 - Normal Wear & Tear
Boom Base Pin & Bushings	3 - Normal Wear & Tear
Boom to Stick Pin & Bushings	3 - Normal Wear & Tear
Stick to Bucket Pin & Bushings	3 - Normal Wear & Tear
Outriggers	2 - Above Average Wear & Tear
Comments	left side outrigger is missing a pad
Overall Chassis	3 - Normal Wear & Tear

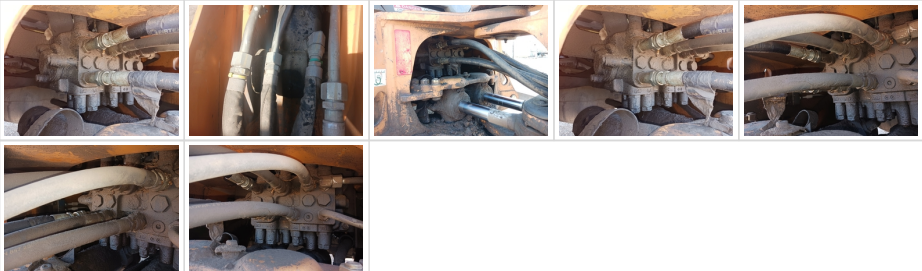
Hydraulic System Photos

Wet or Damp Hydraulic Lines / Fittings	Yes
Appearance of Hydraulic Lines / Fittings	3 - Normal Wear & Tear
Hydraulic Lines / Fittings Condition	Cracking, stiff, or charred hydraulic hoses, Other (see comments)
Comments	aome hoses do have small leaks, mainly seen around seals
Hydraulic Pump(s)	3 - Normal Wear & Tear
Unusual Noises (Hydraulic Pump)	No

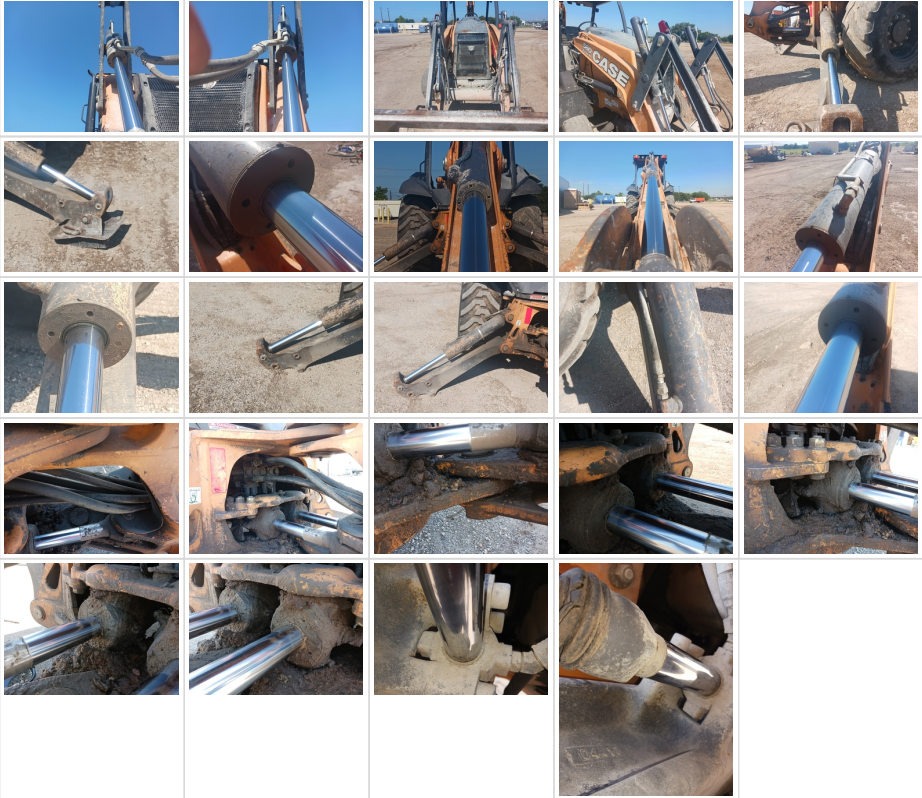
Hydraulic Cylinder(s) Photos

Hydraulic Cylinder(s): Mounting Pins	3 - Normal Wear & Tear
Hydraulic Cylinder(s): Oil Leaks	Yes
Comments	leaks were seen on some cylinders around the seals

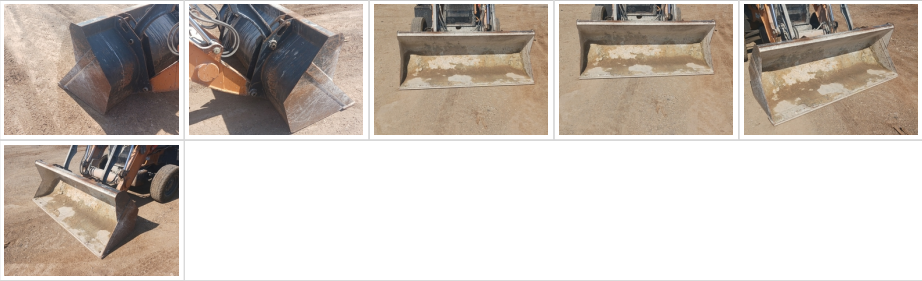
Loader & Backhoe Bucket Photos

Loader Bucket	3 - Normal Wear & Tear
Loader Bucket Edge / Deflectors	3 - Normal Wear & Tear
Backhoe Bucket	0
Backhoe Bucket Edge / Deflectors	0
