Inspection Report (Bulldozer)

B&B Stock Number	A4207041
Year	2004
Make	Caterpillar
Model	D8R
Serial Number	AKA00985
Hour Meter Reading	15253.9
Previous Application (e.g., earth moving, mining, demolition, etc)	Earth moving

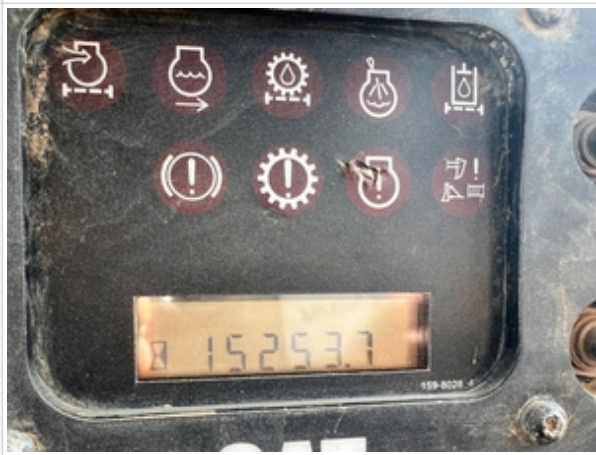
Controls & Switches Condition	Switches have good functionality, minor cosmetic damage observed
Hour Meter Activity	3 - Normal Wear & Tear
Hour Meter Condition	Hour meter is functional and in good condition
Other Gauge Activity	3 - Normal Wear & Tear
Other Gauge Condition	All cockpit gauges are functional and in good condition
Heater & A/C	3 - Normal Wear & Tear
Heater & A/C Condition	Heater and A/C work as expected, Fan vents are very dirty
Travel Alarm	3 - Normal Wear & Tear
Travel Alarm Condition	Travel alarm is installed and functioning as expected
Horn	3 - Normal Wear & Tear
Horn Condition	Horn is installed and functioning as expected
Backup Camera	0
