## Inspection Report (Wheel Loader)

B&B Stock Number	1 (B&B Stock # N/A in HUBSPOT)
Year	2001
Make	CAT
Model	966G
Serial Number	3SW00976
Hour Meter Reading	11,256 Hrs.
Previous Application (e.g., earth moving, mining, demolition, etc)	Rental Equipment

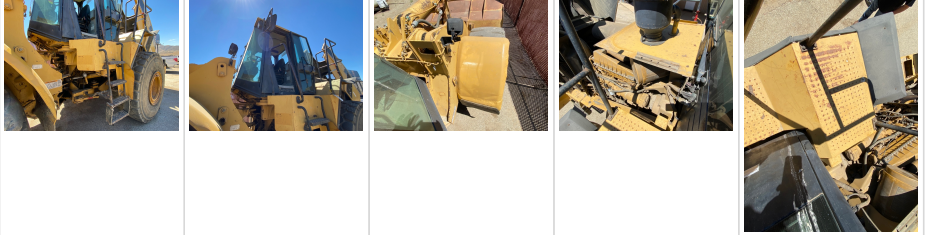
Worn rear step

Minor damage to R/S Step

Worn rear step		L/S Step Ladder bent

<b>Body Panel Condition</b>	Some panel misalignment observed, Visible chipped paint or dents, Other (see comments)
<b>Comments</b>	Normal wear for its age. All steps worn and bent but still usable.
<b>Doors / Canopy Latches</b>	3 - Normal Wear & Tear
<b>Doors / Canopy Latches Condition</b>	Intermittent sticking observed on one or more latches/doors, Other (see comments)
<b>Comments</b>	Main Cab entry door handle has broken cover and R/S Cab Window Latch hard to close
<b>Steps / Ladders</b>	3 - Normal Wear & Tear
<b>Steps / Ladders Condition</b>	Bent or broken steps or rungs
<b>Handrails</b>	3 - Normal Wear & Tear
<b>Handrails Condition</b>	Handrails are fully intact and appear structurally sound
<b>Glass</b>	3 - Normal Wear & Tear
<b>Glass Condition</b>	Glass intact, no visible damage
<b>Mirrors</b>	3 - Normal Wear & Tear
<b>Mirror Condition</b>	Mirrors present and intact, no visible damage
<b>Exterior Lights</b>	3 - Normal Wear & Tear

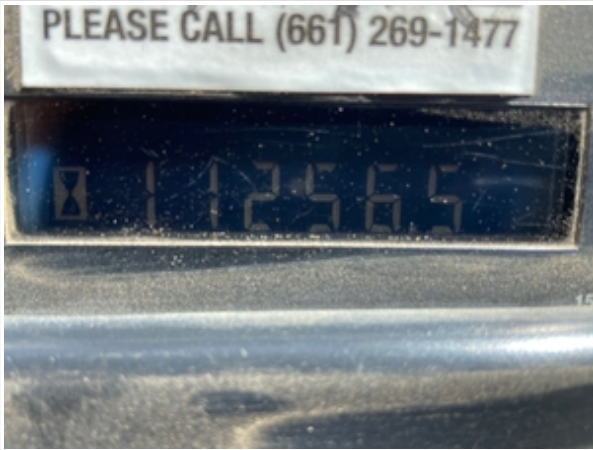
Hour Meter/Odometer

Hour Meter Condition	Hour meter is functional and in good condition
Other Gauge Activity	3 - Normal Wear & Tear
Other Gauge Condition	Gauges are functional, with some wear and/or cosmetic damage
Heater & A/C	3 - Normal Wear & Tear
Heater & A/C Condition	Heater and A/C work as expected
Travel Alarm	3 - Normal Wear & Tear
Travel Alarm Condition	Travel alarm is installed and functioning as expected
Horn	3 - Normal Wear & Tear
Horn Condition	Horn is installed and functioning as expected
Backup Camera	0

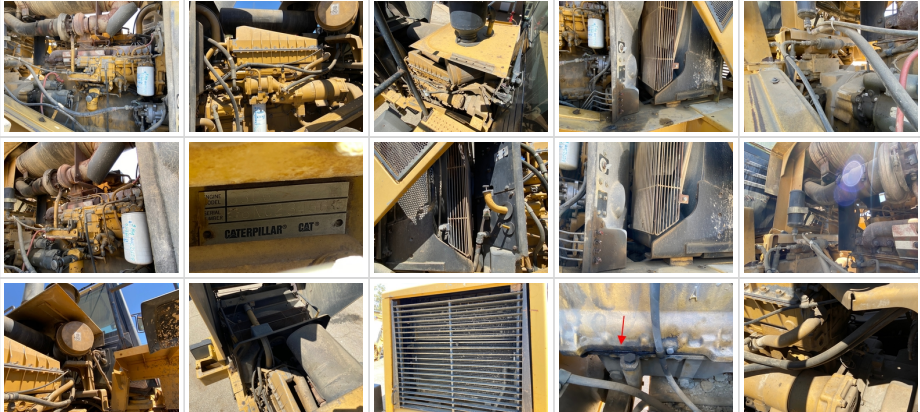
Engine Compartment Photos

<p>Minor oil seepage at oil pan gasket area</p>

Overall Engine Appearance	Clean & dry
Overall Engine Comments	Engine sputtered a bit after initial startup but ran fine after it warmed up. Engine sounds strong and runs well under load. No major engine oil leaks observed. Overall engine has well maintained appearance.

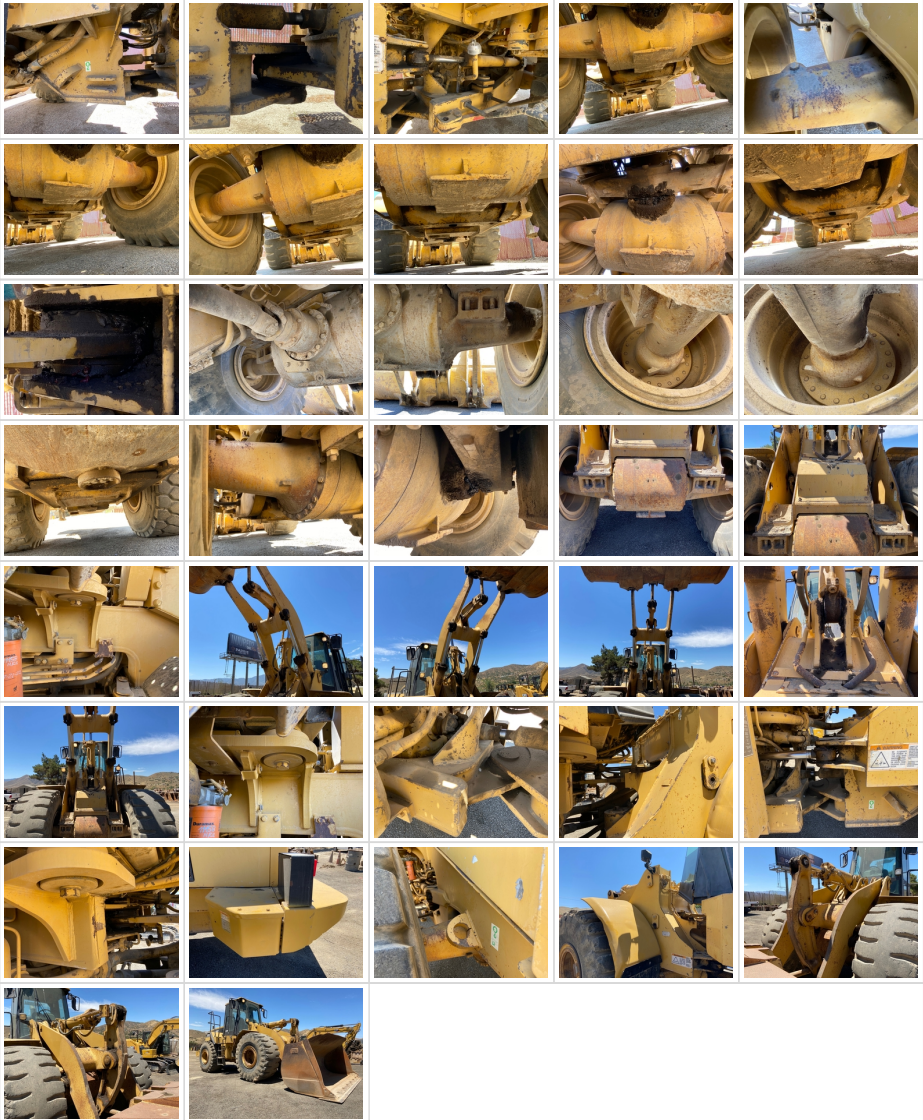
Chassis Photos

Overall Chassis	3 - Normal Wear & Tear
Overall Chassis Comments	Frame and implements in good condition. No excessive play observed at implements. Axles also have a healthy appearance.

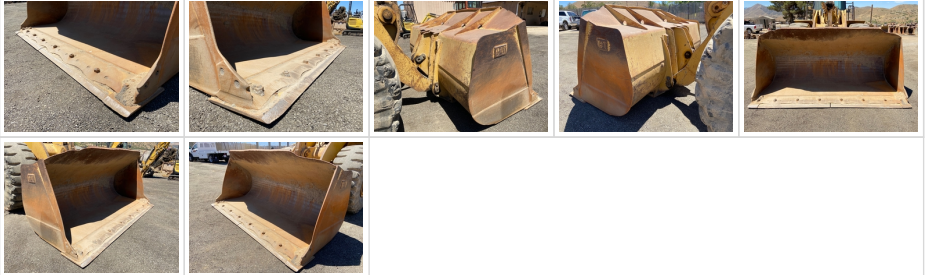
Attachment Type	5 Yard GP Smooth Edge Bucket
Attachment Make	CAT
Attachment Size / Specs	5 Yard
Attachment Condition	3 - Normal Wear & Tear
Comments	Bottom edge of bucket worn but Cutting Edges okay
Attachment Photos
