Inspection Report (On-Highway Dump Truck)

B&B Stock Number	1 (N/A In HUBSPOT)
Year	2016
Make	Freightliner
Model	M2
Serial Number	3ALACWDU6GDFY3260
Truck Odometer Reading	43,721 Mi.
Current Inspection / State Cert / DOT	N/A
Previous Application (e.g., earth moving, mining, demolition, etc)	Asphalt General Construction

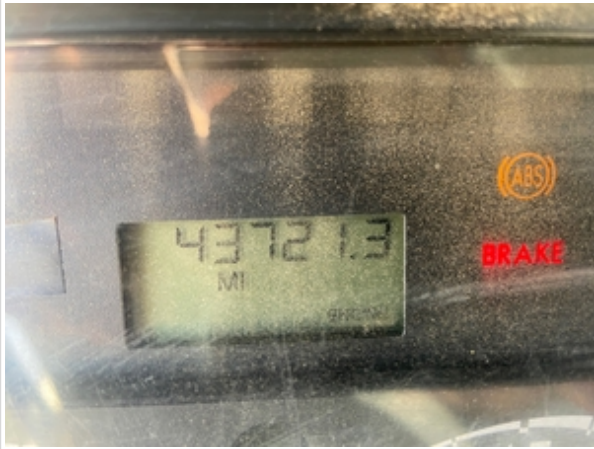
Odometer Photo

Odometer Activity	3 - Normal Wear & Tear
Odometer Condition	Odometer is working and in good condition
Controls/Switches/Gauges	3 - Normal Wear & Tear
Controls/Switches/Gauges Condition	All switches/gauges are in good condition and functioning
Brake System Type	Hydraulic
Clutch	0
Horn	3 - Normal Wear & Tear
Horn Condition	Horn is functioning as expected
Reverse Alarm / Backup Camera	3 - Normal Wear & Tear
Reverse Alarm / Backup Camera Condition	Reverse alarm working as expected
Heater & A/C	3 - Normal Wear & Tear
Heat & A/C Condition	Heater and A/C work as expected
Interior Lights	3 - Normal Wear & Tear
Interior Lights Condition	All interior lights are installed and functioning
Seats/Seat Belts	3 - Normal Wear & Tear
Seats/Seat Belt Condition	Seat belt secures properly, Seat(s) has major surface staining or tears, Other (see comments)
Comments	Driver seat upholstery damaged
Cab Interior Overall Rating	3 - Normal Wear & Tear

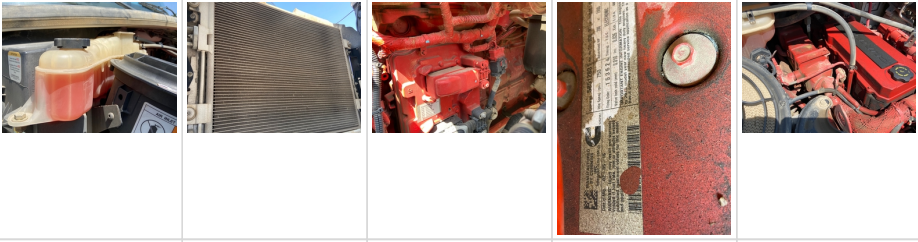
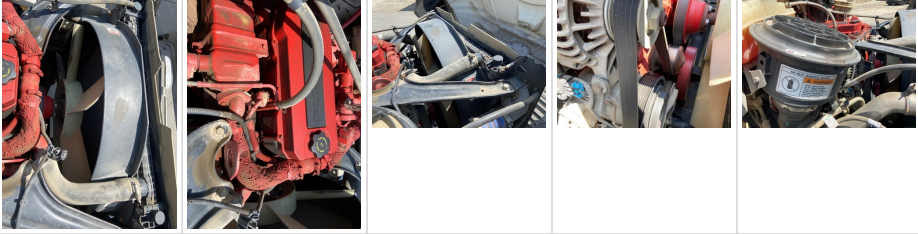
Engine Compartment Photos

Blow-by (Visual Observation Check)	Yes
Comments	Some minor blow by seen at breather tube
Unusual Noises (Upon Start-up, Idle, Shutdown)	No
Engine Smoke (Upon Start-up, Idle, Shutdown)	No
Engine Exhaust Color	Clear
Battery	3 - Normal Wear & Tear
Battery Condition	Clean & dry appearance, tight connections
Radiator	3 - Normal Wear & Tear
Radiator Condition	Radiator fins & components appear to be in good working order, no signs of damage or leaks
Belts	3 - Normal Wear & Tear
Belt Condition	Belts appear in good condition & alignment with proper tension
Hoses	3 - Normal Wear & Tear
Hose Condition	Firm, pliant hoses with no signs of wear or leaks
Water Pump	3 - Normal Wear & Tear
Water Pump Condition	No unusual pump noises heard
Cooling System Leaks	No
Coolant Color / Appearance	3 - Normal Wear & Tear
Coolant Color/Appearance Notes	Normal Translucent appearance, no visual signs of contamination
Oil Leaks	Yes
Oil Leak Notes	Dried oil seepages seen, Other (see comments)

Comments	Residual oil seen around engine. No active leak seen. Further inspection to determine if engine oil leaks exist recommended.
Oil Color / Appearance	3 - Normal Wear & Tear
Oil Color / Appearance Notes	Clean oil appearance, no signs of cross contamination, Appropriate oil level
Fuel Leaks	No
Equipped with DPF (Diesel Particulate Filter)	Yes
DPF Condition	3 - Normal Wear & Tear
DPF Condition Notes	Filter housing is intact with no signs of damage or malfunction, DPF indicator is not illuminated
Requires DEF (Diesel Exhaust Fluid)	Yes
DEF Tank	3 - Normal Wear & Tear
DEF Tank Condition	Area around DEF tank cap is clean, fluid is clear & appears free of contaminants

Overall Engine Rating	3 - Normal Wear & Tear
Overall Engine Appearance	Dusty & dry, Areas of dried seepage seen on engine hoses & components
Overall Engine Comments	Engine fires right up and sounds healthy under load. Minor residual oil observed around engine. No active leaks seen but further inspection of possible oil leaks recommended.

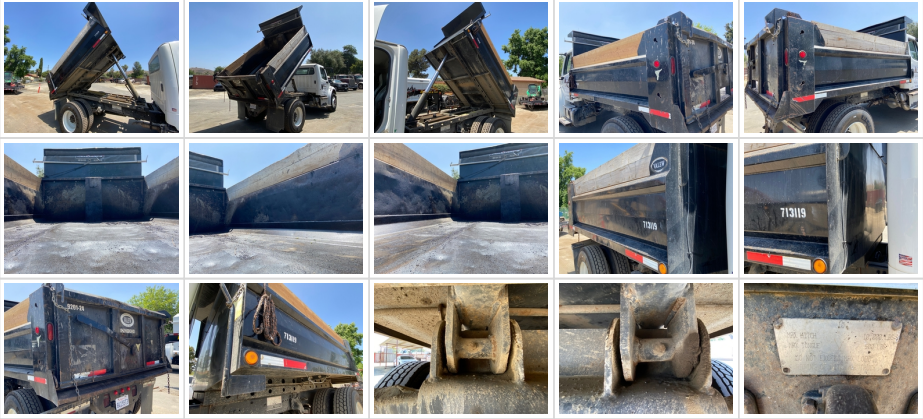
Dump Body Photos

Dump Body Make & Material	Valew
Dump Body Length (ft and inches)	10'
Dump Body Height (ft and inches)	7'2" Dump Height (10'L x 3'H x 8'W)
Bed Body	3 - Normal Wear & Tear
Tailgate	3 - Normal Wear & Tear
Tailgate Latch	3 - Normal Wear & Tear
Support Frame	3 - Normal Wear & Tear
Hinge Points	3 - Normal Wear & Tear
Tarp	3 - Normal Wear & Tear
