## Inspection Report (On-Highway Truck Cab + Chassis)

| Year | 2015 |
| Make | Kenworth |
| Model | T880 |

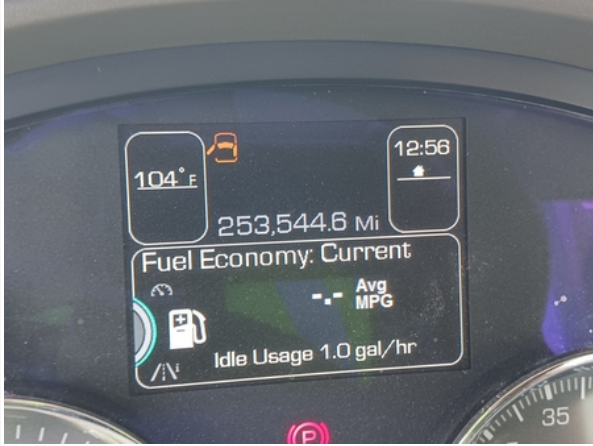
| Odometer Photo | |

| Odometer Activity | 3 - Normal Wear & Tear |
| Odometer Condition | Odometer is working and in good condition |

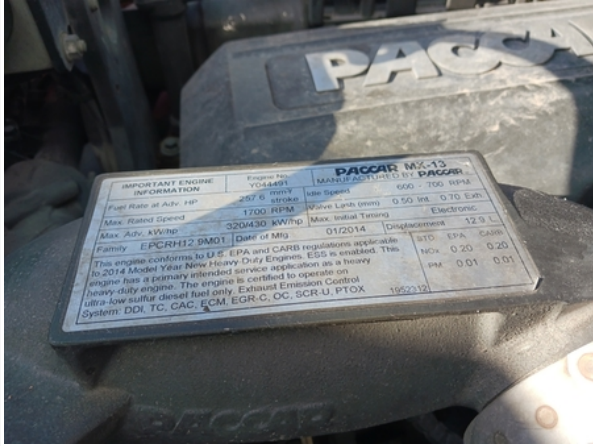
| Engine Data Plate | |

| Engine Type (Make, Model, Cylinders, Hp) | Paccar, MX-13, 12.9L, 405-510Hp |
| Engine Serial Number | Y044491 |

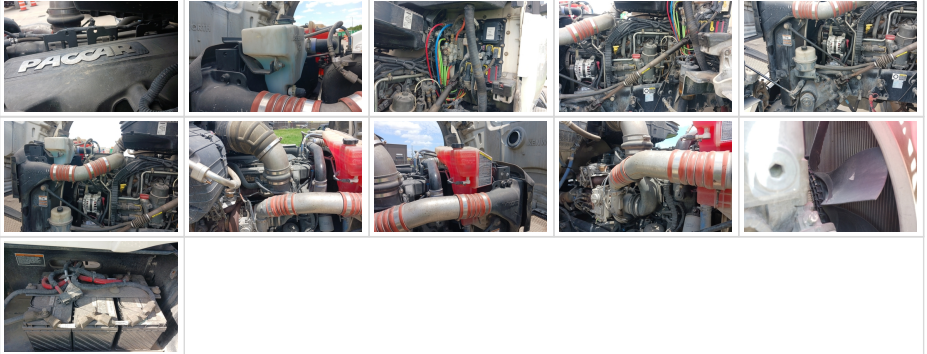
| Engine Compartment Photos | |

| Overall Engine Rating | 3 - Normal Wear & Tear |
| Overall Engine Appearance | Clean & dry |
| Overall Engine Comments | The engine is in good working condition |
