## Inspection Report (On-Highway Flatbed Truck)

| Year | 2015 |
| Make | Ford |
| Model | F750 XLT |

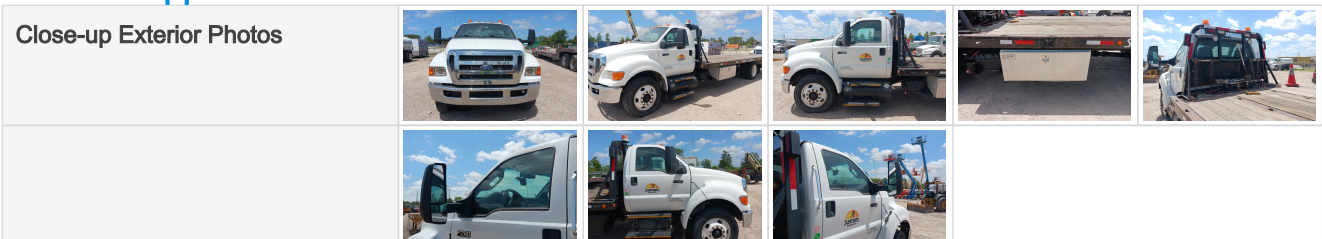
#### General Appearance Photos

| Body Panels | 3 - Normal Wear & Tear |
| Body Panel Condition | No visible damage, good paint condition and panel fitment |
| Doors / Canopy Latches | 3 - Normal Wear & Tear |
| Doors / Canopy Latches Condition | No visible damage |
| Steps / Ladders | 3 - Normal Wear & Tear |
| Steps / Ladders Condition | Steps/ladders are fully intact and appear structurally sound |
| Handrails | 3 - Normal Wear & Tear |
| Handrails Condition | Handrails are fully intact and appear structurally sound |
| Glass | 3 - Normal Wear & Tear |
| Glass Condition | Glass intact, no visible damage |

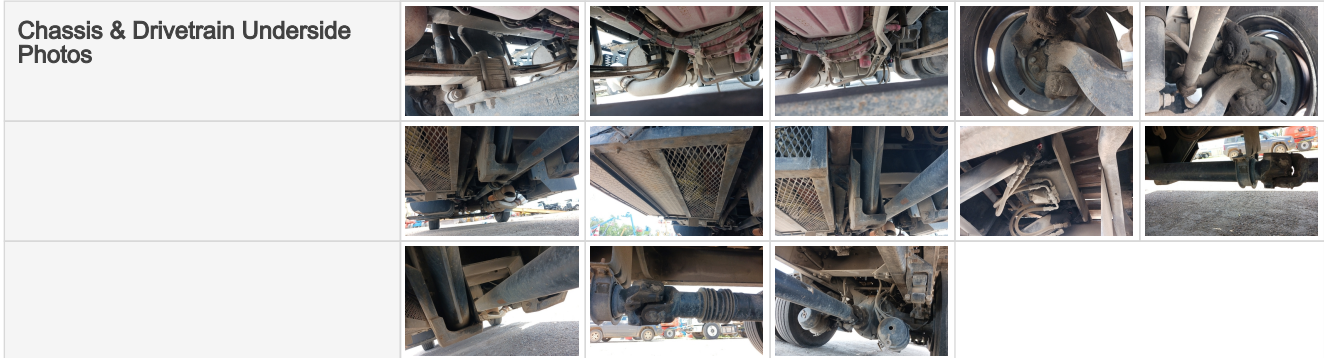
### Chassis & Drivetrain Photos

| Frame | 3 - Normal Wear & Tear |
| Suspension | 3 - Normal Wear & Tear |
| Steer Axle | 3 - Normal Wear & Tear |
| Steering Components | 3 - Normal Wear & Tear |
| Overall Chassis Condition | 3 - Normal Wear & Tear |
| Overall Chassis Comments | In good condition |
