Inspection Report (On-Highway Box Truck)

B&B Stock Number	A5527154
Year	2015
Make	Ford
Model	F 750
Serial Number	3FRNF7FA3FV727536
Truck Odometer Reading	42928.0
Current Inspection / State Cert / DOT	Unable to verify
Previous Application (e.g., earth moving, mining, demolition, etc)	The truck was used in a rental company

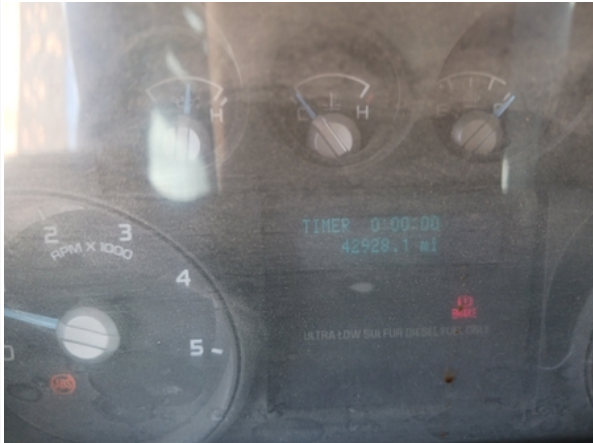
Odometer Photo

Odometer Activity	3 - Normal Wear & Tear				
Odometer Condition	Odometer is working and in good condition
