Inspection Report (Telehandler)

B&B Stock Number	A8290852
Year	2015
Make	JLG Skytrak
Model	6042
Serial Number	0160064224
Hour Meter Reading	1,921 Hrs.
Previous Application (e.g., earth moving, mining, demolition, etc)	Equipment Rental

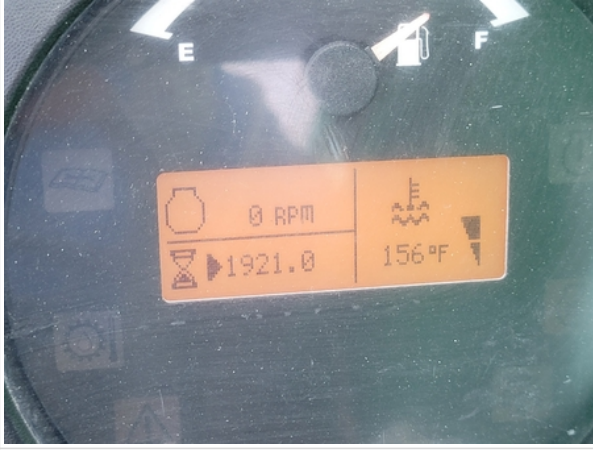
Hour Meter/Odometer

Hour Meter Condition	Hour meter is functional and in good condition
Other Gauge Activity	3 - Normal Wear & Tear
Other Gauge Condition	All cockpit gauges are functional and in good condition, Gauges are functional, with some wear and/or cosmetic damage
Heater & A/C	0
Travel Alarm	3 - Normal Wear & Tear
Travel Alarm Condition	Travel alarm is installed and functioning as expected
Horn	3 - Normal Wear & Tear
Horn Condition	Horn is installed and functioning as expected
Backup Camera	0

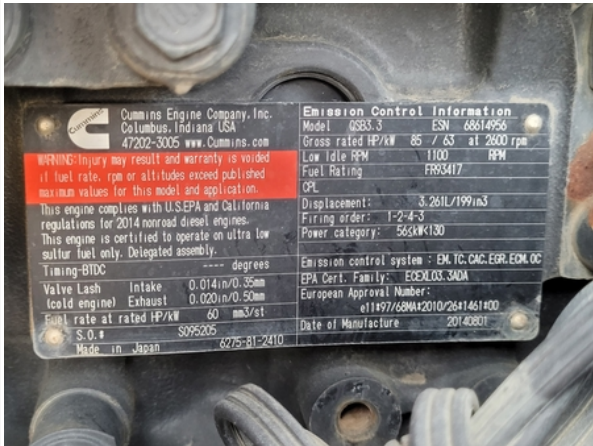
Engine Data Plate

Engine Type (Make, Model, Cylinders, Hp)	Cummins - QSB3.3 ATAAC - 4Cyl. - 85HP				
Emissions Tier	Tier 3				
Engine Serial Number	68614956				
Engine Fuel Type	Diesel

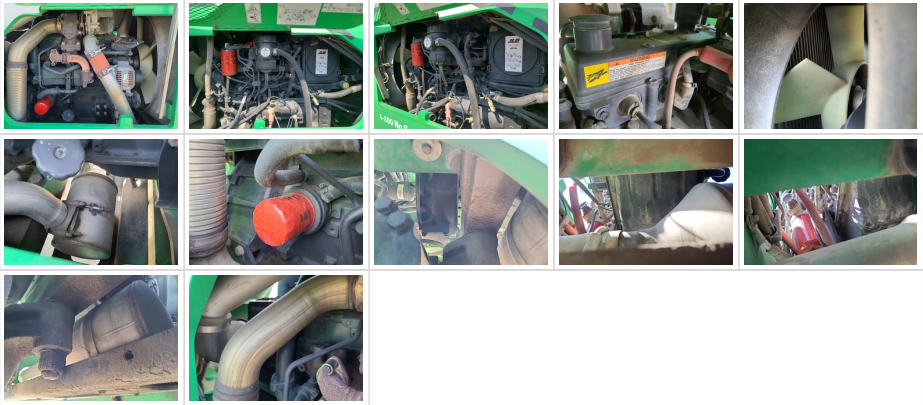
Engine Compartment Photos

Fuel Leaks	No
Equipped with DPF (Diesel Particulate Filter)	No
Requires DEF (Diesel Exhaust Fluid)	No
Overall Engine Rating	3 - Normal Wear & Tear
Overall Engine Appearance	Clean & dry
Overall Engine Comments	Engine has well maintained appearance with no signs of active leaks.

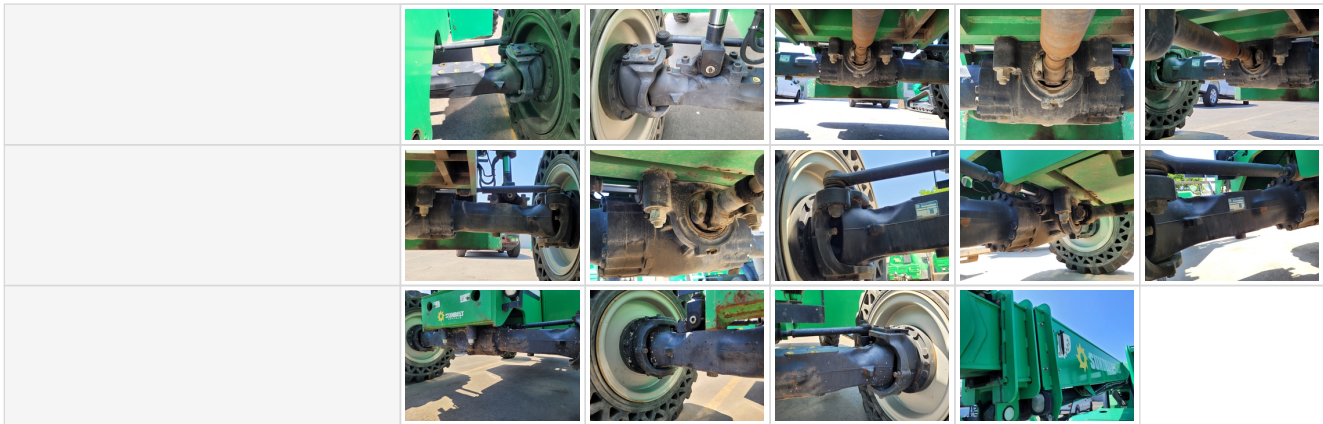
Chassis Photos

Oscillating Pin Appearance	3 - Normal Wear & Tear
Boom Condition	3 - Normal Wear & Tear
Chain / Tensioners	3 - Normal Wear & Tear
Rollers & Guides	3 - Normal Wear & Tear
Boom Wear Guides	3 - Normal Wear & Tear
Overall Chassis	3 - Normal Wear & Tear
Overall Chassis Comments	No operating issues seen with Frame, Implements or drivetrain.
