## Inspection Report (On-Highway Service Truck)

| Year | 2013 |
| Make | Ford |
| Model | F-550 |

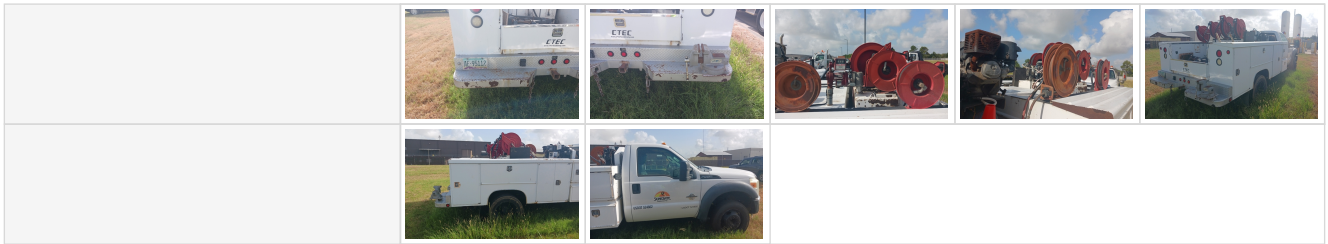
| Close-up Exterior Photos | |

| Body Panels | 3 - Normal Wear & Tear |
| Body Panel Condition | No visible damage, good paint condition and panel fitment |
| Doors / Canopy Latches | 3 - Normal Wear & Tear |
| Doors / Canopy Latches Condition | No visible damage |
| Glass | 3 - Normal Wear & Tear |
| Glass Condition | Glass intact, no visible damage |
| Mirrors | 3 - Normal Wear & Tear |
| Mirror Condition | Mirrors present and intact, no visible damage |
| Exterior Lights | 3 - Normal Wear & Tear |
| Exterior Lights Condition | No visible damage, lighting system is operational |

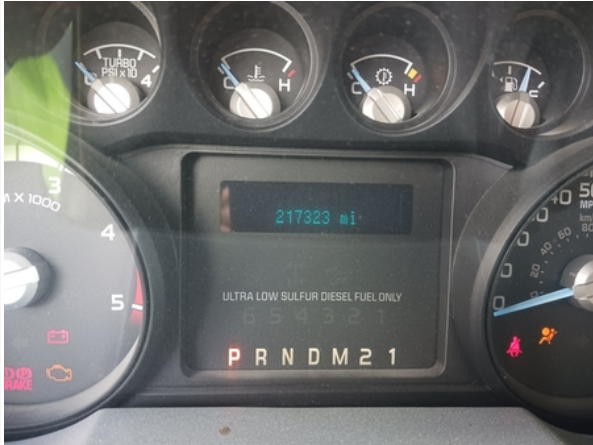
| Odometer Photo | |

| Odometer Activity | 3 - Normal Wear & Tear |
| Odometer Condition | Odometer is working and in good condition |

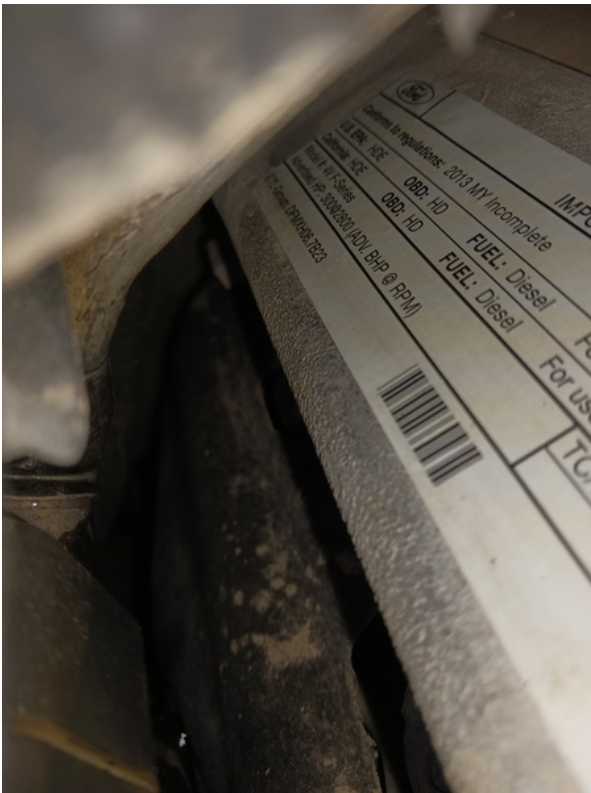
| Engine Data Plate | | | | | |

| Engine Type (Make, Model, Cylinders, Hp) | Ford, 4V F-Series, 300Hp | | | | |

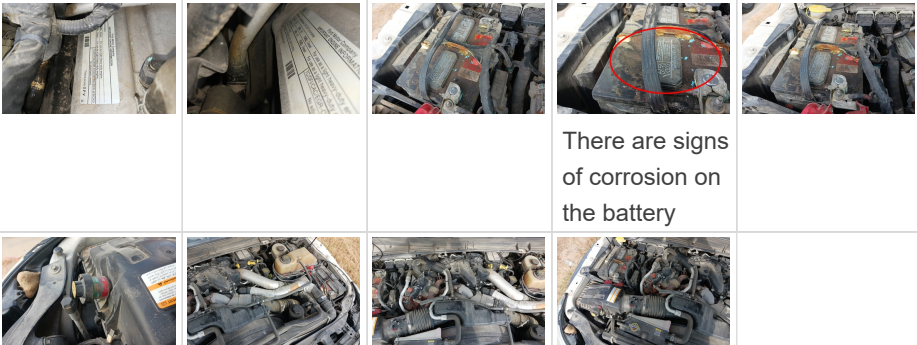
| Engine Compartment Photos | | | | | |

| Battery | 2 - Above Average Wear & Tear |
| Battery Condition | Stains & signs of corrosion seen |
| Overall Engine Appearance | Dusty & dry |

| Overall Engine Comments | Some corrosion was seen on the battery, but other than that, the engine is in good working order |
