## Inspection Report (On-Highway Truck Cab + Chassis)

| Year | 2015 |
| Make | Kenworth |
| Model | T880 |

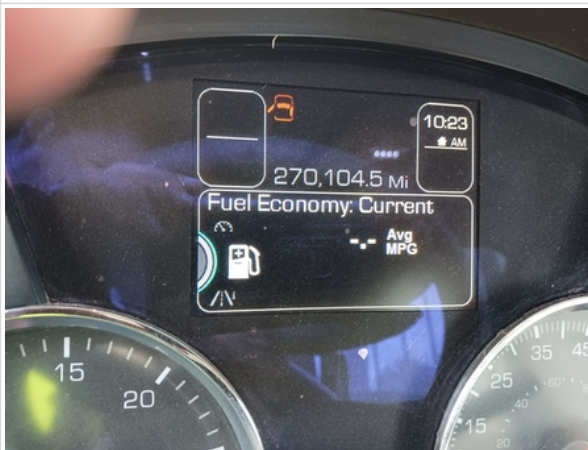
| Odometer Condition | Odometer is working and in good condition | |

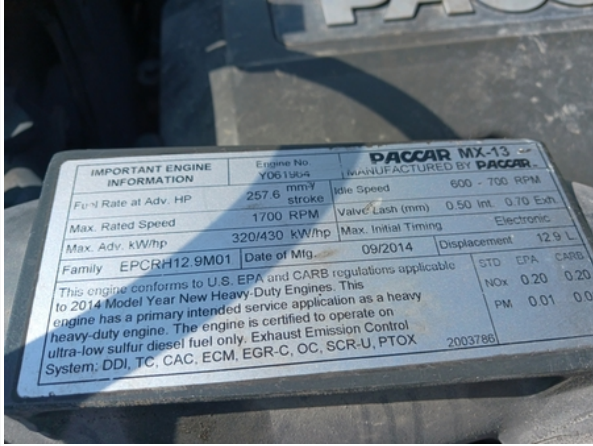
| Engine Data Plate | |

| Engine Type (Make, Model, Cylinders, Hp) | Paccar, MX-13, 12.9L, 405-510Hp |

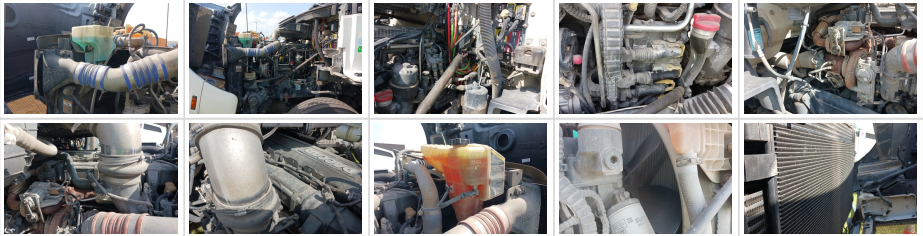
| Engine Compartment Photos | |

| Battery Condition | Dusty & dirty appearance |
| Radiator Condition | Radiator fins & components appear to be in good working order, no signs of damage or leaks |

| Overall Engine Comments | The engine is in good working order |
