Inspection Report (Rough Terrain Crane)

B&B Stock Number	A8856676
Year	2014
Make	Sany
Model	SRC840
Serial Number	14RC00350825
Hour Meter Reading	2027.7
Previous Application (e.g., earth moving, mining, demolition, etc)	This machine was primarily used in the making of bridges

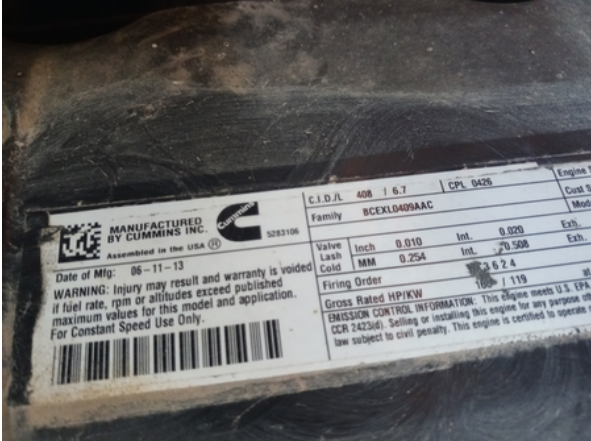
Engine Data Plate

<p>MANUFACTURED BY CUMMINS INC. 3283106 Assembled in the USA</p> <p>Date of Mfg: 06-11-13 WARNING: Injury may result and warranty is voided if fuel rate, rpm or altitudes exceed published maximum values for this model and application. For Constant Speed Use Only.</p> <p>C.I.D./L 408 / 6.7 CPL 0428 Engine T Family BCEXL0409AAC Cust B Valve Lash Inch 0.010 Int. 0.020 Exh. Cold MM 0.254 Int. 20.500 Exh. Firing Order 1-3-6-2-4 Gross Rated HPIKW 100 / 119 EMISSION CONTROL INFORMATION: This engine meets U.S. EPA CCR 2423(d). Sealing or installing this engine for any purpose other than intended may be in violation of law subject to civil penalty. This engine is certified to operate in...</p>
Engine Compartment Photos

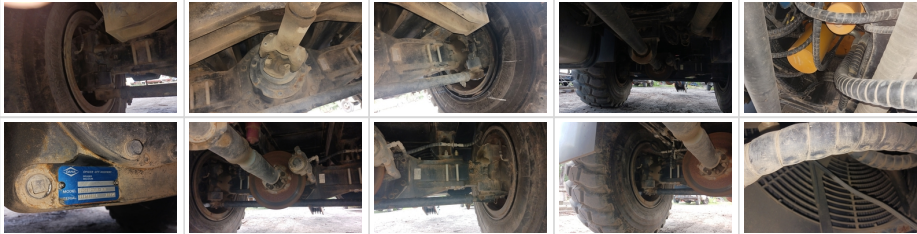
Drivetrain Photos

Hydrostatic Transmission?	Yes
2 Speed?	No
Hydrostatic Drive Configuration	Other (see comments)
Comments	The transmission is a Dana powershift transmission with axel tech axels
Transmission Components	3 - Normal Wear & Tear
Transmission Condition	Good forward and reverse function, No unusual noises or vibrations
Drive Motors	3 - Normal Wear & Tear
Parking Brake	3 - Normal Wear & Tear
Parking Brake Function	Good brake function
Overall Drivetrain Comments	The drivetrain is in good working order

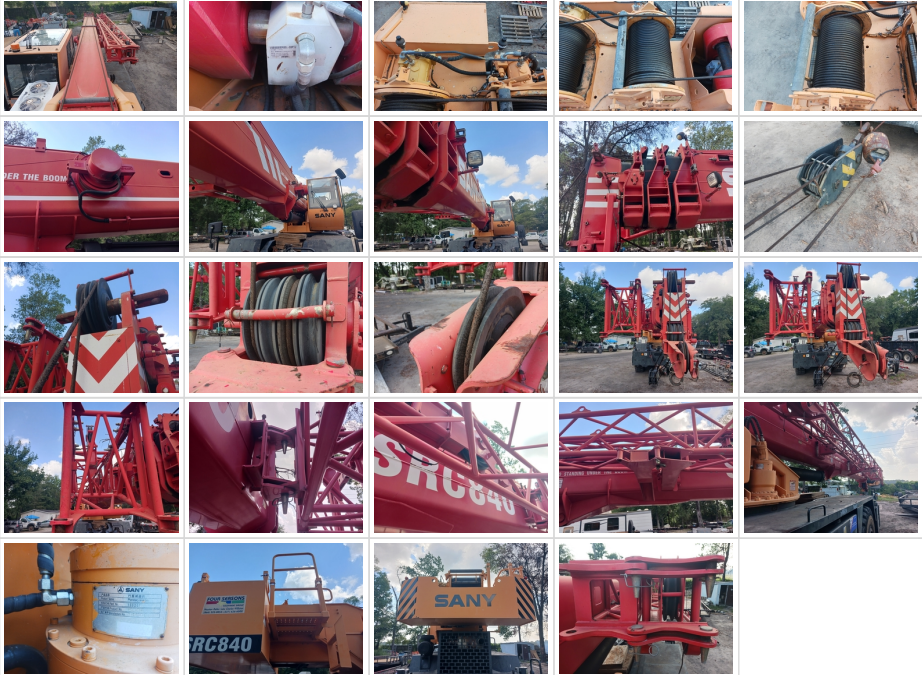
Crane Component Photos

Counterweight	3 - Normal Wear & Tear
Boom Angle Indicator	3 - Normal Wear & Tear
Main Boom Sections	3 - Normal Wear & Tear
Main Boom Pins	3 - Normal Wear & Tear
Boom Head Section	3 - Normal Wear & Tear
Wear Pads	3 - Normal Wear & Tear
Jib	3 - Normal Wear & Tear
Fairlead	3 - Normal Wear & Tear
Sheaves	3 - Normal Wear & Tear
Main Load Block	3 - Normal Wear & Tear
Overhaul Ball	3 - Normal Wear & Tear
