Inspection Report (Telehandler)

B&B Stock Number	1
Year	1998
Make	Gradall
Model	534D-9
Serial Number	0544385
Hour Meter Reading	3,622
Previous Application (e.g., earth moving, mining, demolition, etc)	Yard Forklift

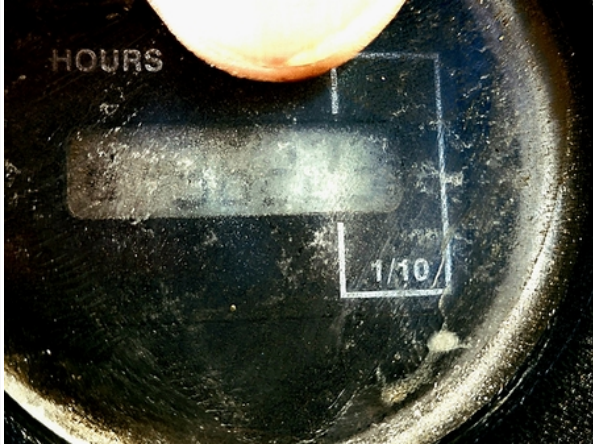
Hour Meter/Odometer

Last Known Hour Meter Reading	Hour meter hard to see due to worn gauge surface
Other Gauge Activity	3 - Normal Wear & Tear
Other Gauge Condition	Gauges are functional, with some wear and/or cosmetic damage
Heater & A/C	0
Travel Alarm	3 - Normal Wear & Tear
Travel Alarm Condition	Travel alarm is installed and functioning as expected
Horn	3 - Normal Wear & Tear
Horn Condition	Horn is installed and functioning as expected
Backup Camera	0
