Inspection Report (Wheel Loader)

B&B Stock Number	A7040886
Year	2018
Make	Caterpillar
Model	982M
Serial Number	CAT0982MAMK610341
Hour Meter Reading	17882
Previous Application (e.g., earth moving, mining, demolition, etc)	The machine was used in mining

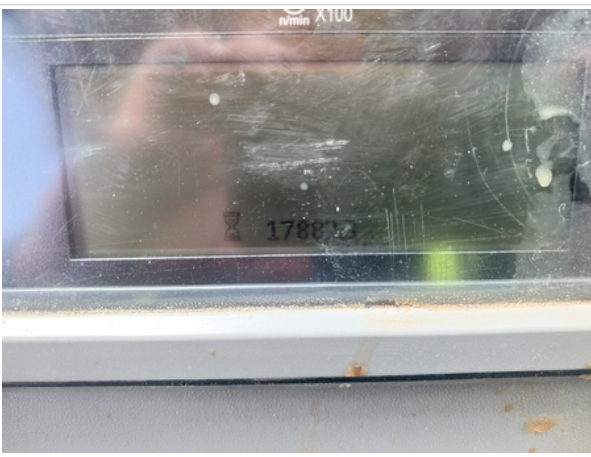
Hour Meter/Odometer

Control Station Overall Rating	3 - Normal Wear & Tear
Control Station Overall Condition	Good cabin appearance, solid floors, panels, and ceiling
Operator Seat	3 - Normal Wear & Tear
Operator Seat Condition	Seat(s) have minor surface staining or small tears, Seat belt secures properly, Seat belt is intact and in good condition
Comments	there is minimal fraying on the seat belt.
Cabin Lights	3 - Normal Wear & Tear
Cabin Lights Condition	Cabin lights are installed with all light covers in place, bulbs are installed and working properly
Safety Lock Out / Stop	3 - Normal Wear & Tear
Safety Lock Out / Stop Condition	Safety lock out device is present, in good condition, and functional
Controls & Switches	3 - Normal Wear & Tear
Controls & Switches Condition	All switches are installed and functional
Hour Meter Activity	3 - Normal Wear & Tear
Hour Meter Condition	Hour meter is functional and in good condition

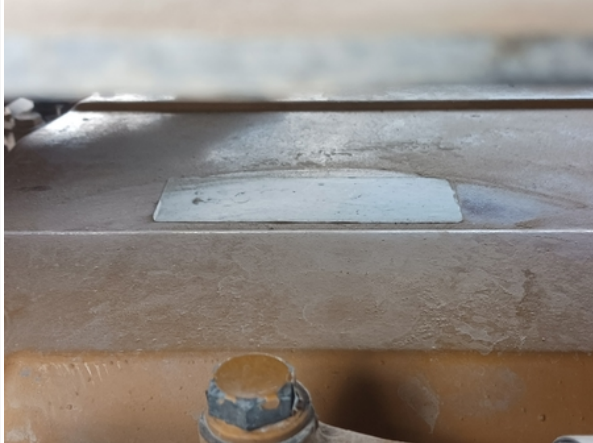
Engine Data Plate

Emissions Tier	Tier 4F
Engine Serial Number	Unable to determine due to faded ID plate
Engine Fuel Type	Diesel
Blow-by (Visual Observation Check)	N/A
Unusual Noises (Upon Start-up, Idle, Shutdown)	No
Engine Smoke (Upon Start-up, Idle, Shutdown)	No
Engine Exhaust Color	Clear
Battery	3 - Normal Wear & Tear
Battery Condition	Dusty & dirty appearance
Radiator	3 - Normal Wear & Tear
Radiator Condition	Radiator fins & components appear to be in good working order, no signs of damage or leaks, Other (see comments), Signs of corrosion on clamps & hoses
Comments	Sings of corrosion was seen on the hoses but the issue was already fixed.
Belts	3 - Normal Wear & Tear
Hoses	3 - Normal Wear & Tear
Hose Condition	Firm, pliant hoses with no signs of wear or leaks, Dried seepages observed
Comments	seeping/corrosion was seen, but the issue was already addressed and has been repaired.
Hose Photos

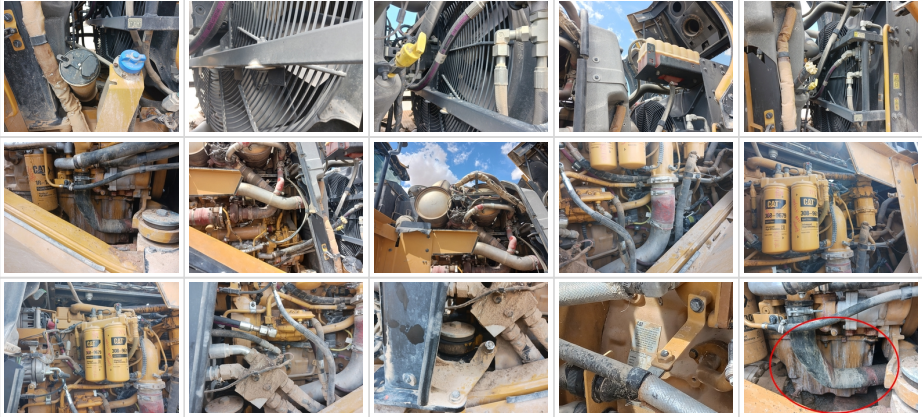
Engine Compartment Photos

<p>Sings of corrosion, The issue was already addressed and repaired.</p>
Engine Type (Make, Model, Cylinders, Hp)	Cat, C13, 6 cylinder, 436Hp

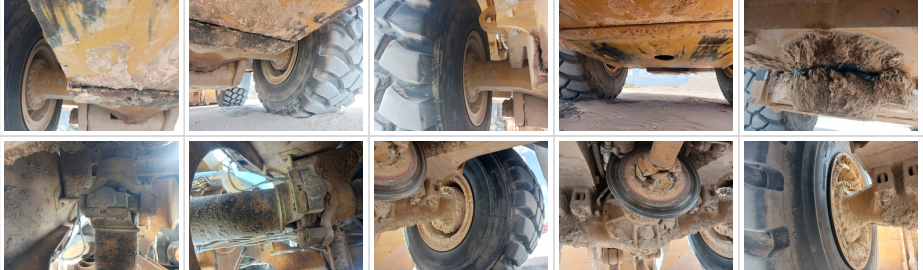
Drivetrain Photos

Hydrostatic Transmission?	No
2 Speed?	No
Hydrostatic Drive Configuration	Other (see comments)
Comments	The transmission is an automatic planetary powershift 4F/4R Transmission
Transmission Info (Make/Model/Speeds)	Unable to determine
Transmission Components	3 - Normal Wear & Tear
Transmission Condition	Good forward and reverse function, No unusual noises or vibrations
Drive Motors	3 - Normal Wear & Tear
Parking Brake	3 - Normal Wear & Tear
Parking Brake Function	Good brake function
Overall Drivetrain Comments	The drivetrain is in good working order
