Inspection Report (Excavator)

B&B Stock Number	A9915587
Year	2013
Make	Komatsu
Model	PC210 LC-10
Serial Number	KMTPC243P02450481
Hour Meter Reading	8,755 Hrs.
Previous Application (e.g., earth moving, mining, demolition, etc)	Demolition

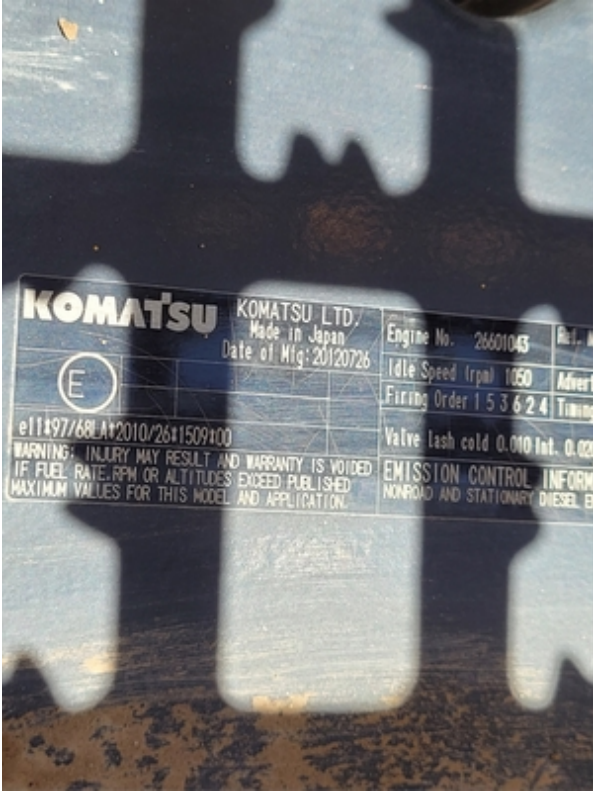
Engine Data Plate

Engine Type (Make, Model, Cylinders, Hp)	Komatsu - SAA6D107E-2 - 6.7L - 6Cyl. - 166HP
Emissions Tier	Tier 4F
Engine Serial Number	26601043
Engine Fuel Type	Diesel
Blow-by (Visual Observation Check)	Yes
Comments	Minor Blowby Seen
Unusual Noises (Upon Start-up, Idle, Shutdown)	No

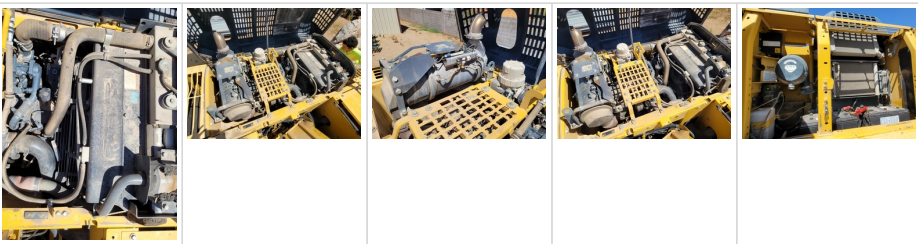
Engine Compartment Photos

Comments	Engine service recommended
Fuel Leaks	No
Equipped with DPF (Diesel Particulate Filter)	Yes
DPF Condition	3 - Normal Wear & Tear
DPF Condition Notes	Filter housing is intact with no signs of damage or malfunction, DPF indicator is not illuminated
Requires DEF (Diesel Exhaust Fluid)	No
Overall Engine Rating	3 - Normal Wear & Tear
Overall Engine Appearance	Clean & dry, Dusty & dry
Overall Engine Comments	Overall engine runs strong and sounds healthy under load. No major active leaks seen. Engine compartment has a well maintained appearance.

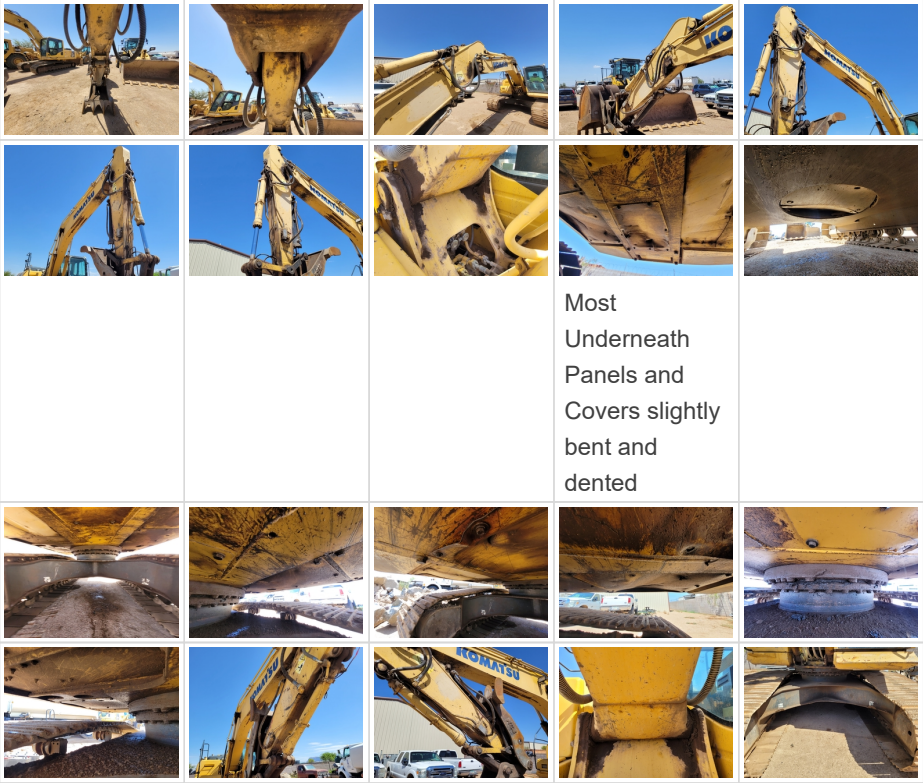
Chassis Photos

<p>Most Underneath Panels and Covers slightly bent and dented</p>
Boom Condition	3 - Normal Wear & Tear
Stick Condition	3 - Normal Wear & Tear
Boom Base Pin & Bushings	3 - Normal Wear & Tear
Boom to Stick Pin & Bushings	3 - Normal Wear & Tear
Stick to Bucket Pin & Bushings	3 - Normal Wear & Tear

Comments	Bucket linkage has some excess play
Turntable Bearing	3 - Normal Wear & Tear
Bottom Covers	3 - Normal Wear & Tear
Comments	Most Underneath Panels and Covers slightly bent and dented
Overall Chassis	3 - Normal Wear & Tear
Overall Chassis Comments	Main frame and implements in good shape. Some excess play seen at bucket linkages.

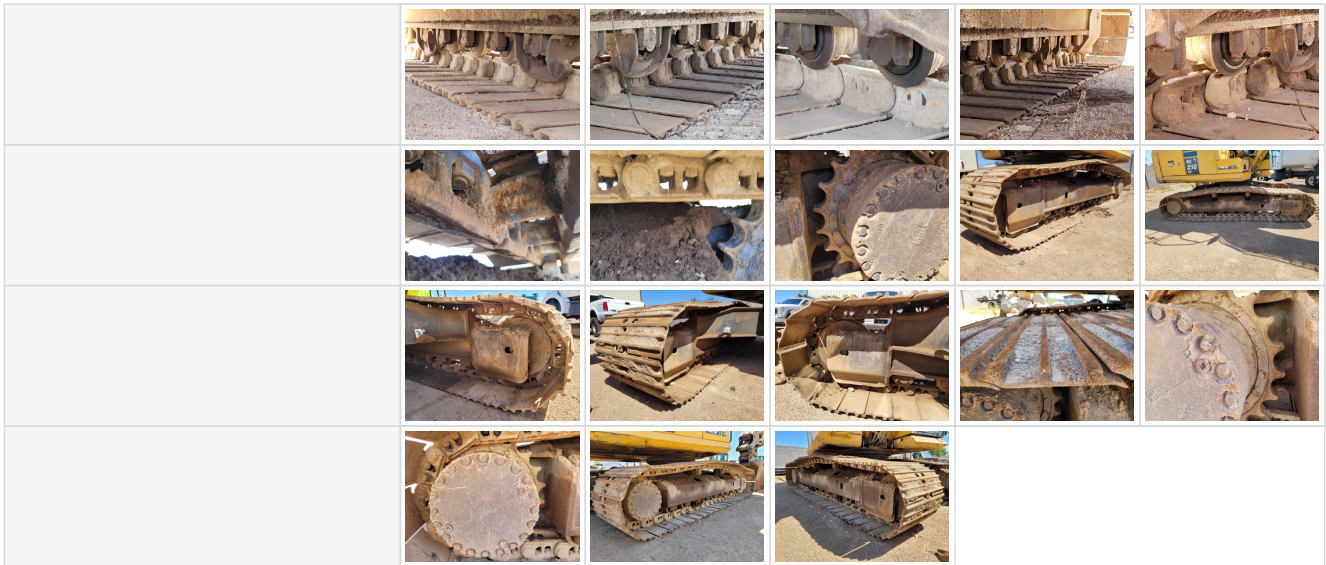
Residual oil buildup seen on tracks are from hydraulics NOT from undercarriage		Minor seepage seen at bottom rollers

Sprocket Teeth	3 - Normal Wear & Tear
Track Bushings	3 - Normal Wear & Tear
Track Frames	3 - Normal Wear & Tear
Pivot Shafts	0
Equalizer Bar & Joints	0
Front Idler	3 - Normal Wear & Tear
Track Tensioner	3 - Normal Wear & Tear
Track links	3 - Normal Wear & Tear
Bottom Rollers	3 - Normal Wear & Tear
Carrier Rollers	3 - Normal Wear & Tear
Overall Undercarriage	3 - Normal Wear & Tear
Overall Percent Estimate	50%
Overall Undercarriage Comments	Undercarriage has a normal wear and tear appearance. Some bottom rollers may be seeping out oil but no major leakage seen.
