Inspection Report (Excavator)

B&B Stock Number	A6252767
Year	2019
Make	Caterpillar
Model	308CR
Serial Number	CAT00308LGX800460
Hour Meter Reading	1182.5
Previous Application (e.g., earth moving, mining, demolition, etc)	Earth moving

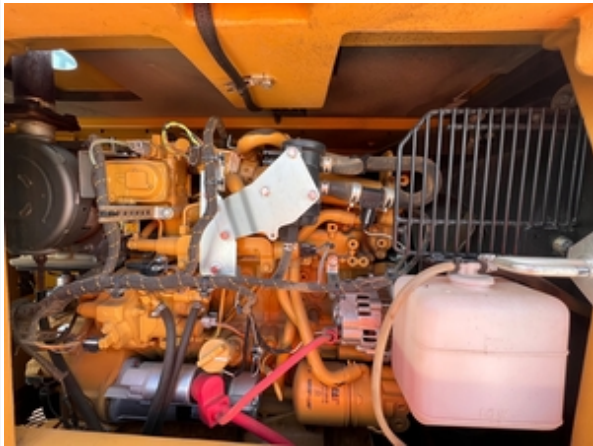
Engine Data Plate

Engine Type (Make, Model, Cylinders, Hp)	Caterpillar
Emissions Tier	Undetermined
Engine Serial Number	V3307-T-8KU3844
Engine Fuel Type	Diesel
Blow-by (Visual Observation Check)	No
Unusual Noises (Upon Start-up, Idle, Shutdown)	No
Engine Smoke (Upon Start-up, Idle, Shutdown)	No
Engine Exhaust Color	Clear
Battery	3 - Normal Wear & Tear
Battery Condition	Clean & dry appearance, tight connections
Radiator	3 - Normal Wear & Tear
Radiator Condition	Radiator fins & components appear to be in good working order, no signs of damage or leaks
Belts	3 - Normal Wear & Tear
Belt Condition	Belts appear in good condition & alignment with proper tension
Hoses	3 - Normal Wear & Tear
Hose Condition	Firm, pliant hoses with no signs of wear or leaks
Water Pump	3 - Normal Wear & Tear
Water Pump Condition	No unusual pump noises heard
Cooling System Leaks	No

Coolant Appearance	3 - Normal Wear & Tear
Coolant Appearance Notes	Normal Translucent appearance, no visual signs of contamination
Oil Leaks	No
Oil Appearance	3 - Normal Wear & Tear

Oil Appearance Notes	Clean oil appearance, no signs of cross contamination
Fuel Leaks	No
Equipped with DPF (Diesel Particulate Filter)	Yes
DPF Condition	3 - Normal Wear & Tear
DPF Condition Notes	Filter housing is intact with no signs of damage or malfunction, DPF indicator is not illuminated
Requires DEF (Diesel Exhaust Fluid)	No
Overall Engine Rating	3 - Normal Wear & Tear
Overall Engine Appearance	Clean & dry
Overall Engine Comments	Normal wear and tear. No major issues to report

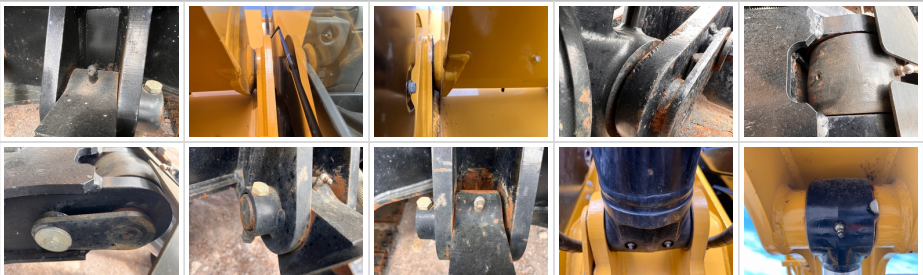
Chassis Photos

Boom Condition	3 - Normal Wear & Tear
Stick Condition	3 - Normal Wear & Tear
Boom Base Pin & Bushings	3 - Normal Wear & Tear
Boom to Stick Pin & Bushings	3 - Normal Wear & Tear
Stick to Bucket Pin & Bushings	3 - Normal Wear & Tear
Turntable Bearing	3 - Normal Wear & Tear
Bottom Covers	3 - Normal Wear & Tear
Overall Chassis	3 - Normal Wear & Tear
Overall Chassis Comments	Norma wear and tear. No major issues to report

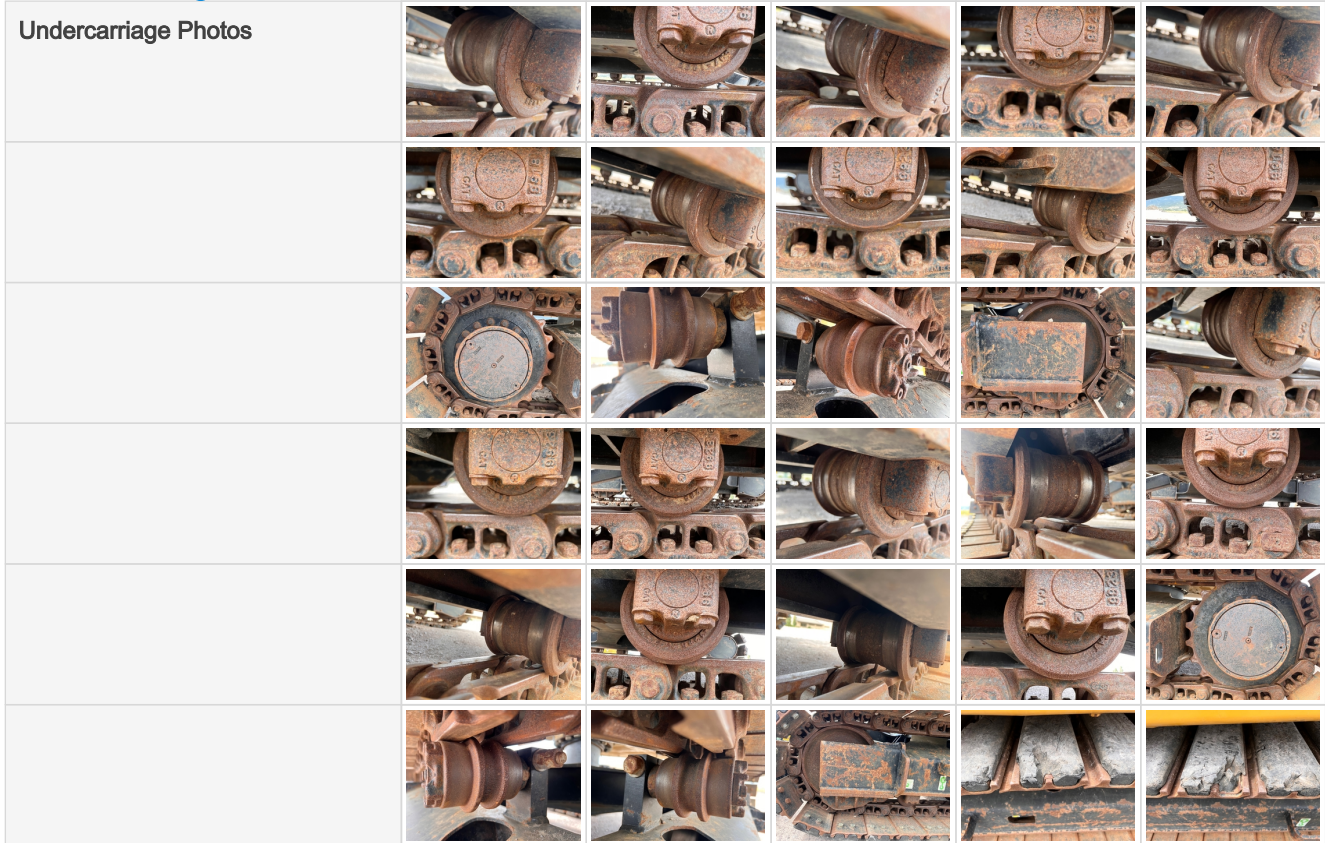
Undercarriage Photos

Sprocket Teeth	3 - Normal Wear & Tear
Track Bushings	3 - Normal Wear & Tear
Track Frames	3 - Normal Wear & Tear
Pivot Shafts	3 - Normal Wear & Tear
Equalizer Bar & Joints	3 - Normal Wear & Tear
Front Idler	3 - Normal Wear & Tear
Track Tensioner	3 - Normal Wear & Tear
Track links	3 - Normal Wear & Tear
Bottom Rollers	3 - Normal Wear & Tear
Carrier Rollers	3 - Normal Wear & Tear
Overall Undercarriage	3 - Normal Wear & Tear
Overall Percent Estimate	30%
Overall Undercarriage Comments	Normal wear and tear. No major issues to report

Safety Rating	4 - Very Light or Minimal Wear
Quality Rating	4 - Very Light or Minimal Wear
Functionality Rating	4 - Very Light or Minimal Wear
Overall Rating	4 - Very Light or Minimal Wear
What's Great About the Machine	Well maintained and like new appearance
What Needs Work	Some rubber pads to the tracks are missing chunks of material
Date/Time	08-25-2023
Inspector Name	Javier Bocanegra

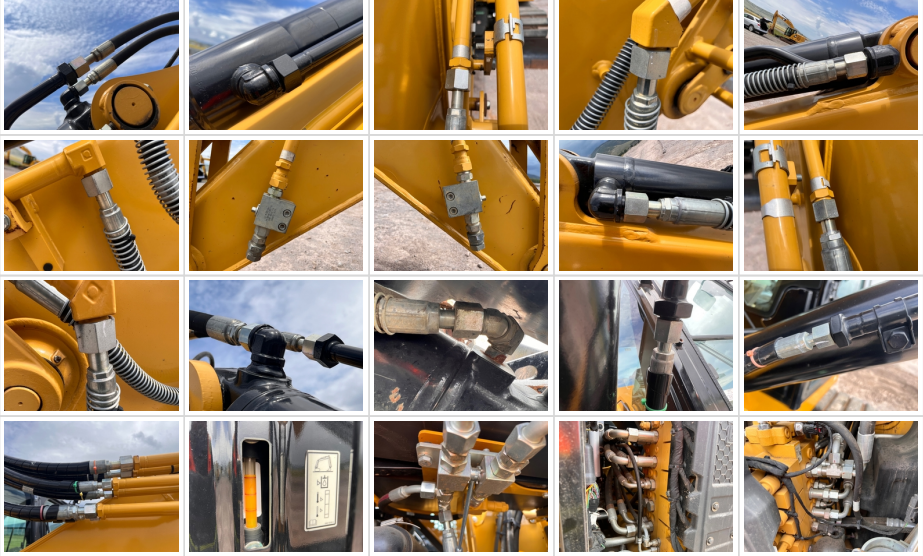
Hydraulic System Photos

Wet or Damp Hydraulic Lines / Fittings	No
Hydraulic Lines/Fittings	4 - Very Light or Minimal Wear
Hydraulic Lines / Fittings Condition	Hydraulic lines & fittings are clean and in good condition
Hydraulic Pump(s)	4 - Very Light or Minimal Wear
Unusual Noises	No
Hydraulic Pump Notes	No unusual noises heard during operation

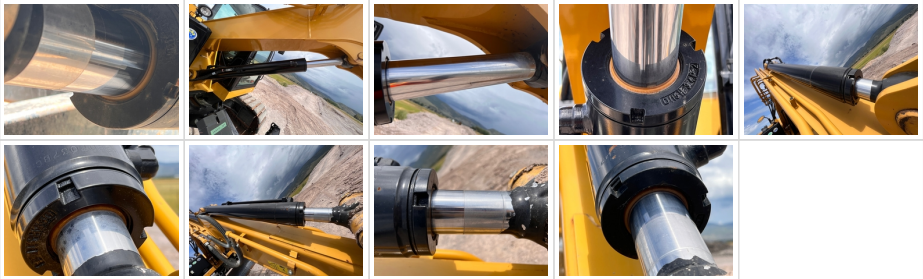
Hydraulic Cylinder Photos

Mounting Pins	3 - Normal Wear & Tear
Cylinder Oil Leaks	No
