Inspection Report (Excavator)

B&B Stock Number	A2195138
Year	2018
Make	Komatsu
Model	PC 78us-10
Serial Number	KMTPC258HJA035012
Hour Meter Reading	2328.6
Previous Application (e.g., earth moving, mining, demolition, etc)	Earth moving

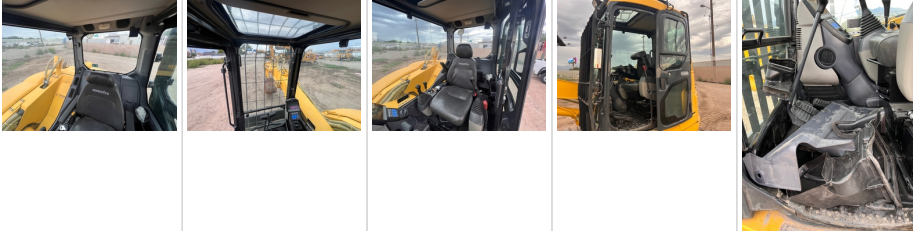
<p data-bbox="1283 611 1414 741">Panels and ducting that have been removed</p>
Serial Number Plate

Comments	Rear panels removed along with a/c ducting

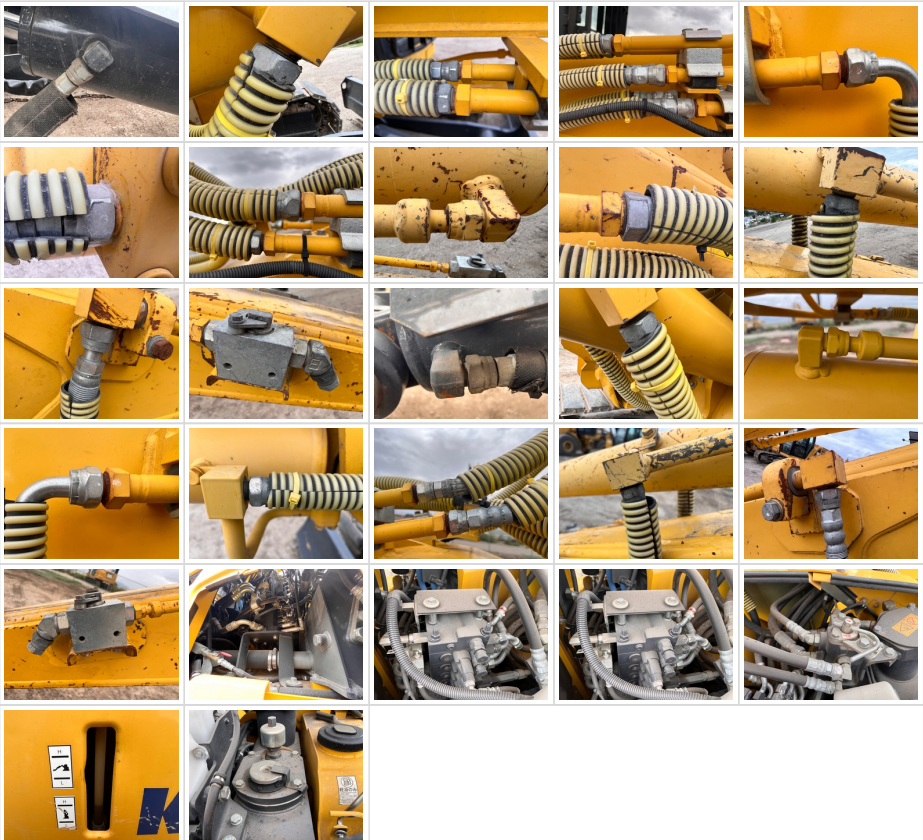
Hydraulic System Photos

Wet or Damp Hydraulic Lines / Fittings	No				
Hydraulic Lines/Fittings	3 - Normal Wear & Tear				
Hydraulic Lines / Fittings Condition	Hydraulic lines & fittings are clean and in good condition				
Hydraulic Pump(s)	3 - Normal Wear & Tear				
Unusual Noises	No

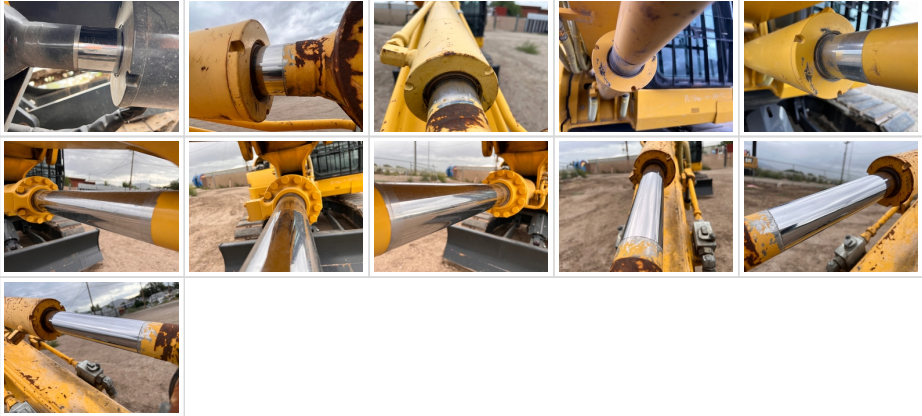
Hydraulic Cylinder Photos

Mounting Pins	3 - Normal Wear & Tear
Cylinder Oil Leaks	No
Comments	Normal wear and tear. No major issues to report

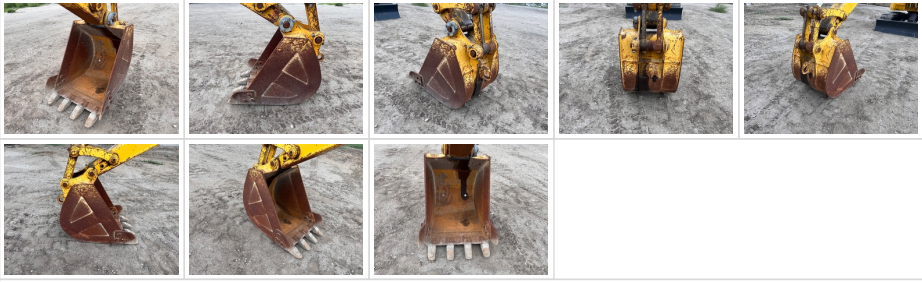
Attachment Photos

Bucket	3 - Normal Wear & Tear
Bucket Teeth	2 - Above Average Wear & Tear
Comments	Worn
Blade	0
Blade Edge	3 - Normal Wear & Tear
