## Inspection Report (Excavator)

B&B Stock Number	1
Year	2015
Make	Bobcat
Model	E32i
Serial Number	AUYJ11260
Hour Meter Reading	2,744 Hrs.
Previous Application (e.g., earth moving, mining, demolition, etc)	Rental Equipment

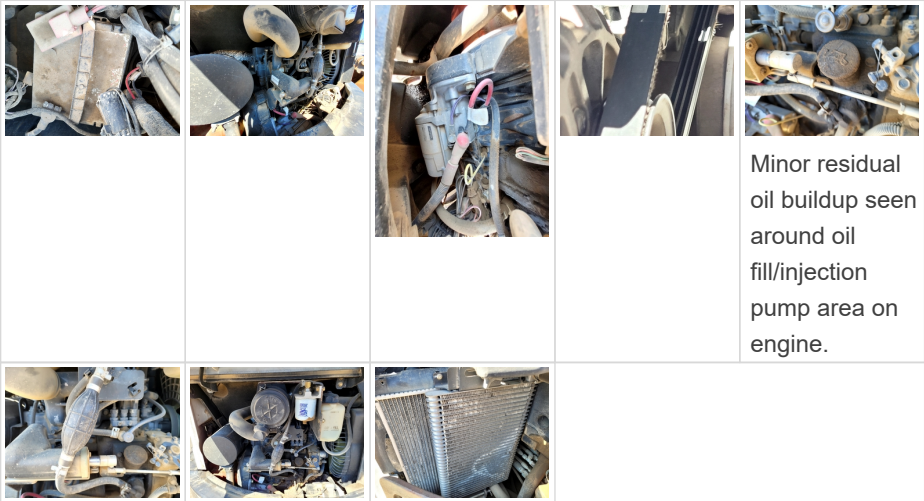
Engine Compartment Photos

<p>Minor residual oil buildup seen around oil fill/injection pump area on engine.</p>
Engine Type (Make, Model, Cylinders, Hp)	Kubota - D1703 - 1.7L - 4Cyl. - 25HP				
Emissions Tier	Tier 4F				
Engine Serial Number	N/A				
Engine Fuel Type	Diesel				
Blow-by (Visual Observation Check)	No				
Unusual Noises (Upon Start-up, Idle, Shutdown)	No

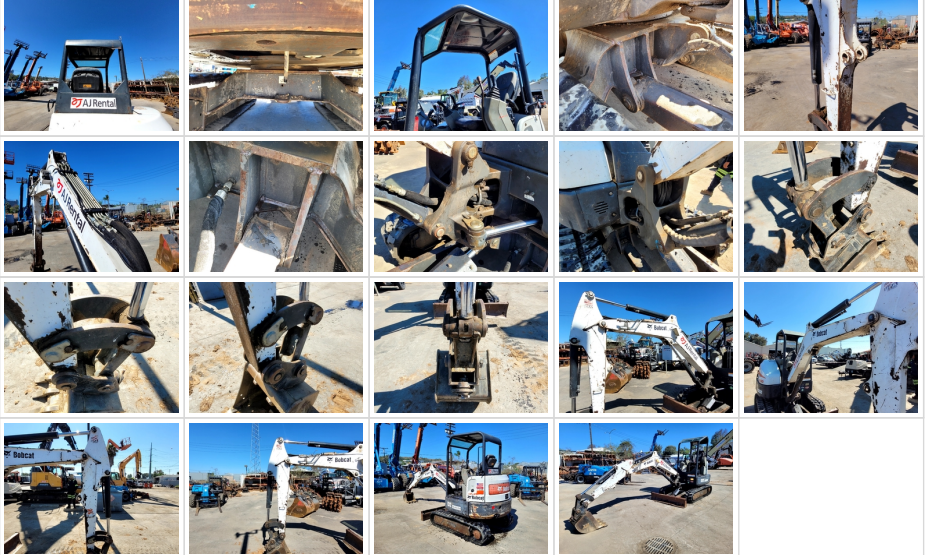
Chassis Photos

Boom Condition	3 - Normal Wear & Tear
Stick Condition	3 - Normal Wear & Tear
Boom Base Pin & Bushings	3 - Normal Wear & Tear
Boom to Stick Pin & Bushings	3 - Normal Wear & Tear
Stick to Bucket Pin & Bushings	3 - Normal Wear & Tear
Turntable Bearing	3 - Normal Wear & Tear
Bottom Covers	3 - Normal Wear & Tear
Overall Chassis	3 - Normal Wear & Tear
Overall Chassis Comments	Machine main frame and implements in good shape with no major excess play observed during operation.

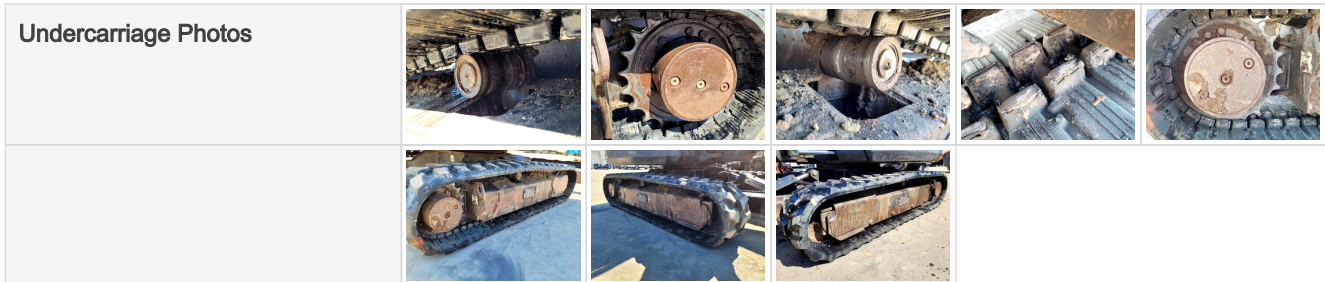
Track Width (inches)	N/A
Track Length (inches)	N/A
Roller Frames	3 - Normal Wear & Tear
Track Belt	3 - Normal Wear & Tear
Rubber Belt Drive Lugs	3 - Normal Wear & Tear
Track Tensioners	3 - Normal Wear & Tear
Front Idlers	3 - Normal Wear & Tear
Rear Idlers	0
Track Rollers	3 - Normal Wear & Tear
Sprockets	3 - Normal Wear & Tear
Overall Undercarriage Rating	3 - Normal Wear & Tear
Left Track Belt - Percent Remaining Estimate	70%
Right Track Belt - Percent Remaining Estimate	70%
Overall Comments	Track belts have plenty of tread life left. Some cuts seen on rubber tracks from jobsite usage. Undercarriage is in good condition with no major issues observed.
