Inspection Report (Rough Terrain Crane)

B&B Stock Number	A8467240
Year	2012
Make	TEREX
Model	RT780
Serial Number	1T9RT700LCW161066
Hour Meter Reading	5,098 Hrs.
Previous Application (e.g., earth moving, mining, demolition, etc)	New Condos / Townhomes Construction

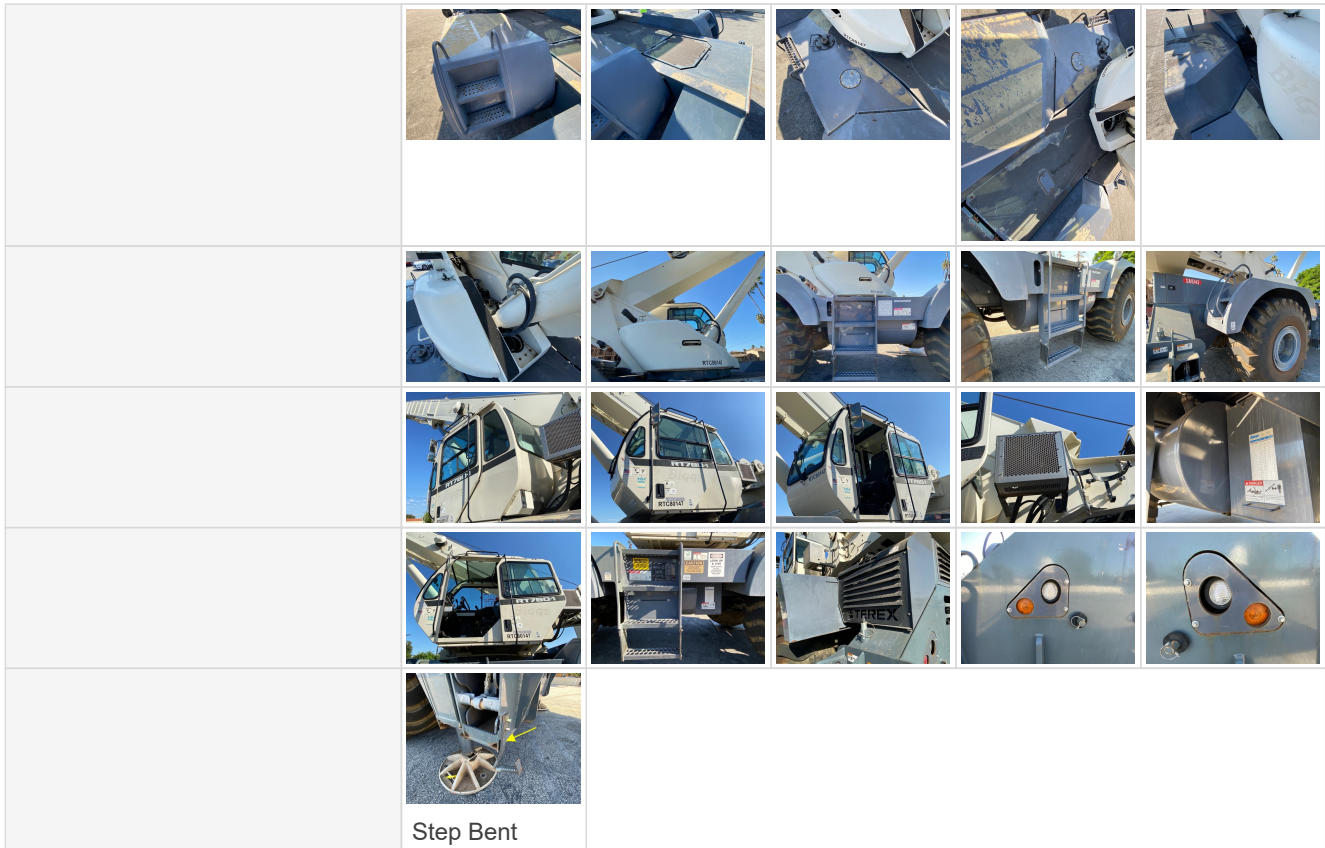
Close-up Exterior Photos

Comments	Front R/S Step bent at outrigger	
Handrails	4 - Very Light or Minimal Wear	
Handrails Condition	Handrails are fully intact and appear structurally sound

Glass	4 - Very Light or Minimal Wear
Glass Condition	Glass intact, no visible damage
Mirrors	4 - Very Light or Minimal Wear
Mirror Condition	Mirrors present and intact, no visible damage
Exterior Lights	3 - Normal Wear & Tear
Exterior Lights Condition	No visible damage, lighting system is operational
Overall Exterior	3 - Normal Wear & Tear
Comments	Machine's exterior panels are in good condition. Front R/S Outrigger Step bent.

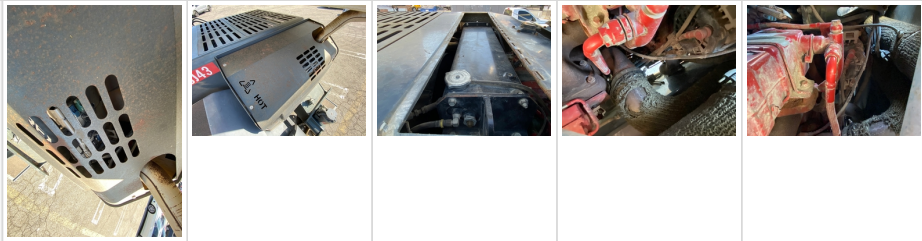
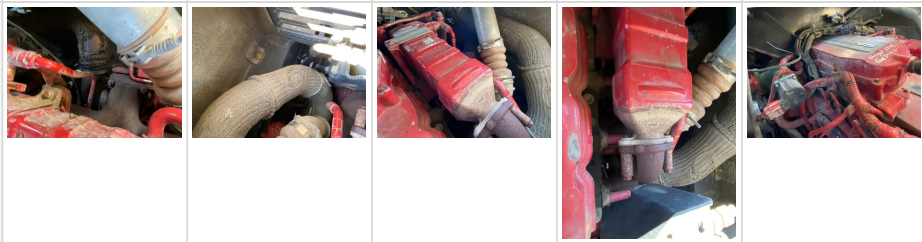
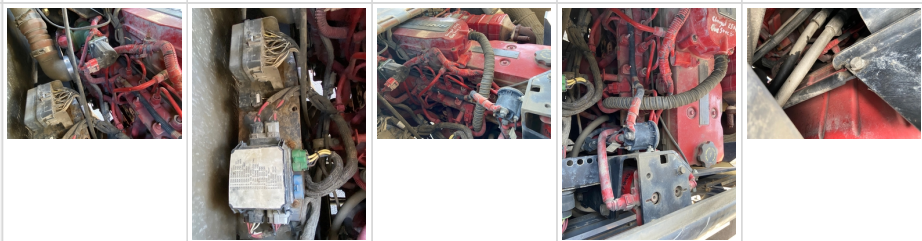
Engine Compartment Photos

Engine Type (Make, Model, Cylinders, Hp)	Cummins - QSB6.7 - 6Cyl. - 260HP
Emissions Tier	Tier 4i
Engine Serial Number	73427777
Engine Fuel Type	Diesel
Blow-by (Visual Observation Check)	No
Unusual Noises (Upon Start-up, Idle, Shutdown)	No
Engine Smoke (Upon Start-up, Idle, Shutdown)	No
Engine Exhaust Color	Clear
Battery	3 - Normal Wear & Tear
Battery Condition	Clean & dry appearance, tight connections
Radiator	3 - Normal Wear & Tear
Radiator Condition	Radiator fins & components appear to be in good working order, no signs of damage or leaks
Belts	3 - Normal Wear & Tear
Belt Condition	Belts appear in good condition & alignment with proper tension
Hoses	3 - Normal Wear & Tear

Hose Condition	Firm, pliant hoses with no signs of wear or leaks
Water Pump	3 - Normal Wear & Tear
Water Pump Condition	No unusual pump noises heard
Cooling System Leaks	No
Coolant Appearance	3 - Normal Wear & Tear
Coolant Appearance Notes	Normal Translucent appearance, no visual signs of contamination
Oil Leaks	No
Oil Appearance	3 - Normal Wear & Tear
Oil Appearance Notes	Clean oil appearance, no signs of cross contamination, Appropriate oil level
Fuel Leaks	No
Equipped with DPF (Diesel Particulate Filter)	Yes
DPF Condition	3 - Normal Wear & Tear
DPF Condition Notes	Filter housing is intact with no signs of damage or malfunction, DPF indicator is not illuminated
Requires DEF (Diesel Exhaust Fluid)	No
Overall Engine Rating	3 - Normal Wear & Tear
Overall Engine Appearance	Clean & dry, Dusty & dry
Overall Engine Comments	Overall engine in well maintained condition. Engine sounds healthy at idle and under load. No operating issues observed.

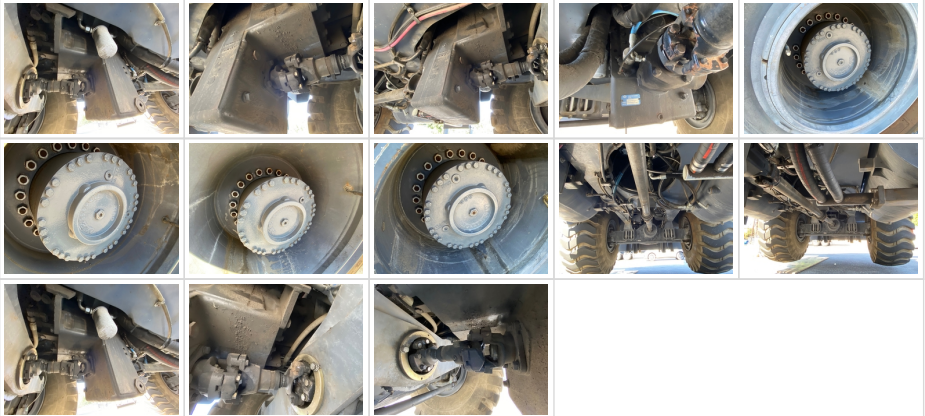
Drivetrain Photos

Transmission Info (Make/Model/Speeds)	Powershift Transmission
Transmission Components	3 - Normal Wear & Tear
Transmission Condition	Good forward and reverse function, No unusual noises or vibrations
Drive Motors	0
Parking Brake	3 - Normal Wear & Tear
Parking Brake Function	Good brake function
Overall Drivetrain Rating	3 - Normal Wear & Tear
Overall Drivetrain Comments	Machine travels well in all directions. Service brakes and parking brake operate well.

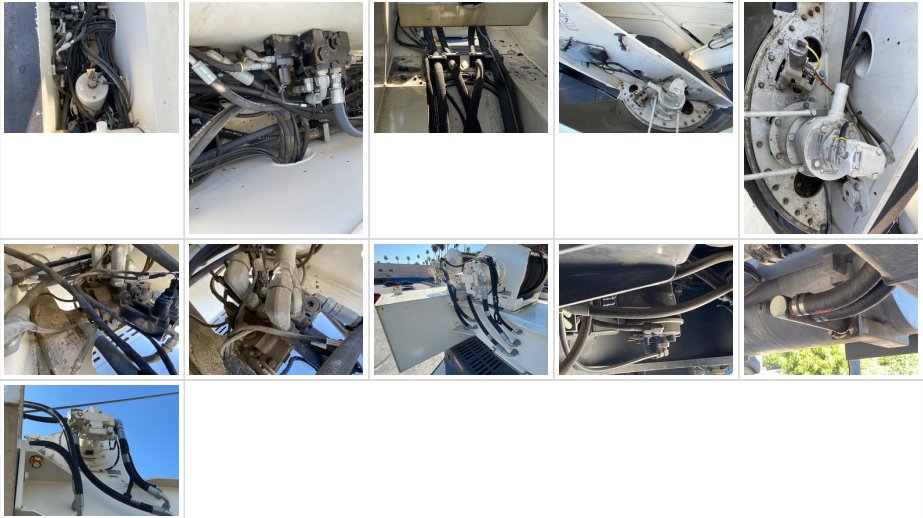
Hydraulic System Photos

Wet or Damp Hydraulic Lines / Fittings	No

Hydraulic Lines/Fittings	3 - Normal Wear & Tear
Hydraulic Lines / Fittings Condition	Hydraulic lines & fittings are clean and in good condition
Hydraulic Pump(s)	3 - Normal Wear & Tear
Unusual Noises	No
Hydraulic Pump Notes	No unusual noises heard during operation

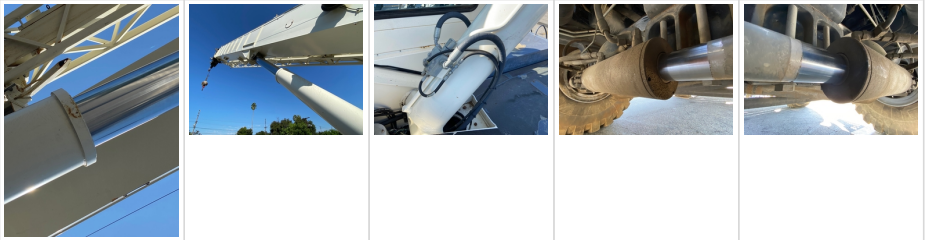
Hydraulic Cylinder Photos

<p>Minor seepage buildup at suspension cylinders</p>

Mounting Pins	3 - Normal Wear & Tear
Cylinder Oil Leaks	No
Comments	Minor seepage buildup seen at steer cylinder and suspension cylinder
Hydraulic System Overall	3 - Normal Wear & Tear
Main Hoist	3 - Normal Wear & Tear
Auxiliary Hoist	3 - Normal Wear & Tear
Swing Motor	3 - Normal Wear & Tear
