Inspection Report (Telehandler)

B&B Stock Number	A3420657
Year	2013
Make	Genie
Model	GTH-5519
Serial Number	GTH5514 B-237
Hour Meter Reading	3283.0
Previous Application (e.g., earth moving, mining, demolition, etc)	Rental equipment

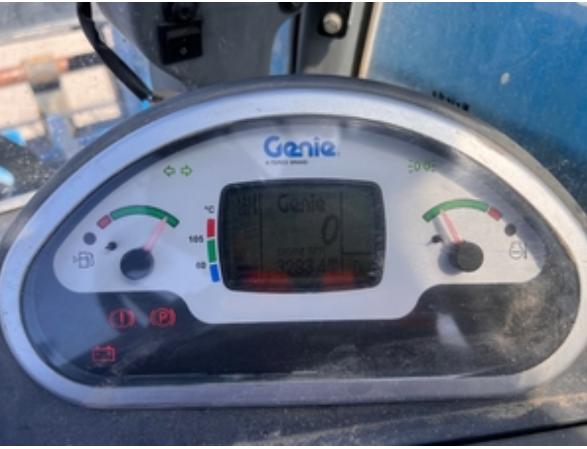
Seat	3 - Normal Wear & Tear
Seat Condition	Seat(s) in good condition, no stains or tears in upholstery
Cabin Lights	0
Safety Lock Out / Stop	3 - Normal Wear & Tear
Safety Lock Out / Stop Condition	Safety lock out device is present, in good condition, and functional
Controls & Switches	3 - Normal Wear & Tear
Controls & Switches Condition	Switches have good functionality, minor cosmetic damage observed, All switches are installed and functional
Hour Meter Activity	3 - Normal Wear & Tear
Hour Meter Condition	Hour meter is functional and in good condition

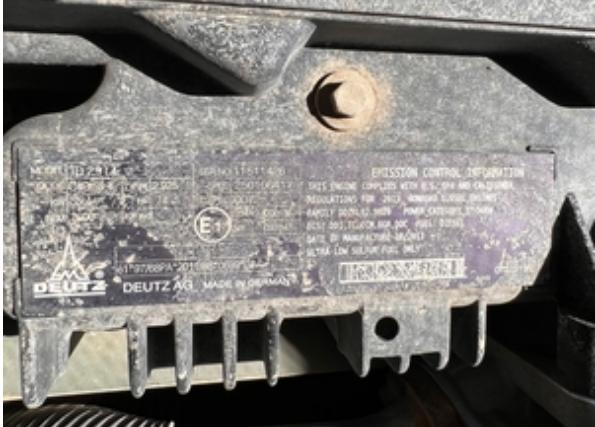
Engine Data Plate

Hood mounting hardware broken off hood
Engine Type (Make, Model, Cylinders, Hp)	Deutz , TD 2.9 L4 , 4 cyl, 74 Hp		
Emissions Tier	Tier 4i		
Engine Serial Number	11511426		
Engine Fuel Type	Diesel		
Blow-by (Visual Observation Check)	No		
Unusual Noises (Upon Start-up, Idle, Shutdown)	No		
Engine Smoke (Upon Start-up, Idle, Shutdown)	No		
Engine Exhaust Color	Clear		
Battery	1 - Service Required		
Battery Condition	Dusty & dirty appearance, Other (see comments)		
Comments	Battery hold down missing		
Radiator	3 - Normal Wear & Tear		
Radiator Condition	Radiator fins & components appear to be in good working order, no signs of damage or leaks		
Belts	3 - Normal Wear & Tear		
Belt Condition	Belts appear in good condition & alignment with proper tension		
Hoses	3 - Normal Wear & Tear		
Hose Condition	Firm, pliant hoses with no signs of wear or leaks		
Water Pump	3 - Normal Wear & Tear		
Water Pump Condition	No unusual pump noises heard

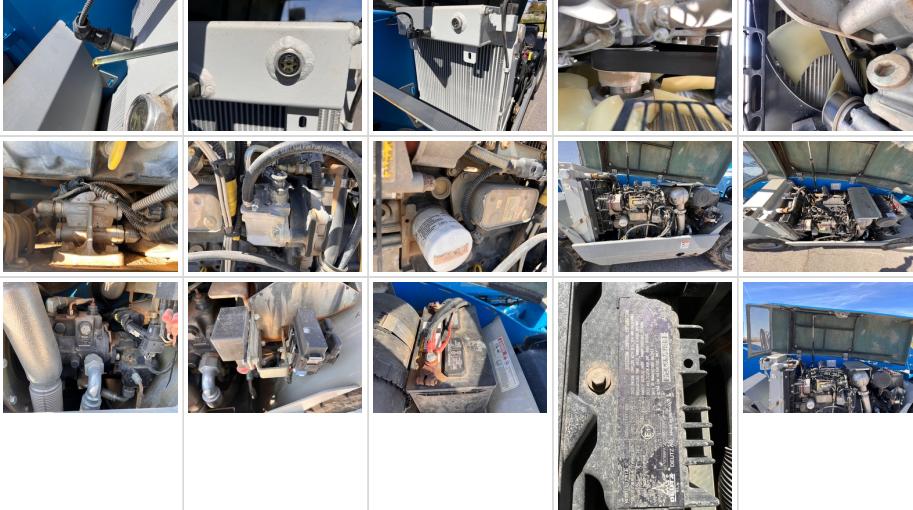
Engine Compartment Photos

Equipped with DPF (Diesel Particulate Filter)	No
Requires DEF (Diesel Exhaust Fluid)	No
Overall Engine Rating	3 - Normal Wear & Tear
Overall Engine Appearance	Dusty & dry, Areas of dried seepage seen on engine hoses & components
Overall Engine Comments	Normal wear and tear. No major issues to report
