Inspection Report (On-Highway Vacuum Truck)

B&B Stock Number	1
Year	2022
Make	Chevrolet
Model	Sierra 2500 HD
Serial Number	1GD08LE78NF251655
Truck Odometer Reading	226 Miles
Current Inspection / State Cert / DOT	N/A
Previous Application (e.g., earth moving, mining, demolition, etc)	General Construction Jobsite, Road Cleanup

Drive Type	4X2
Overdrive	No
Heat	Yes
A/C	Yes
Radio	Yes
Backup Camera	Yes
Cruise Control	Yes
PTO	Yes
PTO Details	Engine/Belt Driven PTO
Engine Brake	No
Differential Lock	No
OMM (Operator & Maintenance Manual)	Yes
Telematics	No
Auxiliary Engine	No
Liftgate	No
Other Configuration Details / Features / Notes	Nite-Hawk - OSPREY Sweeper Vehicle

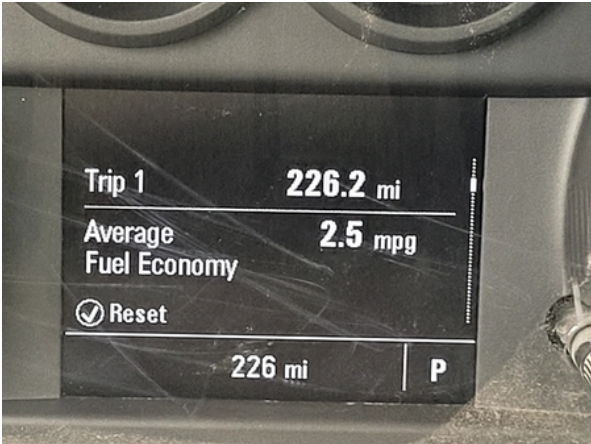
<p>Trip 1 226.2 mi</p> <p>Average Fuel Economy 2.5 mpg</p> <p>Reset</p> <p>226 mi P</p>												
Odometer Activity	5 - Like New, Recently Replaced												
Odometer Condition	Odometer is working and in good condition												
Controls/Switches/Gauges	4 - Very Light or Minimal Wear												
Controls/Switches/Gauges Condition	All switches/gauges are in good condition and functioning												
Brake System Type	Hydraulic												
Clutch	0												
Horn	5 - Like New, Recently Replaced												
Horn Condition	Horn is functioning as expected												
Reverse Alarm / Backup Camera	5 - Like New, Recently Replaced												
Reverse Alarm / Backup Camera Condition	Reverse alarm working as expected, Backup camera has clear display and is working as expected												
Heater & A/C	5 - Like New, Recently Replaced												
Heat & A/C Condition	Heater and A/C work as expected

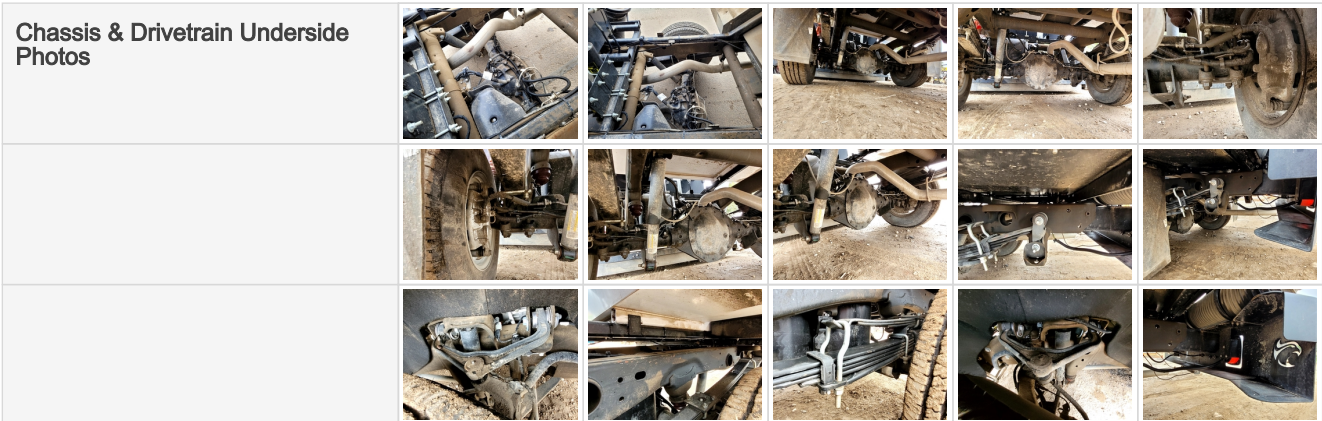
Chassis & Drivetrain Photos

Frame	4 - Very Light or Minimal Wear
Suspension	4 - Very Light or Minimal Wear
Steer Axle	4 - Very Light or Minimal Wear
Steering Components	4 - Very Light or Minimal Wear
Overall Chassis Condition	4 - Very Light or Minimal Wear
Overall Chassis Comments	Overall chassis and main drivetrain components are all in great shape with no issues seen during the inspection.

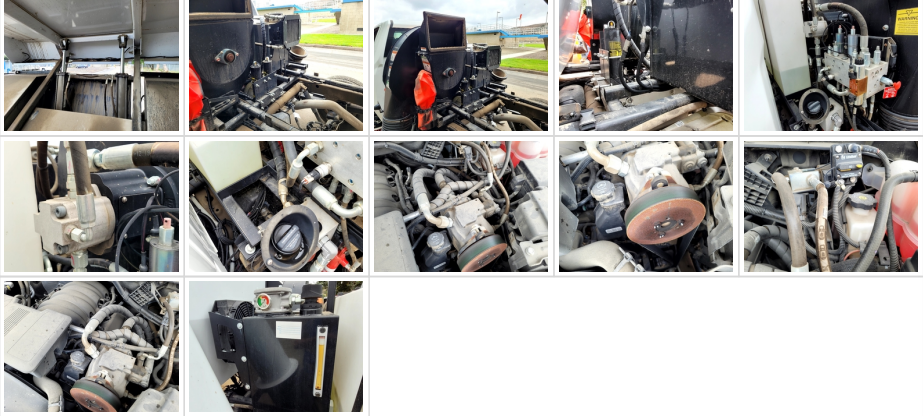
Vacuum Hydraulics Photos

Hydraulics Overall Appearance	4 - Very Light or Minimal Wear
Tank Elevation Hydraulic Function (Lift & Lower)	4 - Very Light or Minimal Wear
Rear Hatch Hydraulic Function (Open & Close)	4 - Very Light or Minimal Wear
