## Inspection Report (Backhoe Loader)

B&B Stock Number	N/a
Year	2016
Make	Cat
Model	420f
Serial Number	C7n30862
Hour Meter Reading	3714.1

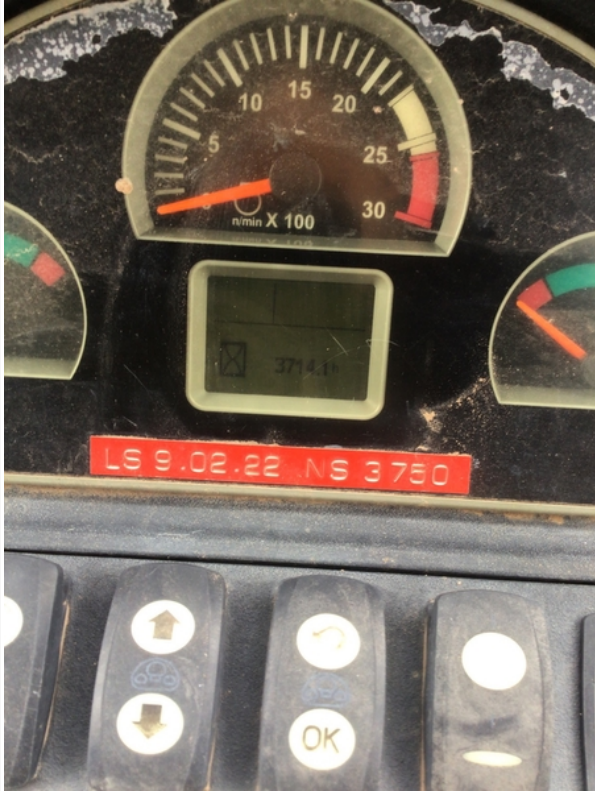
Hour Meter/Odometer

Seat	2 - Above Average Wear & Tear
Seat Condition	Seat(s) has major surface staining or tears
Cabin Lights	5 - Like New, Recently Replaced
Safety Lock Out / Stop	0
Controls & Switches	3 - Normal Wear & Tear
Controls & Switches Condition	Switches have good functionality, minor cosmetic damage observed
Hour Meter Activity	5 - Like New, Recently Replaced
Hour Meter Condition	Hour meter is functional and in good condition
Other Gauge Activity	4 - Very Light or Minimal Wear
Other Gauge Condition	All cockpit gauges are functional and in good condition
Heater & A/C	0
Travel Alarm	0
Horn	0
Backup Camera	0
Control Station Overall Rating	4 - Very Light or Minimal Wear
Control Station Overall Condition	Good cabin appearance, solid floors, panels, and ceiling

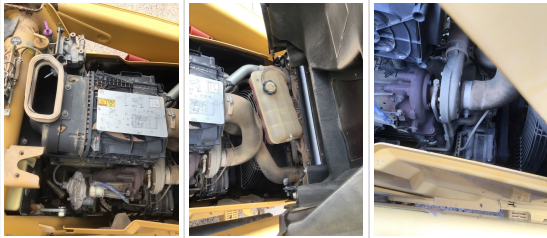
Engine Compartment Photos

Engine Type (Make, Model, Cylinders, Hp)	C4.4		
Emissions Tier	Undetermined		
Engine Fuel Type	Diesel		
Blow-by (Visual Observation Check)	No		
Unusual Noises (Upon Start-up, Idle, Shutdown)	No		
Engine Smoke (Upon Start-up, Idle, Shutdown)	No		
Engine Exhaust Color	Clear		
Battery	5 - Like New, Recently Replaced		
Battery Condition	Clean & dry appearance, tight connections		
Radiator	4 - Very Light or Minimal Wear		
Radiator Condition	Radiator fins & components appear to be in good working order, no signs of damage or leaks		
Belts	3 - Normal Wear & Tear		
Belt Condition	Areas of slick, glazed appearance on one or more belts		
Hoses	5 - Like New, Recently Replaced		
Hose Condition	Firm, pliant hoses with no signs of wear or leaks		
Water Pump	5 - Like New, Recently Replaced		
Water Pump Condition	No unusual pump noises heard

Cooling System Leaks	No
Coolant Appearance	5 - Like New, Recently Replaced
Coolant Appearance Notes	Normal Translucent appearance, no visual signs of contamination
Oil Leaks	No
Oil Appearance	5 - Like New, Recently Replaced
Oil Appearance Notes	Clean oil appearance, no signs of cross contamination
Fuel Leaks	No
Equipped with DPF (Diesel Particulate Filter)	No
Requires DEF (Diesel Exhaust Fluid)	No
Overall Engine Rating	5 - Like New, Recently Replaced
Overall Engine Appearance	Dusty & dry
Overall Engine Comments	Clean, no leaks

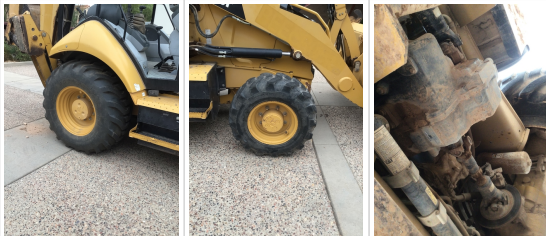
Drivetrain Photos

Hydrostatic Transmission?	Yes	
2 Speed?	Yes	
Hydrostatic Drive Configuration	Close Coupled Transmission	
Transmission Components	5 - Like New, Recently Replaced	
Transmission Condition	Good forward and reverse function, No unusual noises or vibrations	
Drive Motors	5 - Like New, Recently Replaced	
Parking Brake	5 - Like New, Recently Replaced	
Parking Brake Function	Good brake function	
Overall Drivetrain Rating	5 - Like New, Recently Replaced	
Overall Drivetrain Comments	Just dirty but works as should

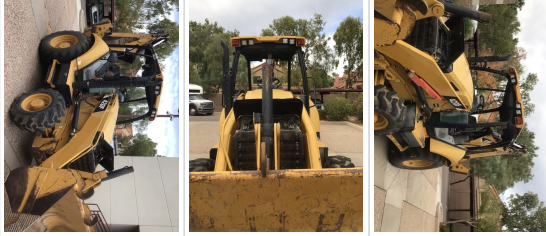
Chassis Photos

Frame	5 - Like New, Recently Replaced
Stance	5 - Like New, Recently Replaced
Front Axle Appearance	5 - Like New, Recently Replaced
Rear Axle Appearance	5 - Like New, Recently Replaced
Oscillating Pin Appearance	5 - Like New, Recently Replaced
Lift Arm	5 - Like New, Recently Replaced
Chassis to Arm Pins	5 - Like New, Recently Replaced
Tilt Linkage	5 - Like New, Recently Replaced
Tilt Linkage Pins & Bushings	5 - Like New, Recently Replaced
Bucket to Arm Pins	5 - Like New, Recently Replaced
Boom	5 - Like New, Recently Replaced
Stick	5 - Like New, Recently Replaced
Stick Extension Wear Guides	5 - Like New, Recently Replaced
Boom Lock	5 - Like New, Recently Replaced
Swing Tower Pivot	5 - Like New, Recently Replaced
Boom Base Pin & Bushings	5 - Like New, Recently Replaced
Boom to Stick Pin & Bushings	5 - Like New, Recently Replaced
Stick to Bucket Pin & Bushings	5 - Like New, Recently Replaced

Outriggers	5 - Like New, Recently Replaced
Overall Chassis	5 - Like New, Recently Replaced

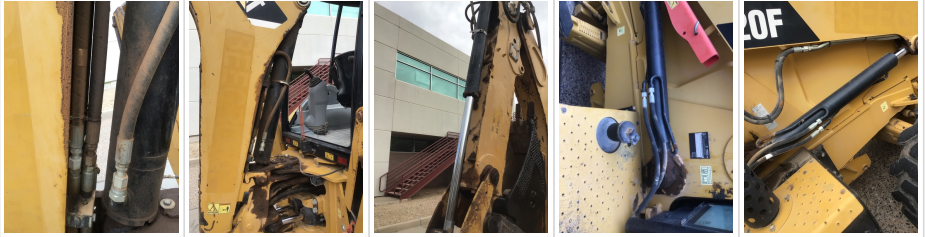
Hydraulic Cylinder Photos

Mounting Pins	4 - Very Light or Minimal Wear				
Cylinder Oil Leaks	Yes				
Hydraulic System Overall	3 - Normal Wear & Tear				
Comments	Some cylinders need re seal

What Needs Work	Cylinders . Seat	
Date/Time	09-20-2023	
Inspector Name	Chad
