## Inspection Report (Rough Terrain Crane)

B&B Stock Number	A6320266
Year	2000
Make	Terex
Model	RT160
Serial Number	160193
Hour Meter Reading	14,195 Hrs.
Previous Application (e.g., earth moving, mining, demolition, etc)	General Construction

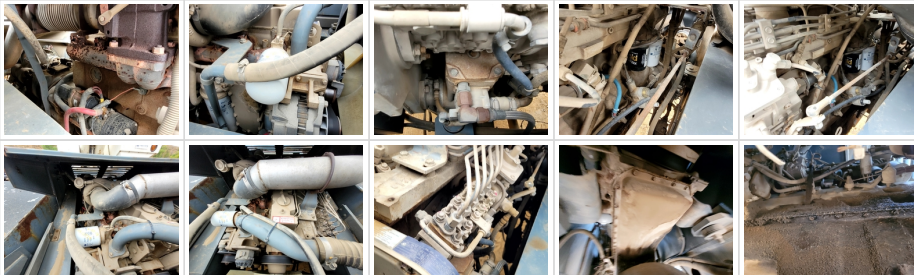
Engine Compartment Photos

<p>Oil pan has residual oil and may be leaking</p>				
Engine Type (Make, Model, Cylinders, Hp)	Cummins - C8.3-C - 6Cyl. - 215 HP				
Emissions Tier	Tier 2				
Engine Serial Number	4596/592				
Engine Fuel Type	Diesel				
Blow-by (Visual Observation Check)	Yes				
Comments	Some blowby observed				
Unusual Noises (Upon Start-up, Idle, Shutdown)	No				
Engine Smoke (Upon Start-up, Idle, Shutdown)	Yes				
Engine Smoke Notes	Engine smoke observed upon start up, Other (see comments)				
Comments	Minor exhaust smoke observed at startup				
Engine Exhaust Color	Black puffs observed under throttle, Clear				
Battery	3 - Normal Wear & Tear				
Battery Condition	Dusty & dirty appearance, Clean & dry appearance, tight connections

Requires DEF (Diesel Exhaust Fluid)	No
Overall Engine Rating	3 - Normal Wear & Tear
Overall Engine Appearance	Dusty & dry
Overall Engine Comments	Engine sputters at cold start and struggled to idle under load. Engine ran okay at operating temperature and sputtering went away.

What Needs Work	Multiple residual oil buildups observed throughout machine and I recommend further inspection of the notated areas. Engine misfires at cold start, at idle and more noticeable under load.	
Date/Time	09-19-2023	
Inspector Name	Mario Ramirez

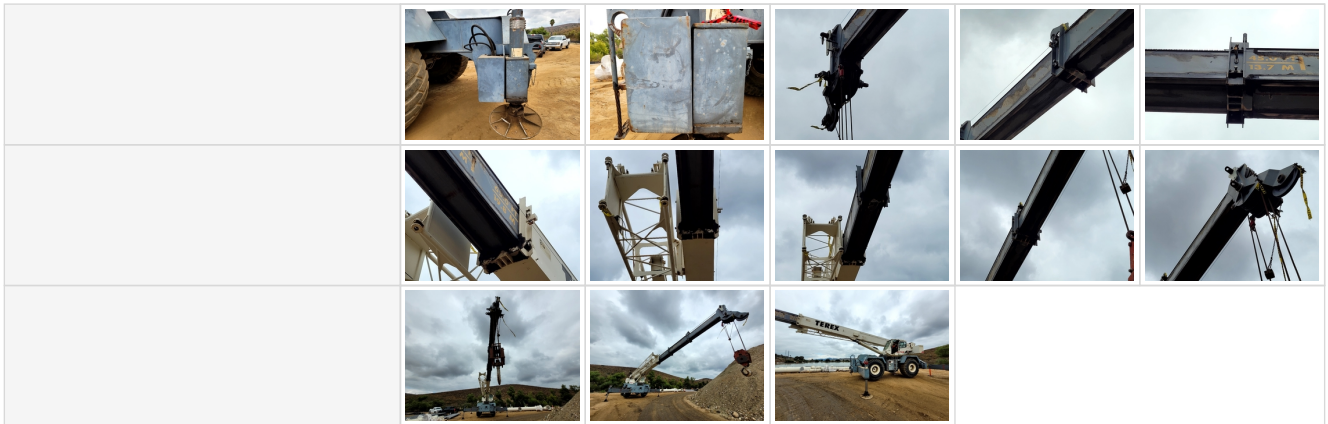
Chassis Photos

Frame	3 - Normal Wear & Tear
Stance	3 - Normal Wear & Tear
Turntable Bearing	3 - Normal Wear & Tear
Front Axle	3 - Normal Wear & Tear
Rear Axle	3 - Normal Wear & Tear
Outriggers	3 - Normal Wear & Tear
Outrigger Pads	3 - Normal Wear & Tear
Overall Chassis	3 - Normal Wear & Tear
Overall Chassis Comments	Main Frame, Outriggers, and Boom assembly in great condition. Front and Rear axle also in solid shape along with steering linkages.

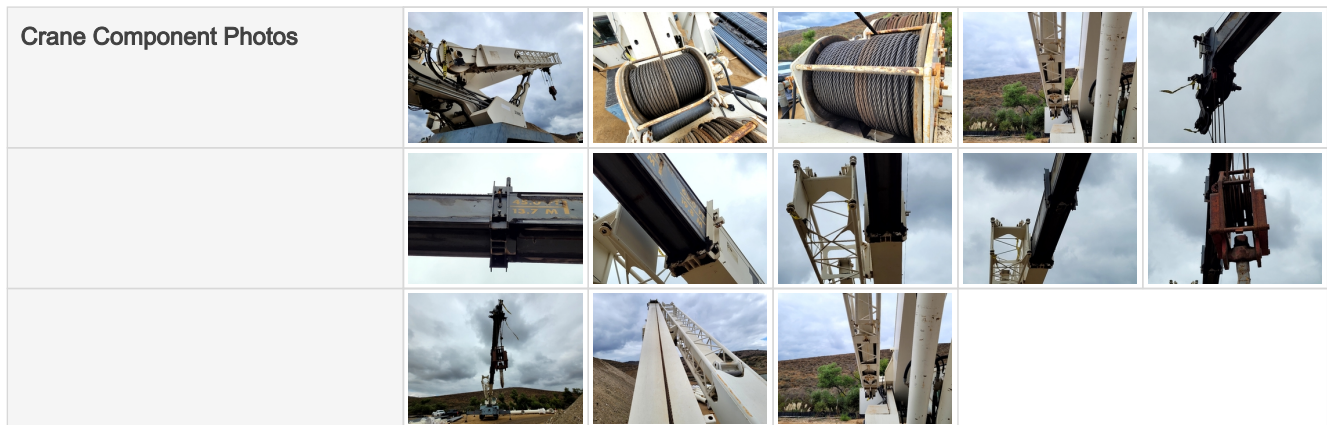
## Crane Components - Photos

Counterweight	3 - Normal Wear & Tear
Boom Angle Indicator	3 - Normal Wear & Tear
Main Boom Sections	3 - Normal Wear & Tear
Main Boom Pins	3 - Normal Wear & Tear
Boom Head Section	3 - Normal Wear & Tear
Wear Pads	3 - Normal Wear & Tear
Jib	3 - Normal Wear & Tear
Fairlead	3 - Normal Wear & Tear
Sheaves	3 - Normal Wear & Tear
Main Load Block	3 - Normal Wear & Tear
Overhaul Ball	0
Crane Components Overall	3 - Normal Wear & Tear
Comments	Cranes main components controlling Boom lift,extend,machine's swing, and Main winch are in good working condition.
