Inspection Report (Compact Track Loader)

B&B Stock Number	A0701461
Year	2012
Make	CAT
Model	259B-3
Serial Number	YYZ02070
Hour Meter Reading	3,624 Hrs.
Previous Application (e.g., earth moving, mining, demolition, etc)	General Construction

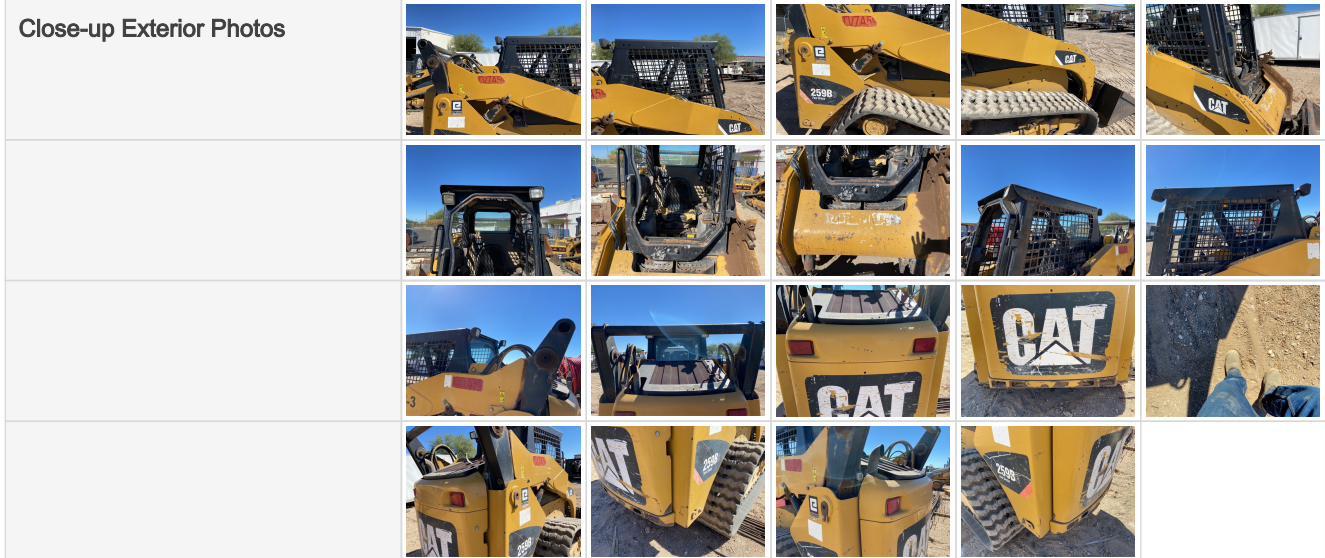
General Appearance Photos

Steps / Ladders Condition	Steps/ladders are fully intact and appear structurally sound	
Handrails	3 - Normal Wear & Tear	
Handrails Condition	Handrails are fully intact and appear structurally sound	
Glass	1 - Service Required	
Glass Condition	Glass is broken or shattered	
Mirrors	3 - Normal Wear & Tear	
Mirror Condition	Mirrors present and intact, no visible damage	
Exterior Lights	3 - Normal Wear & Tear

Exterior Lights Condition	No visible damage, lighting system is operational
Overall Exterior	3 - Normal Wear & Tear
Comments	Machines exterior is in good shape.

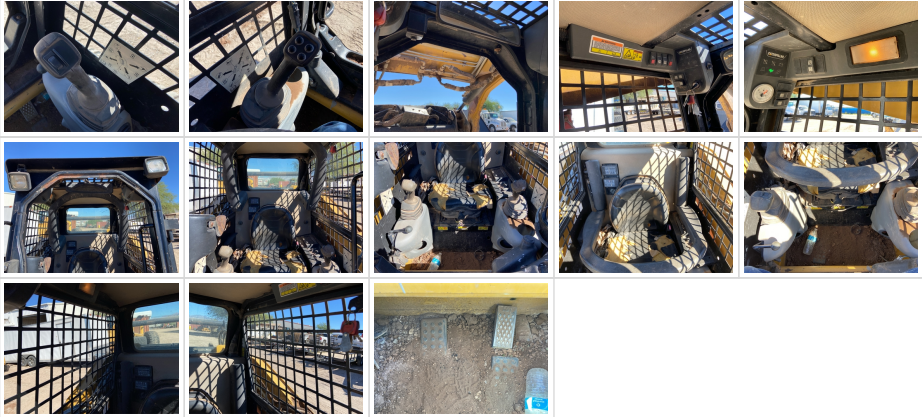
Control Station Photos

Travel Alarm Condition	Travel alarm is installed and functioning as expected
Horn	3 - Normal Wear & Tear
Horn Condition	Horn is installed and functioning as expected
Backup Camera	0
Control Station Overall Rating	3 - Normal Wear & Tear
Control Station Overall Condition	Minor cosmetic wear to cabin surfaces, floors, panels, and ceiling, Other (see comments)
Comments	Besides the seat and Cab door window missing, the rest of the cab interior in descent condition .

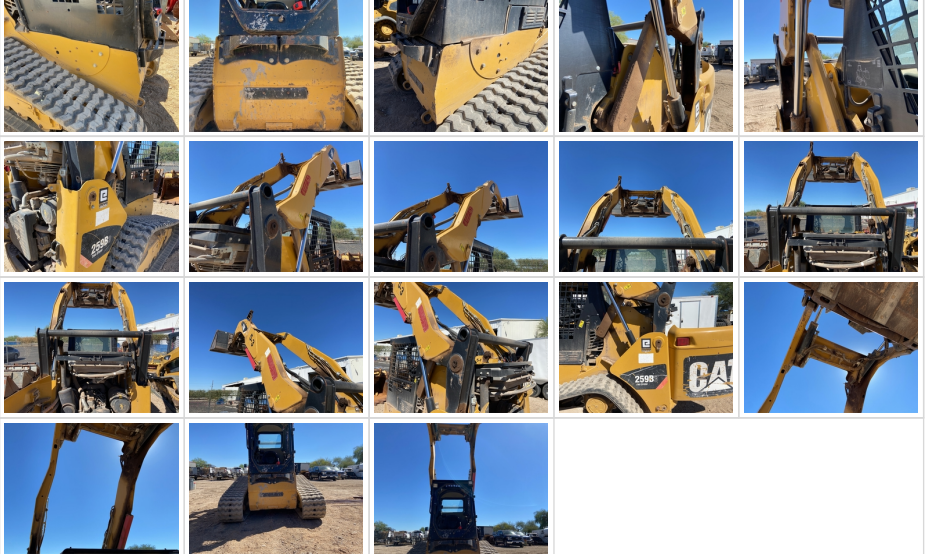
Chassis Photos

Frame	3 - Normal Wear & Tear
Stance	3 - Normal Wear & Tear
Lift Arm	3 - Normal Wear & Tear
Chassis to Arm Pins	3 - Normal Wear & Tear
Quick Coupler	3 - Normal Wear & Tear
Quick Coupler to Arms Pins	3 - Normal Wear & Tear
Overall Chassis	3 - Normal Wear & Tear
Overall Chassis Comments	Main frame and implements are in good condition.
