Inspection Report (Compact Track Loader)

B&B Stock Number	A2620313
Year	2010
Make	CAT
Model	299C
Serial Number	JSP00984
Hour Meter Reading	3,738 Hrs.
Previous Application (e.g., earth moving, mining, demolition, etc)	General Construction

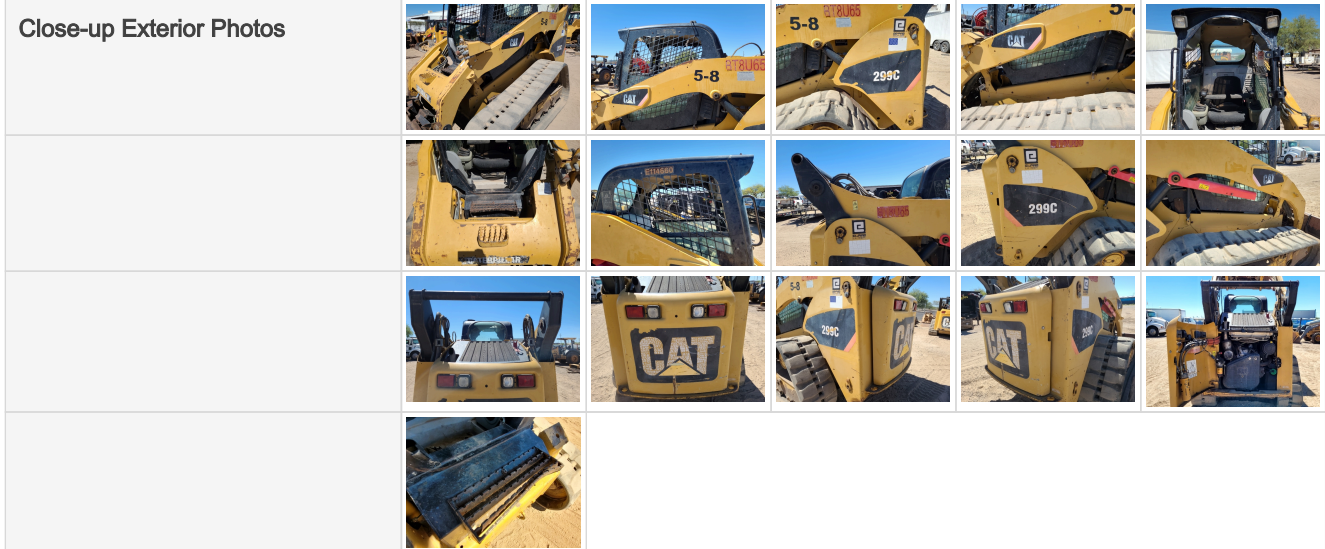
Comments	Enclosed cab missing front door, Door hinge assembly slightly bent	
Steps / Ladders	3 - Normal Wear & Tear	
Steps / Ladders Condition	Bent or broken steps or rungs, Other (see comments)	
Comments	Cab front step slightly bent	
Handrails	3 - Normal Wear & Tear	
Handrails Condition	Handrails are fully intact and appear structurally sound	
Glass	1 - Service Required	
Glass Condition	Not applicable, no glass	
Mirrors	3 - Normal Wear & Tear

Mirror Condition	Mirrors present and intact, no visible damage
Exterior Lights	3 - Normal Wear & Tear
Exterior Lights Condition	No visible damage, lighting system is operational, One or more exterior lights are non-operational
Overall Exterior	3 - Normal Wear & Tear
Comments	Machine has good appearance. Normal wear and tear scuff marks throughout machine.

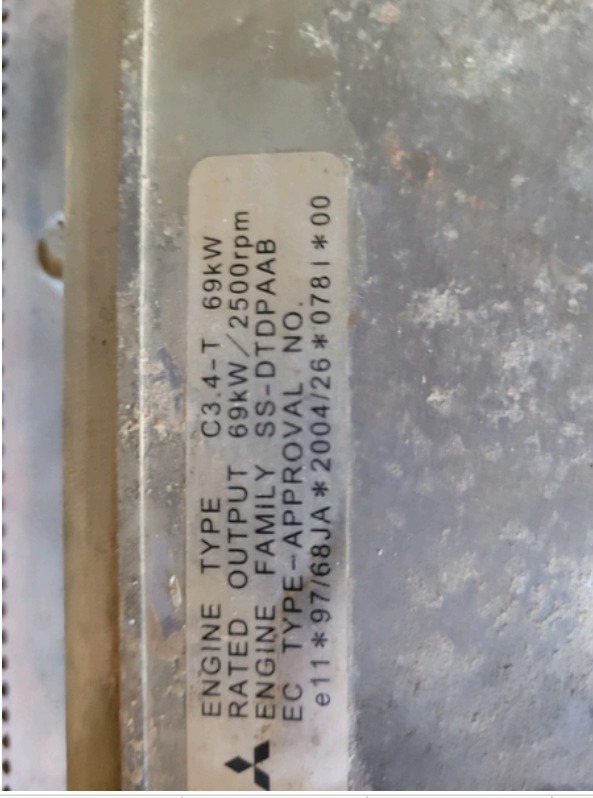
Engine Data Plate

Engine Type (Make, Model, Cylinders, Hp)	CAT - Mitsubishi - C3.4L - 4Cyl. - 92HP
Emissions Tier	Tier 3
Engine Serial Number	CMY13269
Engine Fuel Type	Diesel
Blow-by (Visual Observation Check)	No
Unusual Noises (Upon Start-up, Idle, Shutdown)	No
Engine Smoke (Upon Start-up, Idle, Shutdown)	No
Engine Exhaust Color	Clear
