# Inspection Report (Skid Steer)

Control at time	
B&B Stock Number	A0438988
Year	2011
Make	Vermeer
Model	Rt45
Serial Number	1VRX0721161001237
Hour Meter Reading	1342.9
Previous Application (e.g., earth moving, mining, demolition, etc)	Earth moving

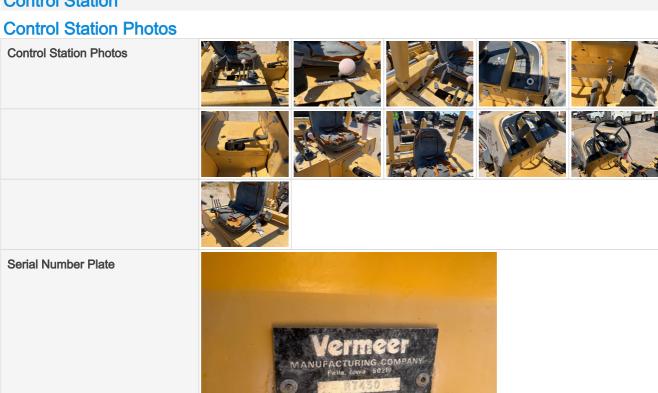
Hour Meter/Odometer

Seat	1 - Service Required
Seat Condition	Seat(s) has major surface staining or tears
Cabin Lights	0
Safety Lock Out / Stop	3 - Normal Wear & Tear

Controls & Switches	3 - Normal Wear & Tear
Hour Meter Activity	3 - Normal Wear & Tear
Hour Meter Condition	Hour meter is functional and in good condition
Other Gauge Activity	2 - Above Average Wear & Tear
Other Gauge Condition	Gauges are functional, with some wear and/or cosmetic damage
Heater & A/C	0
Travel Alarm	0
Horn	3 - Normal Wear & Tear
Horn Condition	Horn is installed and functioning as expected
Backup Camera	0
Control Station Overall Rating	3 - Normal Wear & Tear
Control Station Overall Condition	Minor cosmetic wear to cabin surfaces, floors, panels, and ceiling

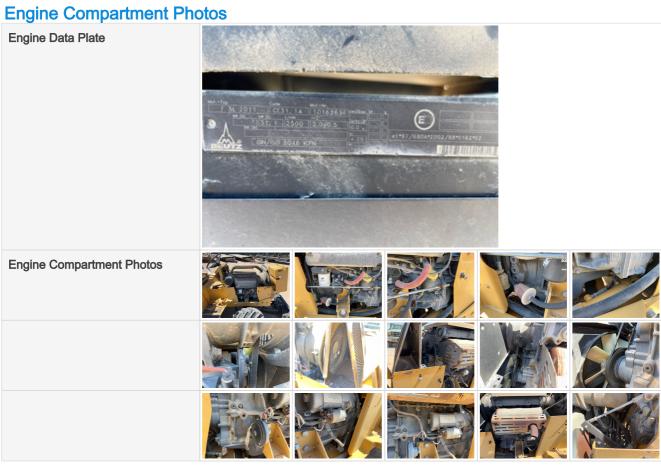
# **Engine**

Engine Type (Make, Model, Cylinders, Hp)	Deutz
Emissions Tier	Undetermined
Engine Serial Number	10162636
Engine Fuel Type	Diesel
Blow-by (Visual Observation Check)	No
Unusual Noises (Upon Start-up, Idle, Shutdown)	No
Engine Smoke (Upon Start-up, Idle, Shutdown)	No
Engine Exhaust Color	Clear
Battery	2 - Above Average Wear & Tear
Battery Condition	Dusty & dirty appearance
Radiator	3 - Normal Wear & Tear
Belts	3 - Normal Wear & Tear
Hoses	3 - Normal Wear & Tear
Water Pump	3 - Normal Wear & Tear
Cooling System Leaks	No
Coolant Appearance	3 - Normal Wear & Tear
Oil Leaks	No
Oil Appearance	3 - Normal Wear & Tear
Fuel Leaks	No
Equipped with DPF (Diesel Particulate Filter)	No
Requires DEF (Diesel Exhaust Fluid)	No
Overall Engine Rating	3 - Normal Wear & Tear
Overall Engine Appearance	Areas of dried seepage seen on engine hoses & components
Overall Engine Comments	Normal wear and tear. No major issues to report

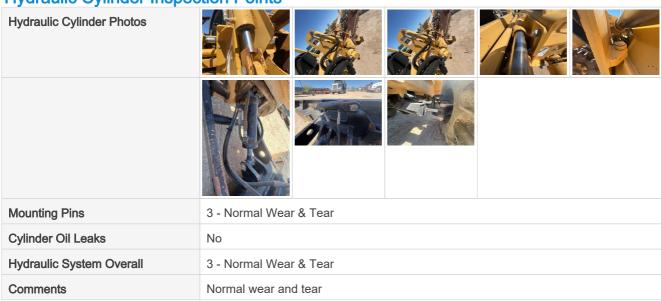
# **Hydraulic Cylinder Inspection Points**

Hydraulic Pump(s)	3 - Normal Wear & Tear
Unusual Noises	No
Hydraulic Pump Notes	No unusual noises heard during operation
