Inspection Report (Rough Terrain Crane)

B&B Stock Number	A4219255
Year	2001
Make	Terex
Model	RT230
Serial Number	12682
Hour Meter Reading	7,963 Hrs.
Previous Application (e.g., earth moving, mining, demolition, etc)	General Construction

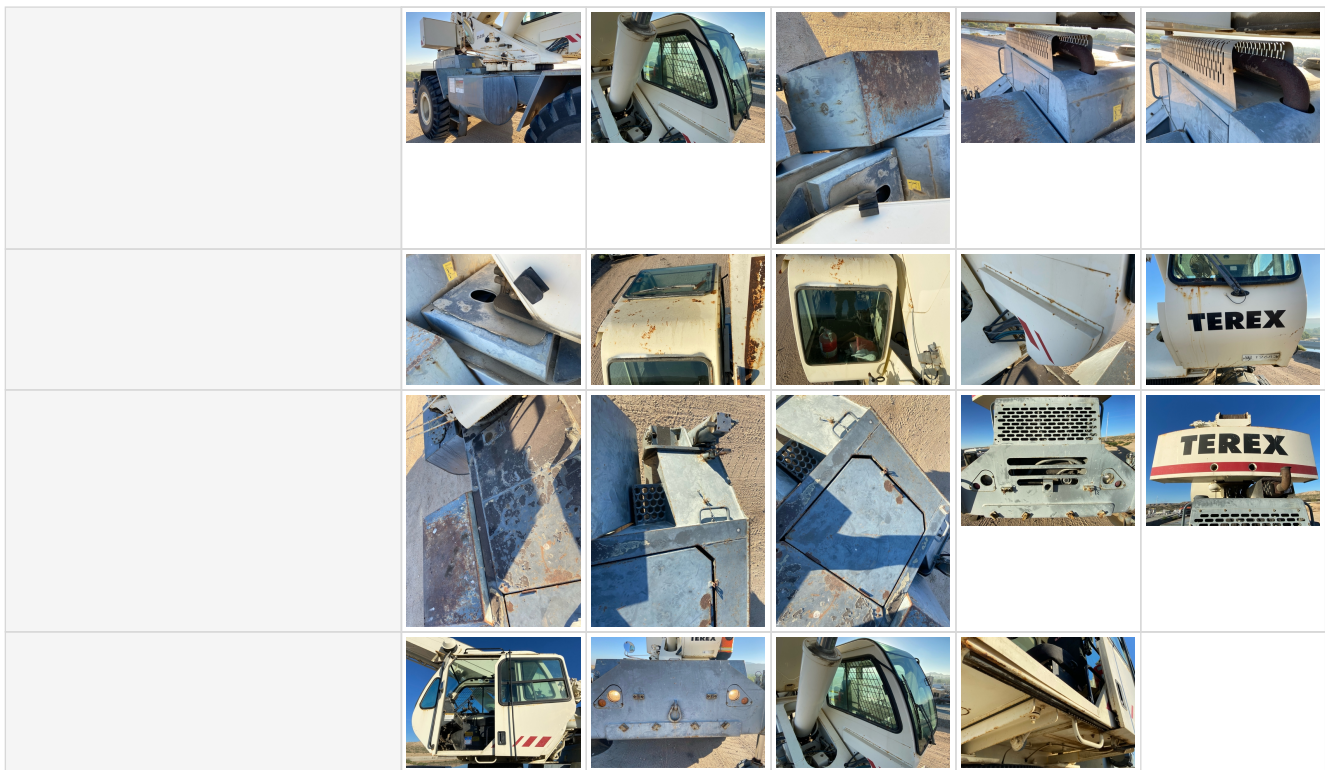
Close-up Exterior Photos

Steps / Ladders Condition	Steps/ladders are fully intact and appear structurally sound, Bent or broken steps or rungs, Other (see comments)	
Comments	R/S Step at Hydraulic Tank slightly bent forward .	
Handrails	3 - Normal Wear & Tear	
Handrails Condition	Handrails are fully intact and appear structurally sound

Glass	3 - Normal Wear & Tear
Glass Condition	Glass intact, no visible damage
Mirrors	3 - Normal Wear & Tear
Mirror Condition	Mirrors present and intact, no visible damage
Exterior Lights	3 - Normal Wear & Tear
Exterior Lights Condition	No visible damage, lighting system is operational
Overall Exterior	3 - Normal Wear & Tear
Comments	Minor rust seen at rear and bottom edges of cab exterior.

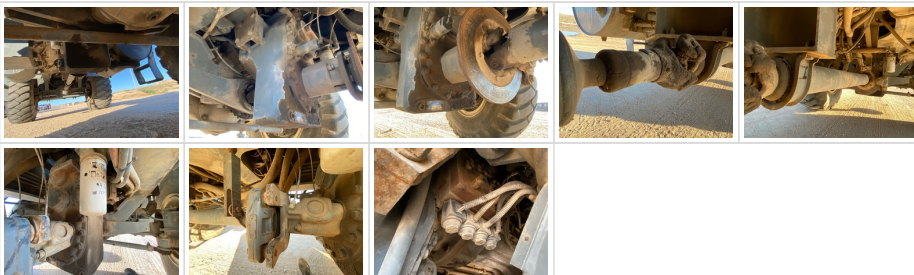
Drivetrain Photos

Hydrostatic Transmission?	No				
2 Speed?	No				
Hydrostatic Drive Configuration	Close Coupled Transmission				
Transmission Info (Make/Model/Speeds)	AWD - Powershift Transmission / 3 Speed Fwd. & Rev.				
Transmission Components	3 - Normal Wear & Tear				
Transmission Condition	Good forward and reverse function, No unusual noises or vibrations, Other (see comments)				
Comments	Dried up oil residue at front, center of transmission
