Inspection Report (On-Highway Dump Truck)

| B&B Stock Number | A2738113 |
| Make | Peterbilt |
| Model | 385 |

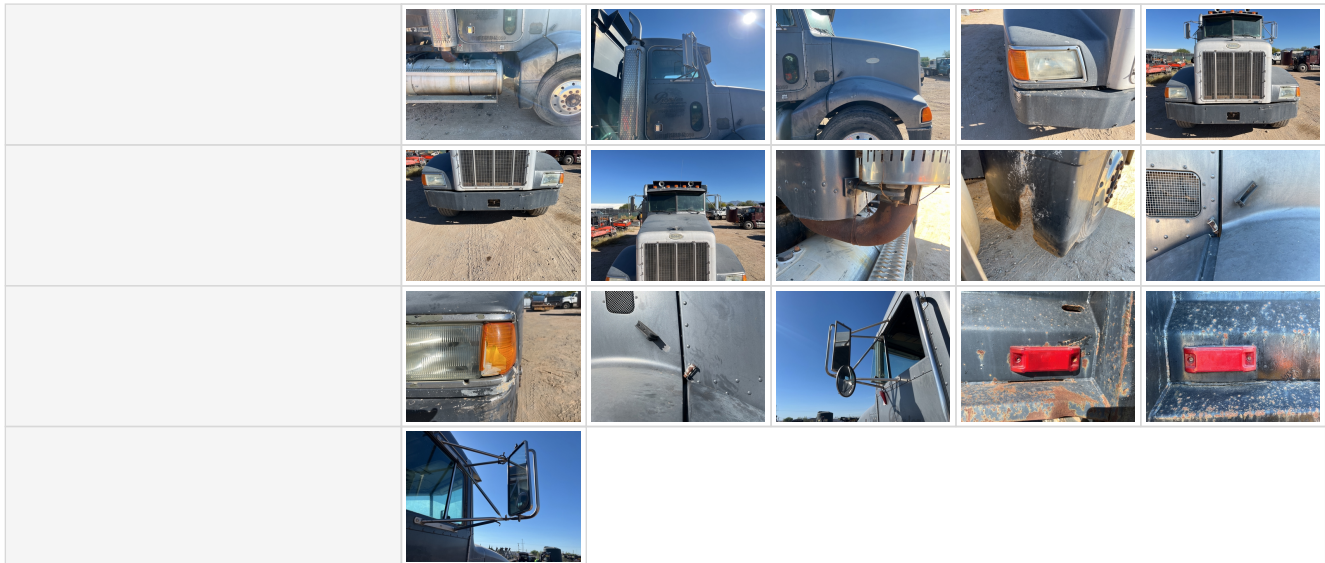
General Appearance Photos

| Body Panels | 2 - Above Average Wear & Tear |
| Body Panel Condition | Visible chipped paint or dents |
| Steps / Ladders | 2 - Above Average Wear & Tear |
| Steps / Ladders Condition | Bent or broken steps or rungs |
| Exterior Lights | 2 - Above Average Wear & Tear |
| Exterior Lights Condition | Minor chips or cracks seen on light casings |

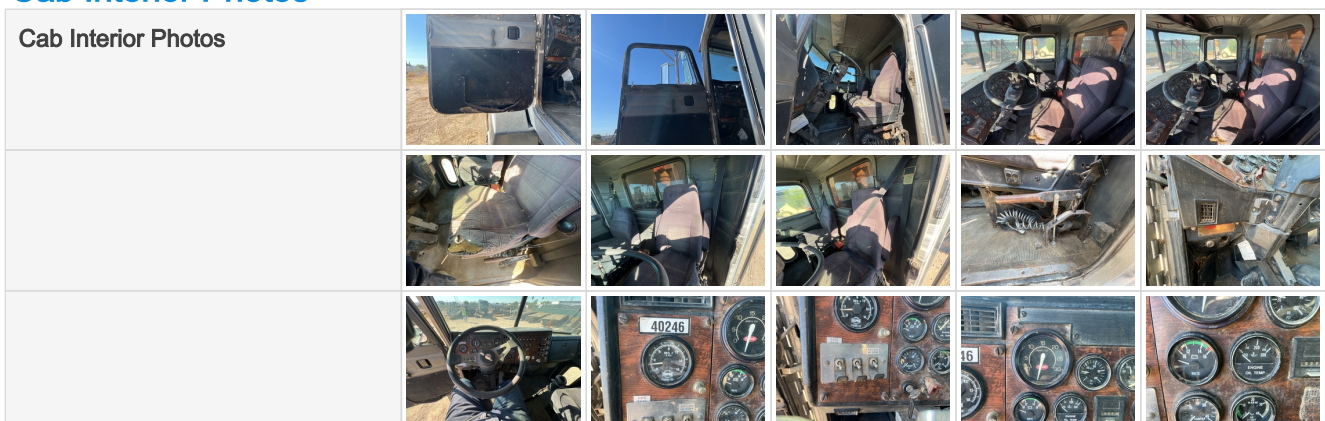
Cab Interior Photos

| Controls/Switches/Gauges | 1 - Service Required |
| Controls/Switches/Gauges Condition | One or more switches/gauges are inoperative or missing |
| Heater & A/C | 1 - Service Required |
| Heat & A/C Condition | Only heat functionality works |
| Interior Lights | 1 - Service Required |
| Interior Lights Condition | One or more lights are inoperative/damaged |
| Comments | Above average wear and tear. A few engine gauges inoperative |

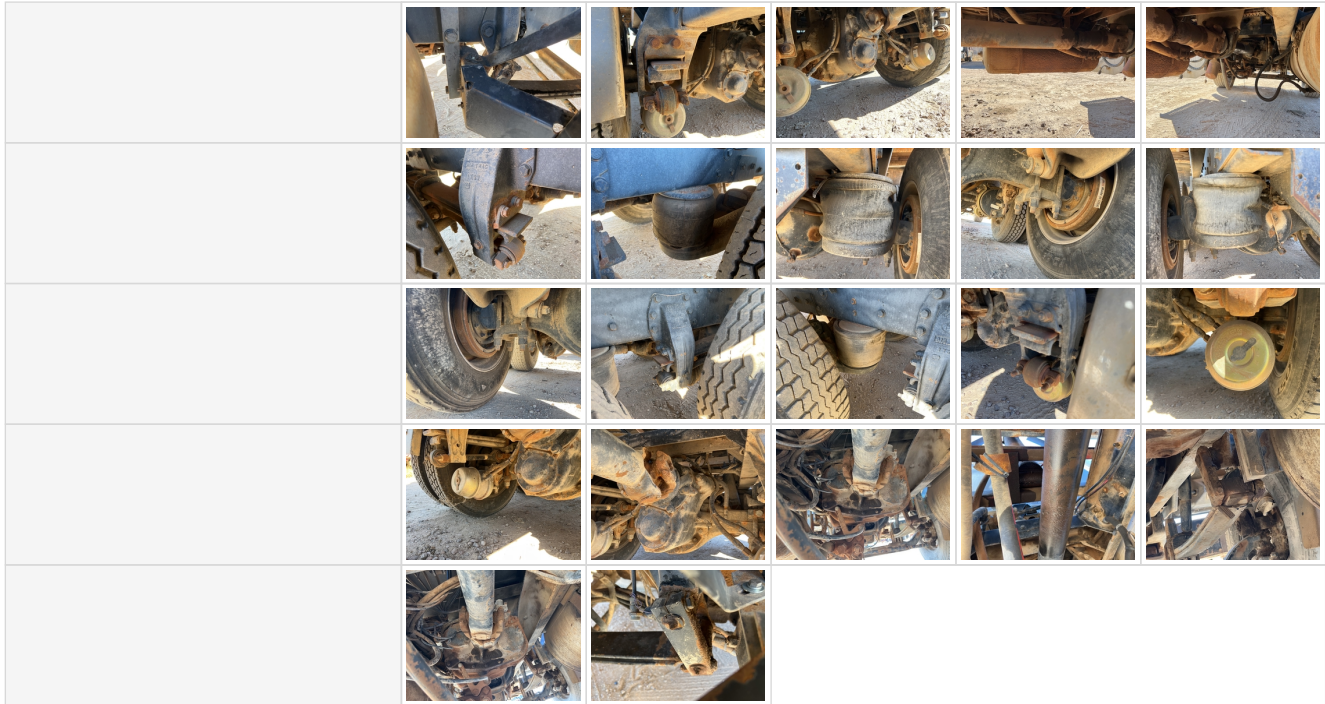
Chassis & Drivetrain Photos

| Rear Differential | 2 - Above Average Wear & Tear |
| Rear Differential Condition | Dried seepages seen on differential housing cover |
| Front Differential Condition | Dried seepages seen on differential housing cover |
| Air Brake System Leaks | Yes |
| Comments | Air leak at air dryer |

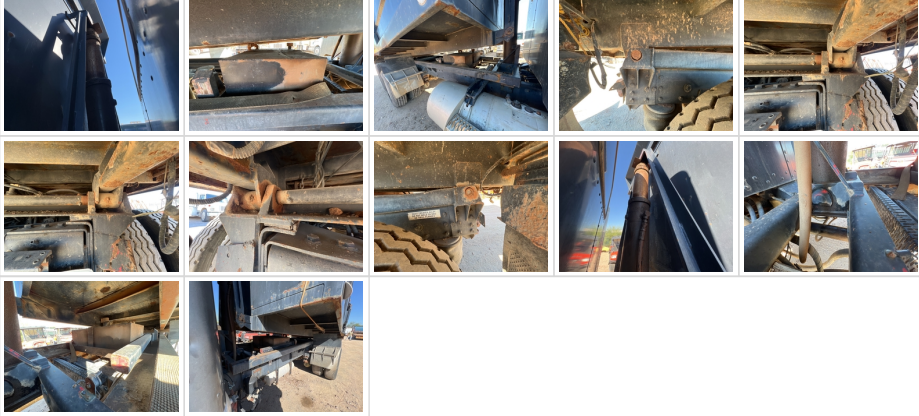
| Dump Body Photos | |

| Bed Body | 2 - Above Average Wear & Tear |
| Comments | Surface rust |
| Tarp | 1 - Service Required |
| Comments | Will not pull out from housing |
