Inspection Report (Telehandler)

B&B Stock Number	A9357354
Year	2006
Make	JLG
Model	G10-55A
Serial Number	160011735
Hour Meter Reading	10,186 Hrs.
Previous Application (e.g., earth moving, mining, demolition, etc)	General Construction

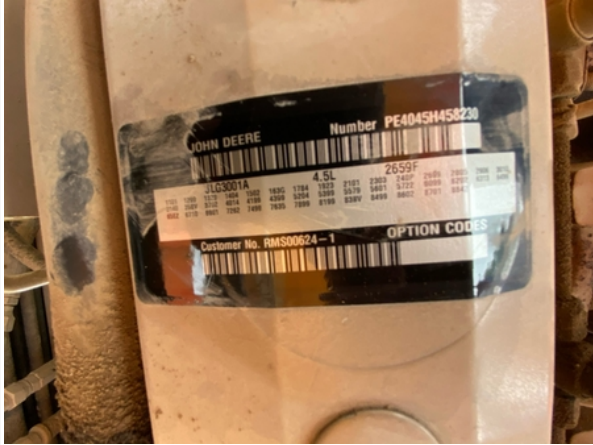
Engine Data Plate

Engine Type (Make, Model, Cylinders, Hp)	John Deere - 4045 - 4.5L - 4Cyl. - 125HP				
Emissions Tier	Tier 3				
Engine Serial Number	N/A				
Engine Fuel Type	Diesel				
Blow-by (Visual Observation Check)	Yes				
Comments	Some blow by seen				
Unusual Noises (Upon Start-up, Idle, Shutdown)	No				
Engine Smoke (Upon Start-up, Idle, Shutdown)	No				
Engine Exhaust Color	Clear				
Battery	3 - Normal Wear & Tear				
Battery Condition	Dusty & dirty appearance				
Radiator	3 - Normal Wear & Tear				
Radiator Condition	Radiator fins & components appear to be in good working order, no signs of damage or leaks				
Belts	3 - Normal Wear & Tear				
Belt Condition	Belts appear in good condition & alignment with proper tension
