## Inspection Report (Skid Steer)

B&B Stock Number	A6678184
Year	2010
Make	Caterpillar
Model	289C
Serial Number	CAT0289CHJMP01467
Hour Meter Reading	3438.4

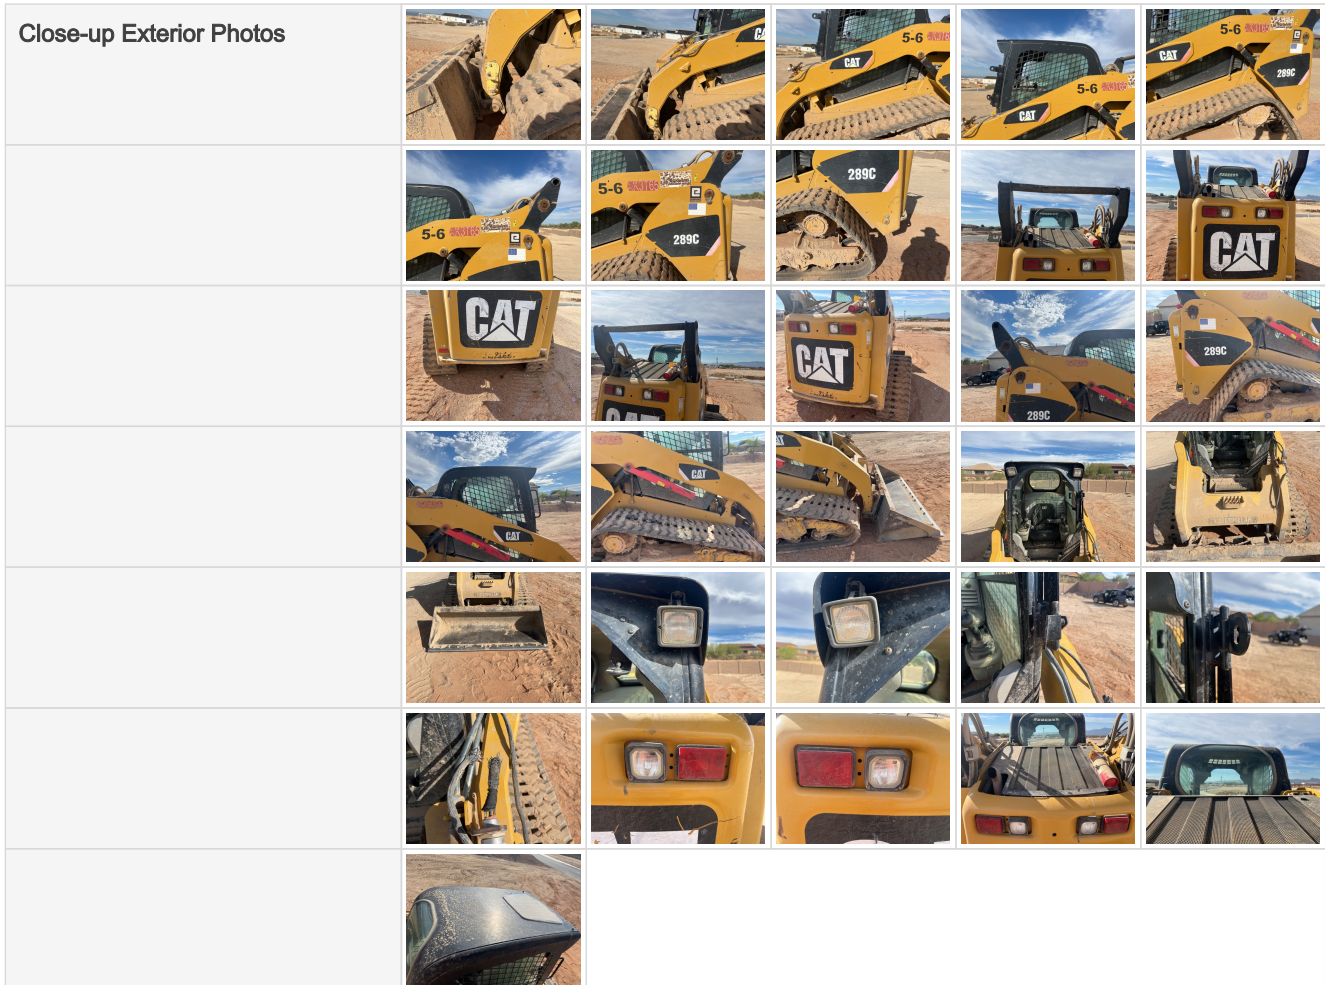
#### General Appearance Photos

Inspection Rating Criteria	Rating Scale	Explanation
	1 - Service Required	Requires immediate repairs to function as expected.
	2 - Above Average Wear & Tear	Exhibits greater wear than expected given age and usage. While operable, further diagnosis may be needed.
	3 - Normal Wear & Tear	Exhibits wear that is consistent with age and usage. Operation is normal, and as expected.
	4 - Very Light or Minimal Wear	Exhibits very minimal wear. Operation is better than expected given age and usage.
	5 - Like New, Recently Replaced	Excellent condition, free of visible wear or damage. Operation is within factory specifications.
Body Panels	3 - Normal Wear & Tear	
Body Panel Condition	Visible chipped paint or dents	
Doors / Canopy Latches	1 - Service Required	
Doors / Canopy Latches Condition	Other (see comments)	
Comments	Front entry door missing	
Steps / Ladders	3 - Normal Wear & Tear

Steps / Ladders Condition	Steps/ladders are fully intact and appear structurally sound
Handrails	3 - Normal Wear & Tear
Glass	3 - Normal Wear & Tear
Mirrors	0
Exterior Lights	3 - Normal Wear & Tear
Overall Exterior	3 - Normal Wear & Tear
Comments	Normal wear and tear no major issues to report

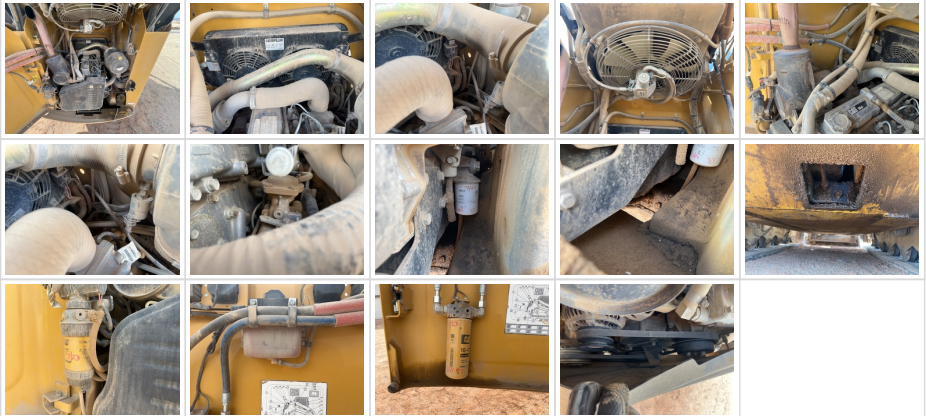
Engine Compartment Photos

Engine Exhaust Color	Heavy black smoke at start up
Battery	3 - Normal Wear & Tear
Battery Condition	Inaccessible, unable to determine condition
Radiator	3 - Normal Wear & Tear
Radiator Condition	Radiator fins & components appear to be in good working order, no signs of damage or leaks
Belts	3 - Normal Wear & Tear
Hoses	3 - Normal Wear & Tear
Hose Condition	Firm, pliant hoses with no signs of wear or leaks
Water Pump	3 - Normal Wear & Tear
Water Pump Condition	No unusual pump noises heard
Cooling System Leaks	No
Coolant Appearance	3 - Normal Wear & Tear
Coolant Appearance Notes	Normal Translucent appearance, no visual signs of contamination
Oil Leaks	No
Oil Appearance	3 - Normal Wear & Tear
Fuel Leaks	Yes
Fuel Leak Notes	Wet spots & streaking on fuel lines indicate an active leak
Comments	Fuel leak near bottom of engine
Equipped with DPF (Diesel Particulate Filter)	No
Requires DEF (Diesel Exhaust Fluid)	No
Overall Engine Rating	2 - Above Average Wear & Tear

Overall Engine Appearance	Active leaks/pooling observed in & around engine compartment
Overall Engine Comments	Fuel leak near bottom of engine

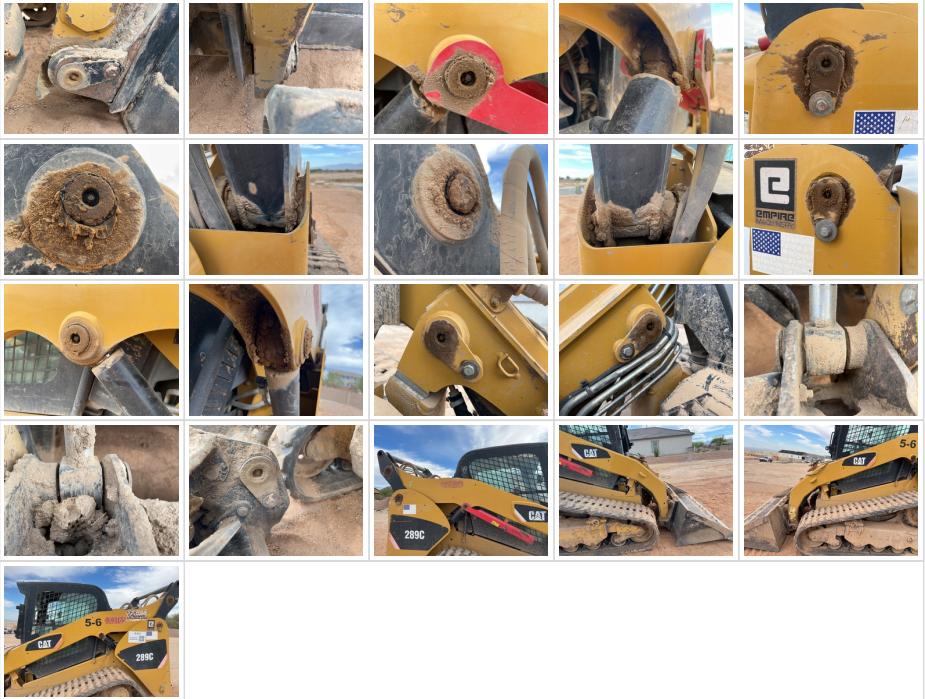
Chassis Photos

Frame	3 - Normal Wear & Tear
Lift Arms	3 - Normal Wear & Tear
Chassis to Arm Pins	3 - Normal Wear & Tear
Quick Coupler	3 - Normal Wear & Tear
Quick Coupler to Arms Pins	3 - Normal Wear & Tear
Overall Chassis	3 - Normal Wear & Tear
Overall Chassis Comments	Normal wear and tear no major issues to report
