Inspection Report (Excavator)

B&B Stock Number	A1888881
Year	2011
Make	John Deere
Model	135D
Serial Number	1FF135DXJBD302768
Hour Meter Reading	8182.1
Previous Application (e.g., earth moving, mining, demolition, etc)	This machine was used in civil construction

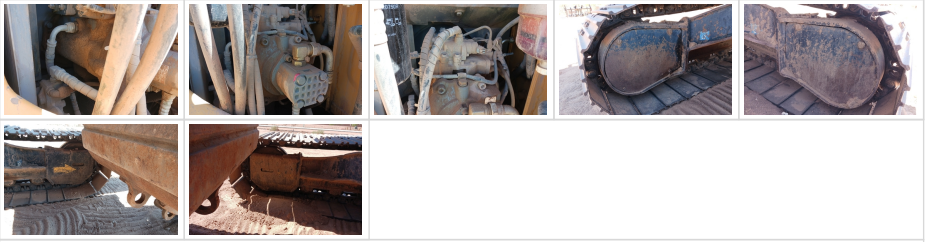
Drivetrain Photos

Hydrostatic Transmission?	Yes
2 Speed?	No
Hydrostatic Drive Configuration	Other (see comments)
Comments	unable to verify
Transmission Components	3 - Normal Wear & Tear
Transmission Condition	Good forward and reverse function
Drive Motors	3 - Normal Wear & Tear
Parking Brake	3 - Normal Wear & Tear
Parking Brake Function	Good brake function
Overall Drivetrain Rating	3 - Normal Wear & Tear
Overall Drivetrain Comments	The drivetrain is in good working order

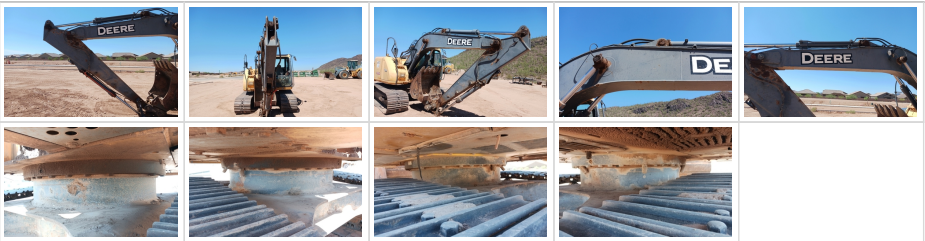
Chassis Photos

Boom Condition	3 - Normal Wear & Tear
Stick Condition	3 - Normal Wear & Tear
Boom Base Pin & Bushings	3 - Normal Wear & Tear
Boom to Stick Pin & Bushings	3 - Normal Wear & Tear
Stick to Bucket Pin & Bushings	3 - Normal Wear & Tear
Turntable Bearing	3 - Normal Wear & Tear
Bottom Covers	3 - Normal Wear & Tear

Overall Chassis	3 - Normal Wear & Tear
Overall Chassis Comments	The chassis is in good working order

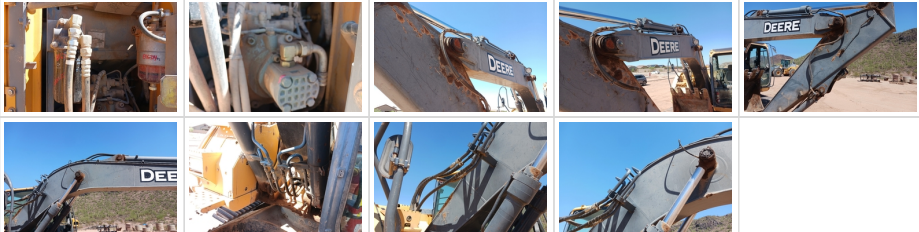
Hydraulic System Photos

Wet or Damp Hydraulic Lines / Fittings	No
Hydraulic Lines/Fittings	3 - Normal Wear & Tear
Hydraulic Lines / Fittings Condition	Hydraulic lines & fittings are clean and in good condition
Hydraulic Pump(s)	3 - Normal Wear & Tear
Unusual Noises	No
Hydraulic Pump Notes	No unusual noises heard during operation

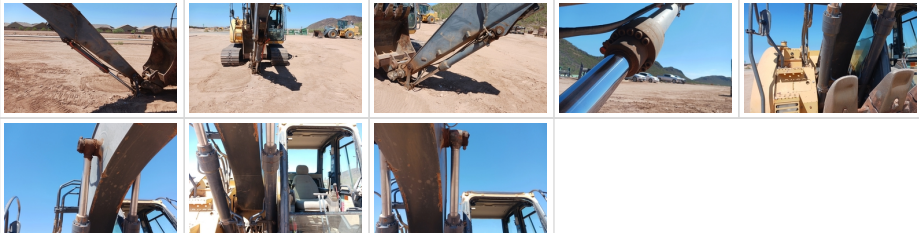
Hydraulic Cylinder Photos

Mounting Pins	3 - Normal Wear & Tear
Cylinder Oil Leaks	No
Hydraulic System Overall	3 - Normal Wear & Tear
