Inspection Report (Excavator)

B&B Stock Number	A3848495
Year	2013
Make	John Deere
Model	50D
Serial Number	1FF050DXHCG277239
Hour Meter Reading	4767
Previous Application (e.g., earth moving, mining, demolition, etc)	This machine

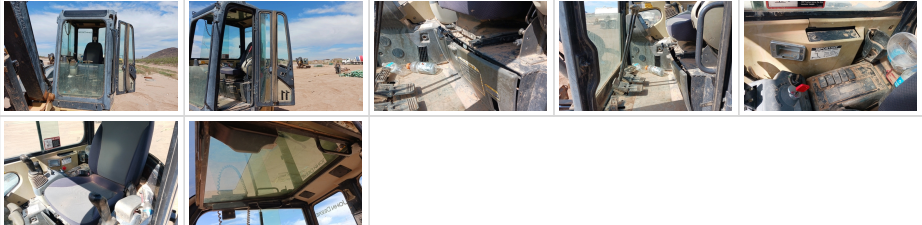
Control Station Photos

Seat	3 - Normal Wear & Tear
Seat Condition	Seat(s) have minor surface staining or small tears, Seat belt shows limited functionality or does not secure properly
Cabin Lights	0
Safety Lock Out / Stop	3 - Normal Wear & Tear
Safety Lock Out / Stop Condition	Safety lock out device is present, in good condition, and functional
Controls & Switches	3 - Normal Wear & Tear
Controls & Switches Condition	All switches are installed and functional

Hour Meter Activity	3 - Normal Wear & Tear
Hour Meter Condition	Hour meter is functional and in good condition
Other Gauge Activity	3 - Normal Wear & Tear
Heater & A/C	0
Travel Alarm	3 - Normal Wear & Tear
Horn	3 - Normal Wear & Tear
Backup Camera	0
Control Station Overall Rating	2 - Above Average Wear & Tear
Control Station Overall Condition	Minor cosmetic wear to cabin surfaces, floors, panels, and ceiling

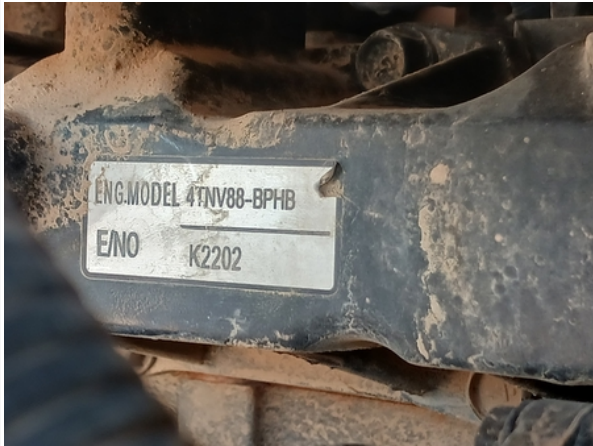
Engine Data Plate

Battery Condition	Stains & signs of corrosion seen
Radiator	3 - Normal Wear & Tear
Radiator Condition	Radiator fins & components appear to be in good working order, no signs of damage or leaks
Belts	3 - Normal Wear & Tear
Belt Condition	Belts appear in good condition & alignment with proper tension
Hoses	3 - Normal Wear & Tear
Hose Condition	Firm, pliant hoses with no signs of wear or leaks
Water Pump	3 - Normal Wear & Tear
Water Pump Condition	No unusual pump noises heard
Cooling System Leaks	No
Coolant Appearance	2 - Above Average Wear & Tear
Coolant Appearance Notes	Dark, opaque appearance
Oil Leaks	No
Oil Appearance	2 - Above Average Wear & Tear
Oil Appearance Notes	Very dark, black & burnt oil appearance, Appropriate oil level
Fuel Leaks	No
Equipped with DPF (Diesel Particulate Filter)	No
Requires DEF (Diesel Exhaust Fluid)	No
Overall Engine Rating	3 - Normal Wear & Tear
Overall Engine Appearance	Very dirty

Overall Engine Comments	The engine is in working order but the engine and battery are very dirty

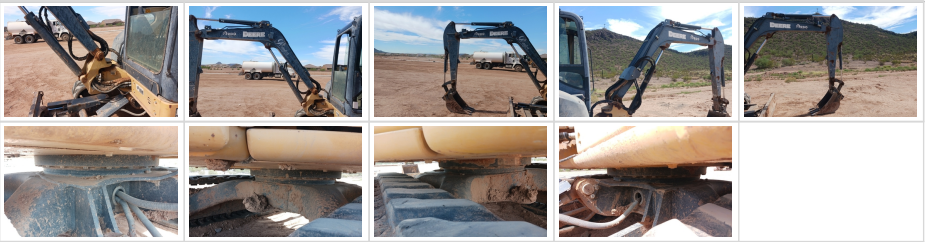
Chassis Photos

Boom Condition	3 - Normal Wear & Tear
Stick Condition	3 - Normal Wear & Tear
Boom Base Pin & Bushings	3 - Normal Wear & Tear
Boom to Stick Pin & Bushings	3 - Normal Wear & Tear
Stick to Bucket Pin & Bushings	3 - Normal Wear & Tear
Turntable Bearing	3 - Normal Wear & Tear
Bottom Covers	3 - Normal Wear & Tear
Overall Chassis	3 - Normal Wear & Tear
Overall Chassis Comments	The chassis is in good working condition

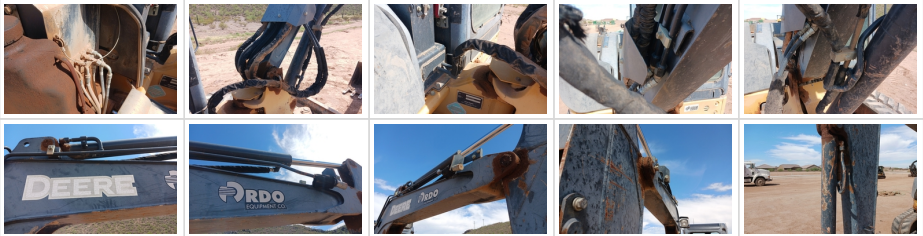
Hydraulic System Photos

Wet or Damp Hydraulic Lines / Fittings	No
Hydraulic Lines/Fittings	3 - Normal Wear & Tear
Hydraulic Lines / Fittings Condition	Hydraulic lines & fittings are clean and in good condition
Hydraulic Pump(s)	3 - Normal Wear & Tear
Unusual Noises	No
Hydraulic Pump Notes	No unusual noises heard during operation
