Inspection Report (Excavator)

B&B Stock Number	A6419627
Year	2011
Make	Caterpillar
Model	FF135DX
Serial Number	1FF135DXEBD302651
Hour Meter Reading	5018
Previous Application (e.g., earth moving, mining, demolition, etc)	This machine was used in civil construction

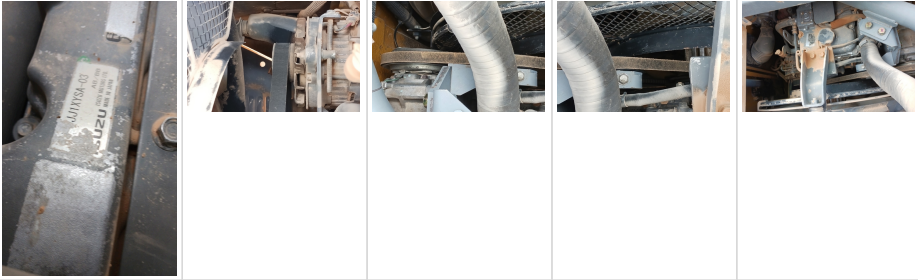
Engine Compartment Photos

Battery	3 - Normal Wear & Tear
Battery Condition	Dusty & dirty appearance
Radiator	3 - Normal Wear & Tear
Radiator Condition	Radiator fins & components appear to be in good working order, no signs of damage or leaks
Belts	2 - Above Average Wear & Tear
Belt Condition	Frayed belt edges observed
Hoses	3 - Normal Wear & Tear
Hose Condition	Firm, pliant hoses with no signs of wear or leaks
Water Pump	3 - Normal Wear & Tear
Water Pump Condition	No unusual pump noises heard
Cooling System Leaks	No
Coolant Appearance	3 - Normal Wear & Tear
Coolant Appearance Notes	Normal Translucent appearance, no visual signs of contamination
Oil Leaks	No
Oil Appearance	3 - Normal Wear & Tear
Oil Appearance Notes	Very dark, black & burnt oil appearance, Appropriate oil level
Fuel Leaks	No
Equipped with DPF (Diesel Particulate Filter)	No
Requires DEF (Diesel Exhaust Fluid)	No
Overall Engine Rating	3 - Normal Wear & Tear
Overall Engine Appearance	Dusty & dry

Overall Engine Comments	The engine is in good working order, but a belt was seen with frayed edges.

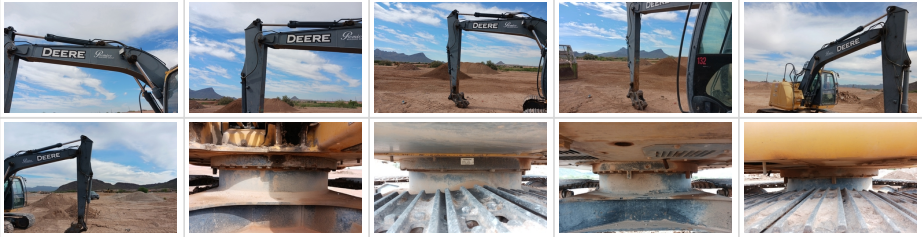
Chassis Photos

Boom Condition	3 - Normal Wear & Tear
Stick Condition	3 - Normal Wear & Tear
Boom Base Pin & Bushings	3 - Normal Wear & Tear
Boom to Stick Pin & Bushings	3 - Normal Wear & Tear
Stick to Bucket Pin & Bushings	3 - Normal Wear & Tear
Turntable Bearing	3 - Normal Wear & Tear
Bottom Covers	3 - Normal Wear & Tear
Overall Chassis	3 - Normal Wear & Tear
Overall Chassis Comments	The chassis is in good working order

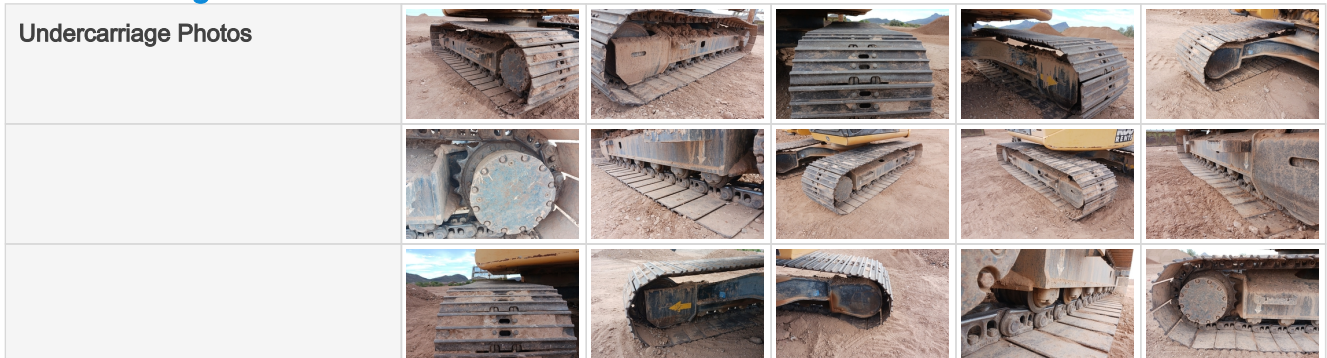
Undercarriage Photos

Sprocket Teeth	2 - Above Average Wear & Tear
Comments	the sprocket teeth display above normal wear and tear
Track Bushings	3 - Normal Wear & Tear
Track Frames	3 - Normal Wear & Tear
Pivot Shafts	3 - Normal Wear & Tear
Equalizer Bar & Joints	3 - Normal Wear & Tear
Front Idler	3 - Normal Wear & Tear
Track Tensioner	3 - Normal Wear & Tear
Track links	3 - Normal Wear & Tear
Bottom Rollers	3 - Normal Wear & Tear
Carrier Rollers	3 - Normal Wear & Tear
Overall Undercarriage	3 - Normal Wear & Tear
Overall Percent Estimate	50%
Overall Undercarriage Comments	The undercarriage is in good working order
