Inspection Report (Bulldozer)

B&B Stock Number	A2618669
Year	2013
Make	Caterpillar
Model	D6K2 XL
Serial Number	CAT00D6KHWMR00245
Hour Meter Reading	5415
Previous Application (e.g., earth moving, mining, demolition, etc)	This machine was used in civil construction

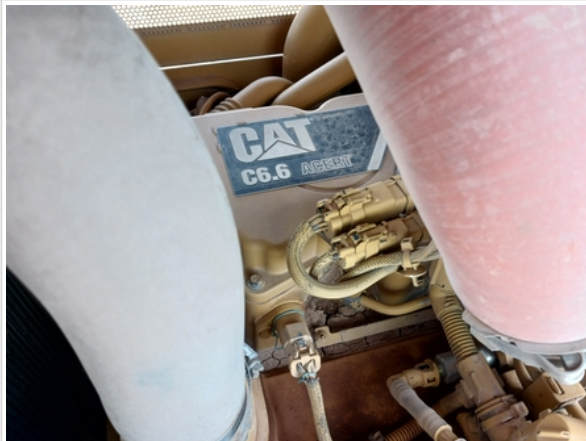
Engine Data Plate

Engine Type (Make, Model, Cylinders, Hp)	Cat, C6.6 acert
Emissions Tier	Undetermined
Engine Serial Number	C8N08553
Engine Fuel Type	Diesel
Blow-by (Visual Observation Check)	No
Unusual Noises (Upon Start-up, Idle, Shutdown)	No
Engine Smoke (Upon Start-up, Idle, Shutdown)	No
Engine Exhaust Color	Clear
Battery	3 - Normal Wear & Tear
Battery Condition	Dusty & dirty appearance
Radiator	3 - Normal Wear & Tear
Radiator Condition	Radiator fins & components appear to be in good working order, no signs of damage or leaks
Belts	4 - Very Light or Minimal Wear
Belt Condition	Belts appear in good condition & alignment with proper tension
Hoses	3 - Normal Wear & Tear
Hose Condition	Firm, pliant hoses with no signs of wear or leaks
Water Pump	3 - Normal Wear & Tear
Water Pump Condition	No unusual pump noises heard
Cooling System Leaks	No
Coolant Appearance	3 - Normal Wear & Tear
