## Inspection Report (Excavator)

B&B Stock Number	A5492407
Year	2012
Make	John deere
Model	50D
Serial Number	1FF050DXPCG277232
Hour Meter Reading	5324.8
Previous Application (e.g., earth moving, mining, demolition, etc)	Earth moving

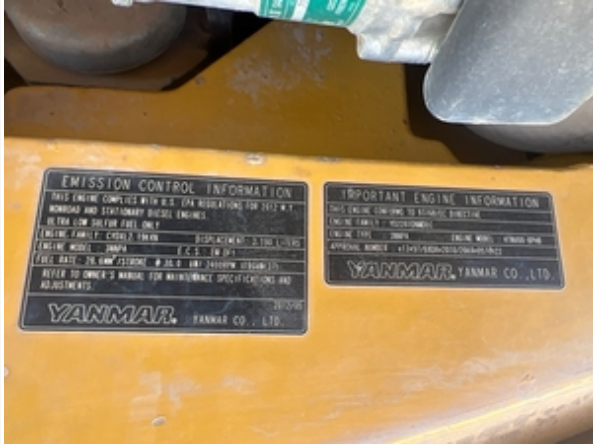
Engine Data Plate

Engine Type (Make, Model, Cylinders, Hp)	Yanmar, 4TNV88-BPHB				
Emissions Tier	Undetermined				
Engine Serial Number	K2072				
Engine Fuel Type	Diesel				
Blow-by (Visual Observation Check)	No				
Unusual Noises (Upon Start-up, Idle, Shutdown)	No				
Engine Smoke (Upon Start-up, Idle, Shutdown)	No				
Engine Exhaust Color	Clear				
Battery	3 - Normal Wear & Tear

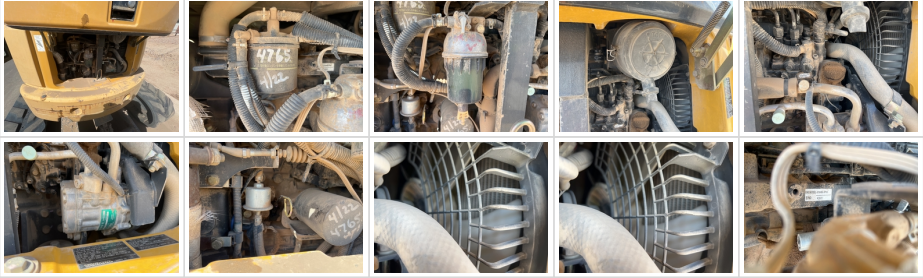
Engine Compartment Photos

Battery Condition	Dusty & dirty appearance
Radiator	3 - Normal Wear & Tear
Radiator Condition	Radiator fins & components appear to be in good working order, no signs of damage or leaks
Belts	3 - Normal Wear & Tear
Belt Condition	Belts appear in good condition & alignment with proper tension
Hoses	3 - Normal Wear & Tear
Hose Condition	Firm, pliant hoses with no signs of wear or leaks
Water Pump	3 - Normal Wear & Tear
Water Pump Condition	No unusual pump noises heard
Cooling System Leaks	No
Coolant Appearance	3 - Normal Wear & Tear
Oil Leaks	No
Oil Appearance	3 - Normal Wear & Tear
Oil Appearance Notes	Appropriate oil level
Fuel Leaks	No
Equipped with DPF (Diesel Particulate Filter)	No
Requires DEF (Diesel Exhaust Fluid)	No
Overall Engine Rating	3 - Normal Wear & Tear
Overall Engine Appearance	Dusty & dry
Overall Engine Comments	Normal wear and tear no major issues to report

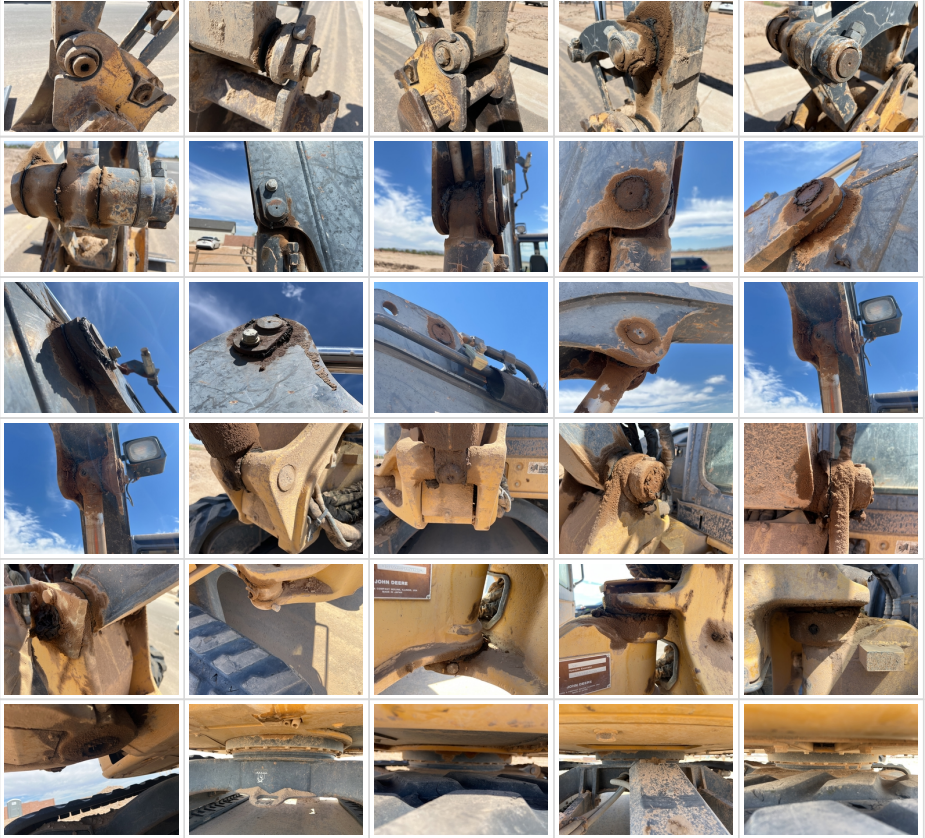
Chassis Photos

Boom Condition	3 - Normal Wear & Tear
Stick Condition	3 - Normal Wear & Tear
Boom Base Pin & Bushings	3 - Normal Wear & Tear
Boom to Stick Pin & Bushings	3 - Normal Wear & Tear
Stick to Bucket Pin & Bushings	2 - Above Average Wear & Tear
Comments	Sloppy / worn
Turntable Bearing	3 - Normal Wear & Tear
Bottom Covers	3 - Normal Wear & Tear
Overall Chassis	3 - Normal Wear & Tear
Overall Chassis Comments	Normal wear and tear no major issues to report

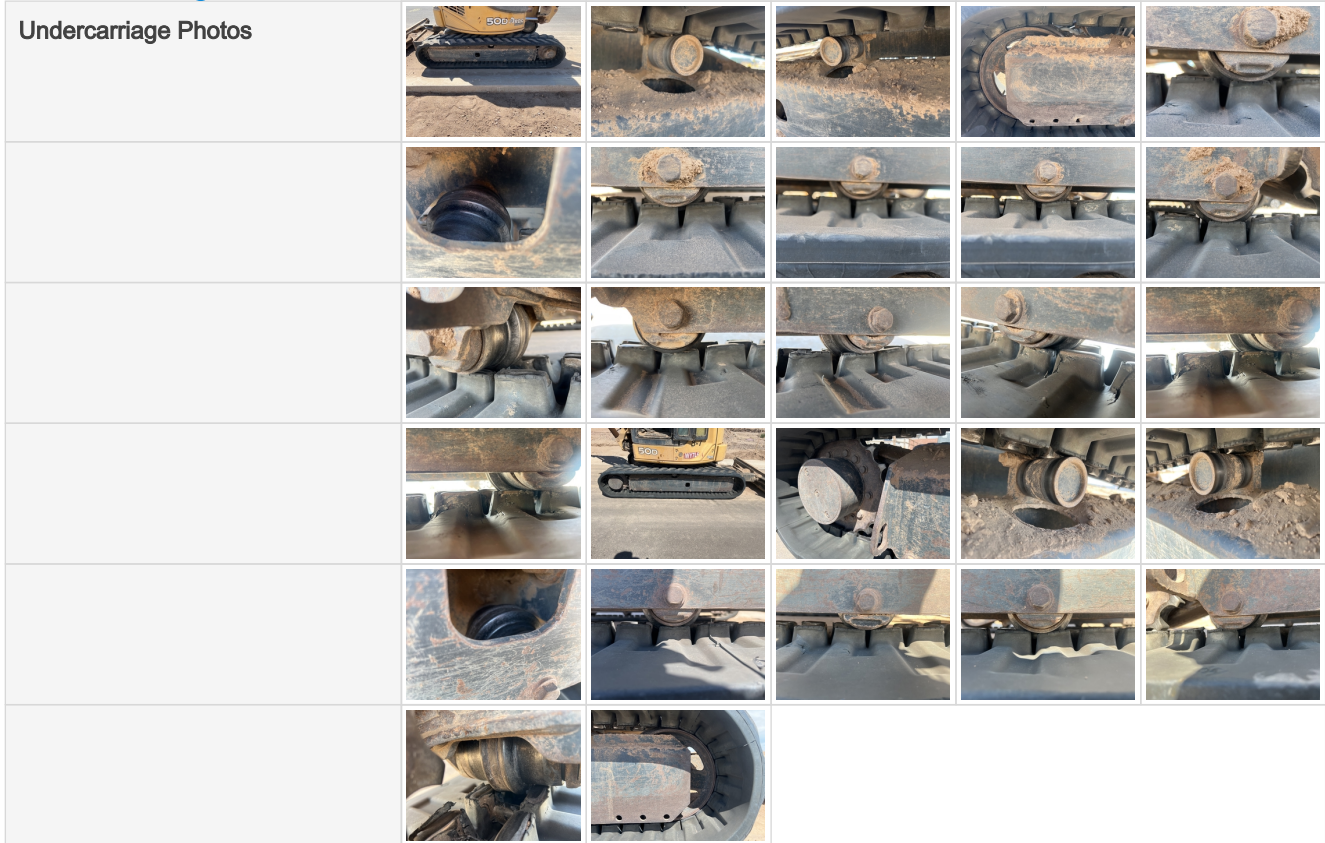
### Undercarriage Photos

Track Width (inches)	16"
Track Length (inches)	83"
Roller Frames	3 - Normal Wear & Tear
Track Belt	3 - Normal Wear & Tear
Rubber Belt Drive Lugs	3 - Normal Wear & Tear
Track Tensioners	3 - Normal Wear & Tear
Front Idlers	3 - Normal Wear & Tear
Rear Idlers	3 - Normal Wear & Tear
Track Rollers	3 - Normal Wear & Tear
Sprockets	3 - Normal Wear & Tear
Overall Undercarriage Rating	3 - Normal Wear & Tear
Left Track Belt - Percent Remaining Estimate	90%
Right Track Belt - Percent Remaining Estimate	90%
Overall Comments	Normal wear and tear no major issues to report

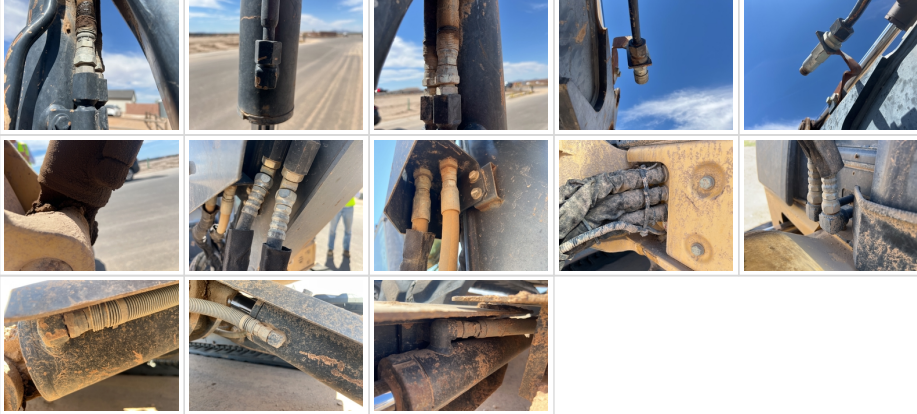
Hydraulic System Photos

Wet or Damp Hydraulic Lines / Fittings	No
Hydraulic Lines/Fittings	3 - Normal Wear & Tear
Hydraulic Lines / Fittings Condition	Dried seepages observed
Hydraulic Pump(s)	3 - Normal Wear & Tear
Unusual Noises	No
Hydraulic Pump Notes	No unusual noises heard during operation

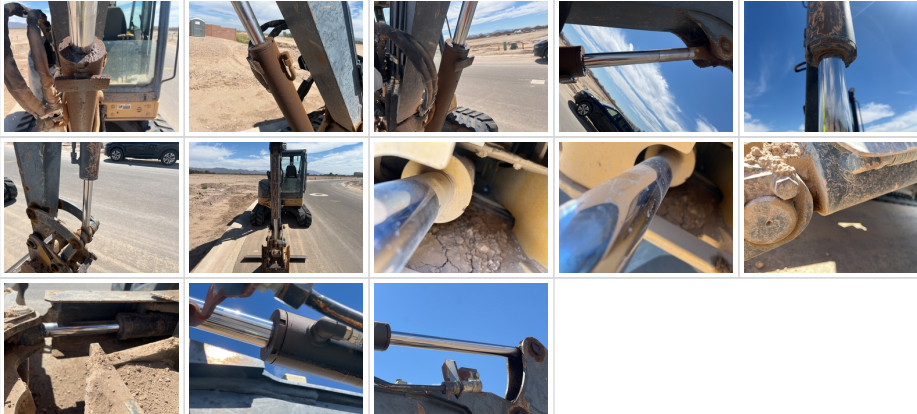
Hydraulic Cylinder Photos

Mounting Pins	3 - Normal Wear & Tear
Cylinder Oil Leaks	Yes
Comments	Main lift and main dig cylinders leaking
Hydraulic System Overall	2 - Above Average Wear & Tear
Comments	Both lift and dig cylinders leaking fluid
