Inspection Report (Skip Loader)

B&B Stock Number	A0013610
Year	2014
Make	John Deere
Model	210K
Serial Number	1T8210EKJEG892052
Hour Meter Reading	7,714 Hrs.
Previous Application (e.g., earth moving, mining, demolition, etc)	Landscape Construction

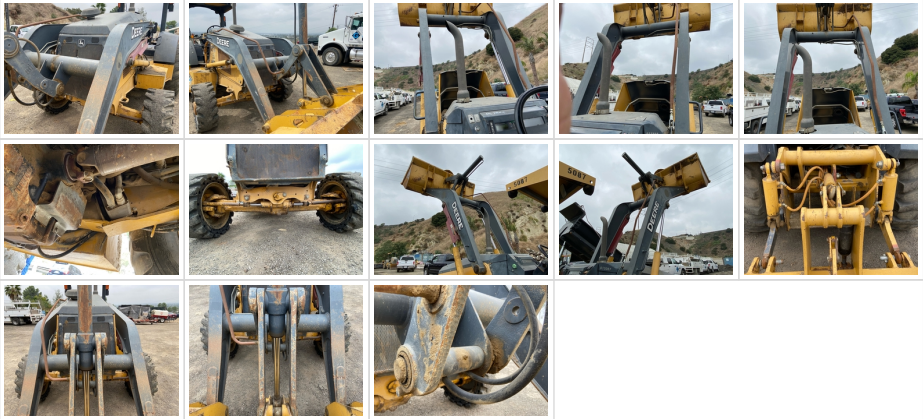
Frame	3 - Normal Wear & Tear				
Stance	3 - Normal Wear & Tear				
Front Axle	2 - Above Average Wear & Tear				
Comments	Front L/S Hub has excessive play where it connects to main axle. Further inspection as to why, recommended.				
Rear Axle	3 - Normal Wear & Tear				
Oscillating Pin	3 - Normal Wear & Tear				
Lift Arm	3 - Normal Wear & Tear				
Chassis to Arm Pins	3 - Normal Wear & Tear				
Tilt Linkage	3 - Normal Wear & Tear				
Tilt Linkage Pins & Bushings	3 - Normal Wear & Tear				
Bucket to Arm Pins	3 - Normal Wear & Tear

Overall Chassis	3 - Normal Wear & Tear
Overall Chassis Comments	Main frame and front loader arms are in good condition. The rear frame to the rear box is also in good shape. The rear axle has a good working, healthy appearance. The front main axle and R/S hub in okay shape. The Front L/S Hub needs attention.
