Inspection Report (Excavator)

B&B Stock Number	A4810043
Year	2018
Make	Kubota
Model	U17
Serial Number	46727
Hour Meter Reading	363.4 Hrs.
Previous Application (e.g., earth moving, mining, demolition, etc)	Residential Plumbing Services

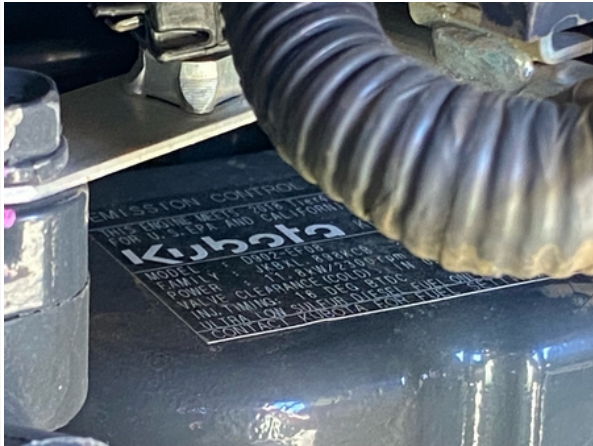
Engine Data Plate

Engine Type (Make, Model, Cylinders, Hp)	Kubota - D902-EF08 - 3Cyl. - 16Hp				
Emissions Tier	Tier 4F				
Engine Serial Number	4JL5696				
Engine Fuel Type	Diesel				
Blow-by (Visual Observation Check)	No				
Unusual Noises (Upon Start-up, Idle, Shutdown)	No				
Engine Smoke (Upon Start-up, Idle, Shutdown)	No				
Engine Exhaust Color	Clear				
Battery	3 - Normal Wear & Tear				
Battery Condition	Clean & dry appearance, tight connections				
Radiator	3 - Normal Wear & Tear				
Radiator Condition	Radiator fins & components appear to be in good working order, no signs of damage or leaks				
Belts	3 - Normal Wear & Tear				
Belt Condition	Belts appear in good condition & alignment with proper tension				
Hoses	3 - Normal Wear & Tear				
Hose Condition	Firm, pliant hoses with no signs of wear or leaks				
Water Pump	3 - Normal Wear & Tear

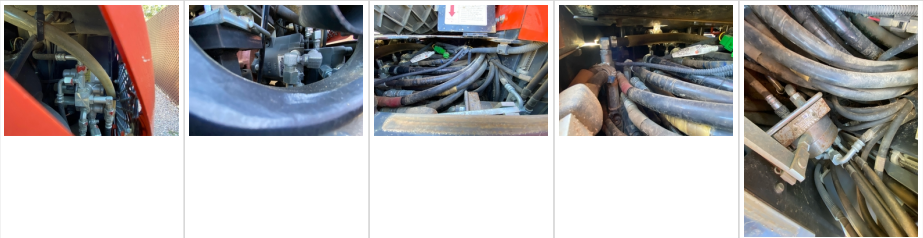
Hydraulic System Photos

Wet or Damp Hydraulic Lines / Fittings	Yes				
Hydraulic Lines/Fittings	4 - Very Light or Minimal Wear				
Hydraulic Lines / Fittings Condition	Hydraulic lines & fittings are clean and in good condition				
Hydraulic Pump(s)	3 - Normal Wear & Tear				
Unusual Noises	No				
Hydraulic Pump Notes	No unusual noises heard during operation
