Inspection Report (Wheel Loader)

B&B Stock Number	A2041321
Year	2022
Make	Hitachi
Model	ZW75-6C
Serial Number	W09P85329NBA08914
Hour Meter Reading	133.4
Previous Application (e.g., earth moving, mining, demolition, etc)	Light Construction

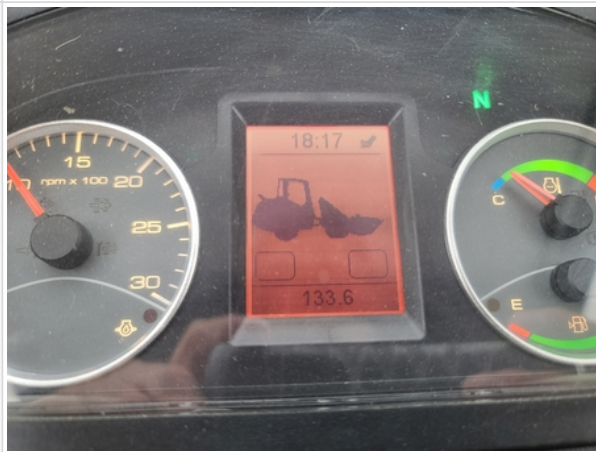
Hour Meter/Odometer

Seat	4 - Very Light or Minimal Wear
Seat Condition	Seat(s) in good condition, no stains or tears in upholstery
Cabin Lights	5 - Like New, Recently Replaced
Safety Lock Out / Stop	5 - Like New, Recently Replaced
Controls & Switches	5 - Like New, Recently Replaced
Hour Meter Activity	5 - Like New, Recently Replaced
Hour Meter Condition	Hour meter is functional and in good condition

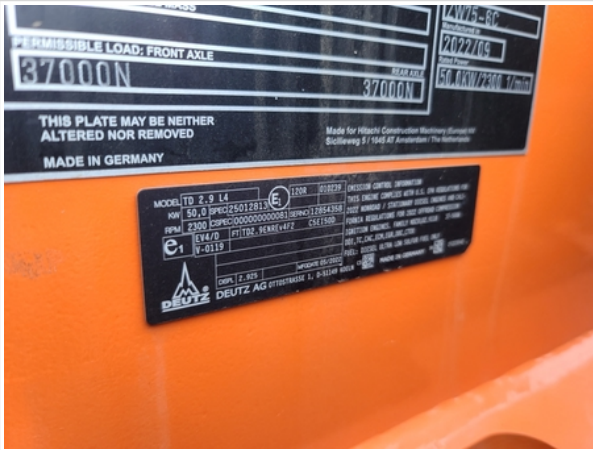
Engine Data Plate

Engine Type (Make, Model, Cylinders, Hp)	Deutz TD 2.9 L4				
Emissions Tier	Tier 4F				
Engine Serial Number	12854358				
Engine Fuel Type	Diesel				
Blow-by (Visual Observation Check)	No				
Unusual Noises (Upon Start-up, Idle, Shutdown)	No				
Engine Smoke (Upon Start-up, Idle, Shutdown)	No				
Engine Exhaust Color	Clear				
Battery	5 - Like New, Recently Replaced				
Battery Condition	Like new, recently replaced

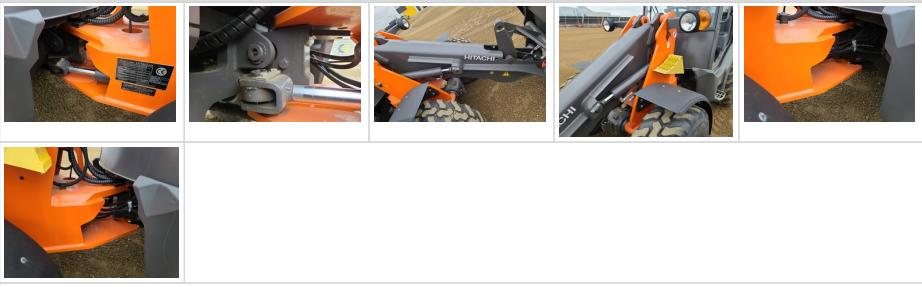
Chassis Photos

Frame	5 - Like New, Recently Replaced
Stance	5 - Like New, Recently Replaced
Front Axle Appearance	5 - Like New, Recently Replaced
Rear Axle Appearance	5 - Like New, Recently Replaced
Articulating Center Pin Appearance	5 - Like New, Recently Replaced
Lift Arm	5 - Like New, Recently Replaced
Chassis to Arm Pins	5 - Like New, Recently Replaced
Tilt Linkage	5 - Like New, Recently Replaced
Tilt Linkage Pins and Bushings	5 - Like New, Recently Replaced
Quick Coupler	5 - Like New, Recently Replaced
Quick Coupler to Arms Pins	5 - Like New, Recently Replaced
Overall Chassis	5 - Like New, Recently Replaced
