## Inspection Report (Backhoe Loader)

B&B Stock Number	A7677763
Year	2016
Make	Kubota
Model	L47
Serial Number	A0697
Hour Meter Reading	798 Hrs.
Previous Application (e.g., earth moving, mining, demolition, etc)	Plumbing Repair Services

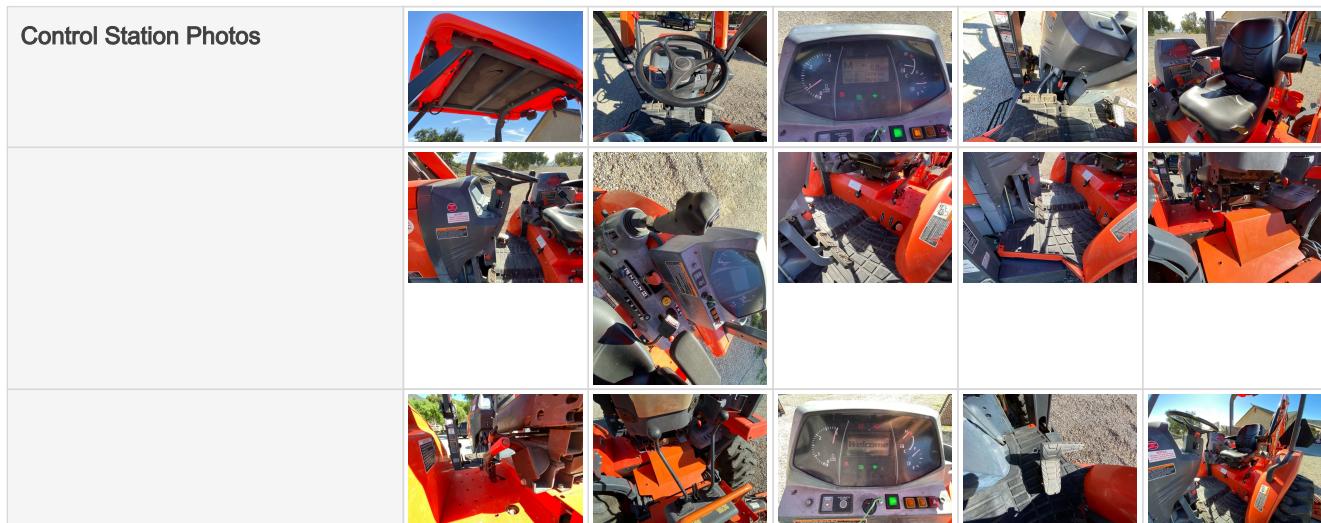
#### Control Station Photos

Seat	3 - Normal Wear & Tear
Seat Condition	Seat(s) have minor surface staining or small tears, Seat(s) is damaged due to sun exposure; fading, cracking observed
Cabin Lights	0
Safety Lock Out / Stop	3 - Normal Wear & Tear
Safety Lock Out / Stop Condition	Safety lock out device is present, in good condition, and functional
Controls & Switches	3 - Normal Wear & Tear
Controls & Switches Condition	All switches are installed and functional
Hour Meter Activity	3 - Normal Wear & Tear
Hour Meter Condition	Hour meter is functional and in good condition
Other Gauge Activity	3 - Normal Wear & Tear
Other Gauge Condition	All cockpit gauges are functional and in good condition
Heater & A/C	0
Travel Alarm	3 - Normal Wear & Tear
Travel Alarm Condition	Travel alarm is installed and functioning as expected
Horn	3 - Normal Wear & Tear
Horn Condition	Horn is installed and functioning as expected
Backup Camera	0
Control Station Overall Rating	3 - Normal Wear & Tear

Control Station Overall Condition	Good cabin appearance, solid floors, panels, and ceiling

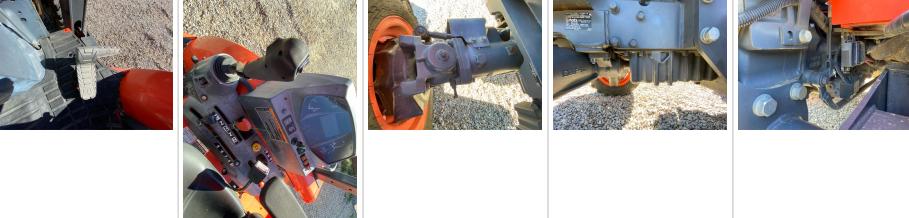
Drivetrain Photos

Hydrostatic Transmission?	Yes
2 Speed?	No
Hydrostatic Drive Configuration	Other (see comments)
Comments	Hydrostatic
Drive	4WD
Transmission Components	3 - Normal Wear & Tear
Transmission Condition	Good forward and reverse function, No unusual noises or vibrations
Drive Motors	0
Parking Brake	3 - Normal Wear & Tear
Parking Brake Function	Good brake function
Overall Drivetrain Rating	3 - Normal Wear & Tear
Overall Drivetrain Comments	Machine travels well in all directions with no operational issues seen.
