## Inspection Report (Vibratory Compactor)

B&B Stock Number	A2691455
Year	2017
Make	Volvo
Model	DD110B
Serial Number	VCED110BT0S285209
Hour Meter Reading	672 Hrs.
Previous Application (e.g., earth moving, mining, demolition, etc)	Equipment Rental

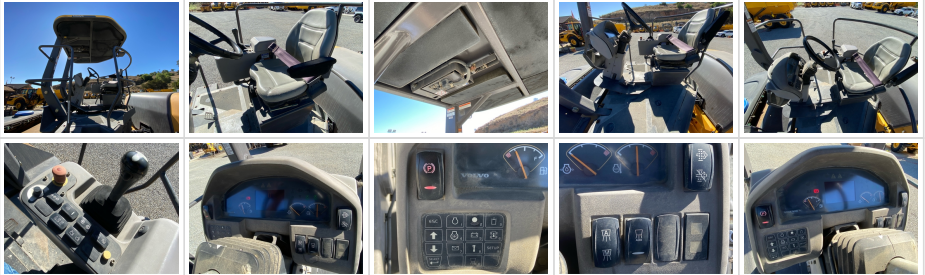
Control Station Photos

Seat Condition	Seat(s) have minor surface staining or small tears, Seat(s) is damaged due to sun exposure; fading, cracking observed
Comments	Seat has minor surface cracks but overall in good shape
Cabin Lights	0
Safety Lock Out / Stop	3 - Normal Wear & Tear
Safety Lock Out / Stop Condition	Safety lock out device is present, in good condition, and functional
Controls & Switches	3 - Normal Wear & Tear
Controls & Switches Condition	All switches are installed and functional
Hour Meter Activity	3 - Normal Wear & Tear
Hour Meter Condition	Hour meter is functional and in good condition
Other Gauge Activity	3 - Normal Wear & Tear
Other Gauge Condition	Gauges are functional, with some wear and/or cosmetic damage, Other (see comments)
Comments	Digital Screen a bit hard to read
Heater & A/C	0
Travel Alarm	2 - Above Average Wear & Tear
Travel Alarm Condition	System is configured but not operating correctly
Horn	3 - Normal Wear & Tear

Horn Condition	Horn is installed and functioning as expected
Backup Camera	0
Control Station Overall Rating	3 - Normal Wear & Tear
Control Station Overall Condition	Good cabin appearance, solid floors, panels, and ceiling, Minor cosmetic wear to cabin surfaces, floors, panels, and ceiling
Comments	Operator station is in good condition

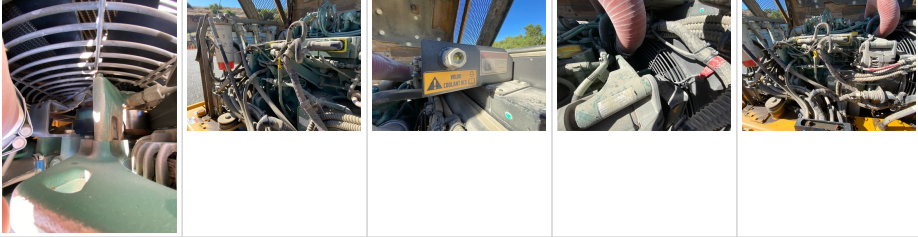
<b>Engine Compartment Photos</b>

Belts	3 - Normal Wear & Tear
Belt Condition	Belts appear in good condition & alignment with proper tension
Hoses	3 - Normal Wear & Tear
Hose Condition	Firm, pliant hoses with no signs of wear or leaks
Water Pump	3 - Normal Wear & Tear
Water Pump Condition	No unusual pump noises heard
Cooling System Leaks	No
Coolant Appearance	3 - Normal Wear & Tear
Coolant Appearance Notes	Normal Translucent appearance, no visual signs of contamination
Oil Leaks	No
Oil Appearance	3 - Normal Wear & Tear
Oil Appearance Notes	Clean oil appearance, no signs of cross contamination, Appropriate oil level
Fuel Leaks	No
Equipped with DPF (Diesel Particulate Filter)	Yes
DPF Condition	3 - Normal Wear & Tear
DPF Condition Notes	Filter housing is intact with no signs of damage or malfunction, DPF indicator is not illuminated
Requires DEF (Diesel Exhaust Fluid)	No
Overall Engine Rating	3 - Normal Wear & Tear
Overall Engine Appearance	Dusty & dry

Overall Engine Comments	Overall the engine has a healthy appearance and had no signs of issues.

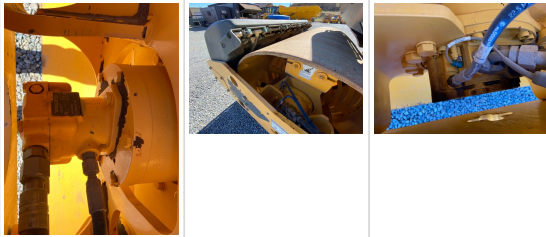
Drivetrain Photos

Transmission Components	3 - Normal Wear & Tear
Transmission Condition	Good forward and reverse function, No unusual noises or vibrations
Drive Motors	3 - Normal Wear & Tear
Parking Brake	3 - Normal Wear & Tear
Parking Brake Function	Good brake function
Overall Drivetrain Rating	3 - Normal Wear & Tear
Overall Drivetrain Comments	Machine travels well in all speeds and in all directions.

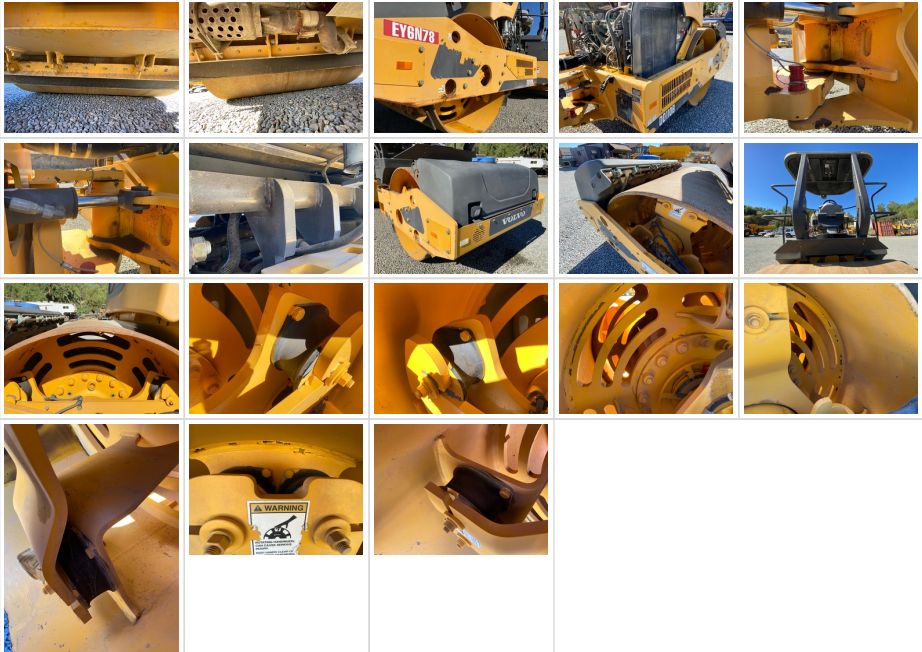
Chassis Photos

Frame	3 - Normal Wear & Tear				
Stance	3 - Normal Wear & Tear				
Drum(s) Condition	3 - Normal Wear & Tear				
Vibratory Rubber Mounts (Front & Rear)	3 - Normal Wear & Tear				
Drum Scraper	3 - Normal Wear & Tear				
Overall Chassis	3 - Normal Wear & Tear				
Overall Chassis Comments	Overall main frame and both drum assemblies are in great shape. No major issues seen with the overall chassis.
